MERCEDES GLA: 1JRZ769

Limited Technical Inspection

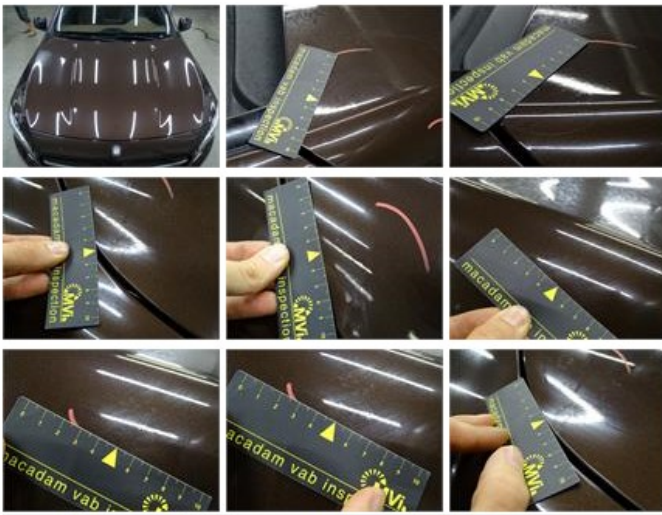
Total cost ex VAT	2264,11
Bonnet, Chemical polution, LI - Repair and paint (complete)	348,09

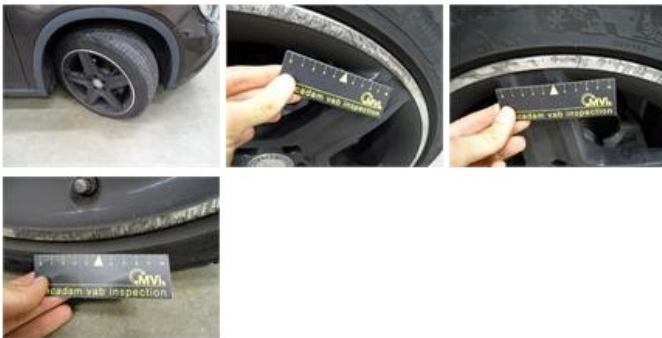
Alloy rim F R polished, Scratch(es), LI - Repair and paint (complete) 95,00

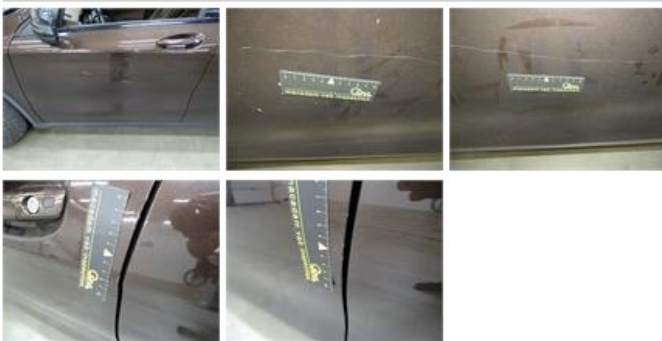
Door F L, Scratch(es), LI - Repair and paint (complete) 382,02

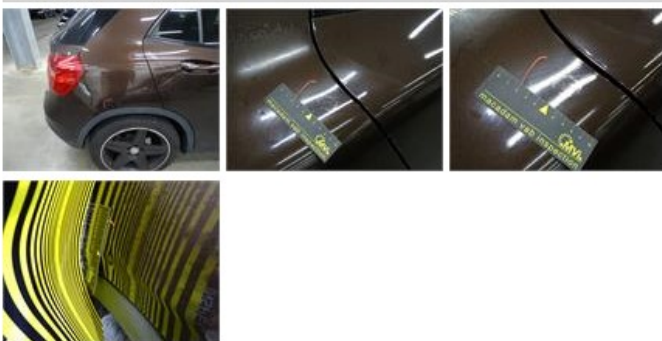
Wing R R, Chemical polution, LI - Repair and paint (complete) 369,84

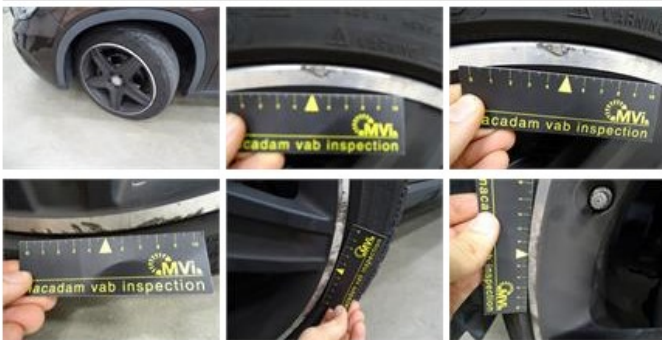
Alloy rim F L polished, Scratch(es), LI - Repair and paint (complete) 95,00

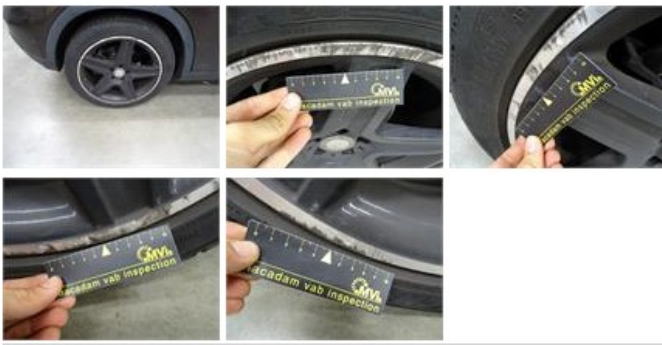
Alloy rim R R polished, Scratch(es), LI - Repair and paint (complete) 95,00

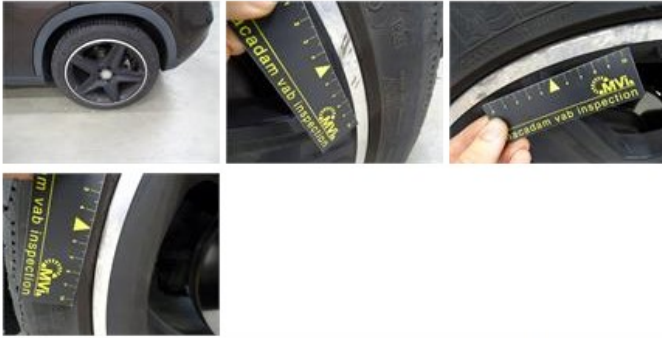
Alloy rim R L polished, Scratch(es), LI - Repair and paint (complete) 95,00

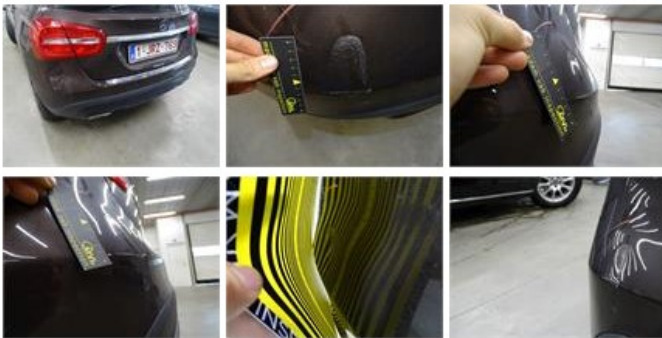
Bumper R, Dent(s) and scratch(es), LI - Repair and paint (complete) 254,16

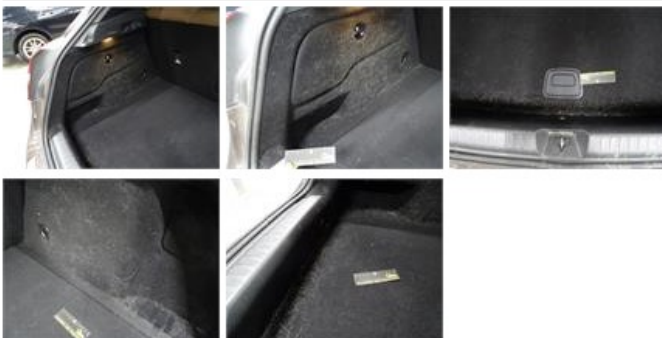
Interior, Dirty, Chemical cleaning 50,00

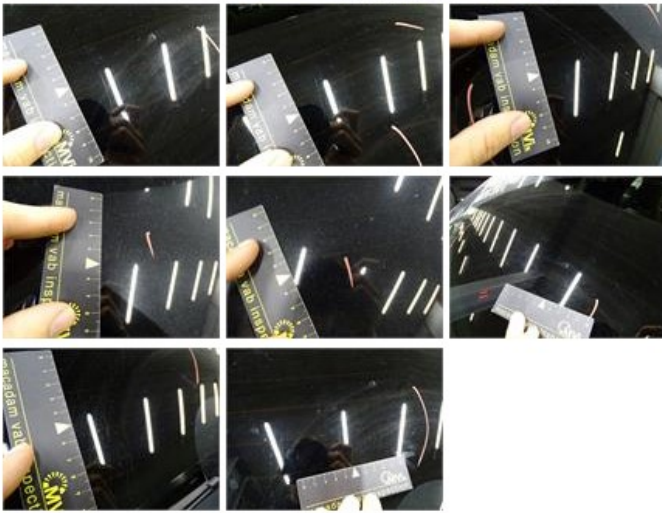
Rear window, Scratch(es), E - Replace 420,00
