MINI Mini: 1HRT425			
Vinnumber:	WMWXN310403A05314	Versionname:	MINI BER Cooper 116PK Aut.
First Registrationdate:	16/09/2014	Fiscalpower:	
Expertise Mileage:	79930	Power Kw:	85
Bodytype:		Body color:	Red
Gearbox:	Automatic	Paint type:	Opaque
Transmission:	Front	Rims summer:	Aluminium
Fueltype:	Diesel	Oil level:	OK
Battery functioning:	Yes	Parking lot:	3322
Number of doors:	3		
Number of seats:	4		
Number head rests:	4		
Rims summer:	Aluminium		
Category:	Passenger Car		
Oil level:	OK		
Registration Certificate Car (BE):	Yes

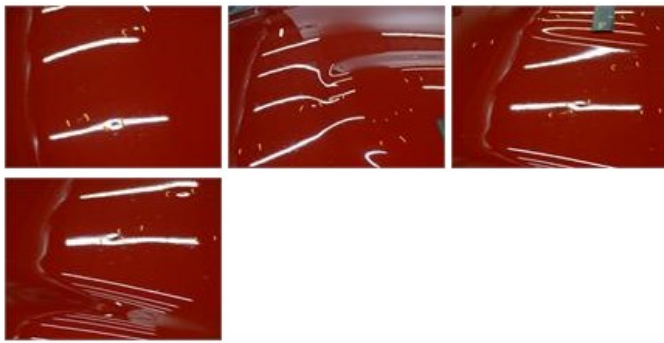
Total cost ex VAT	359,00
Bonnet, Hail damage, Le - Replace and paint	0,00

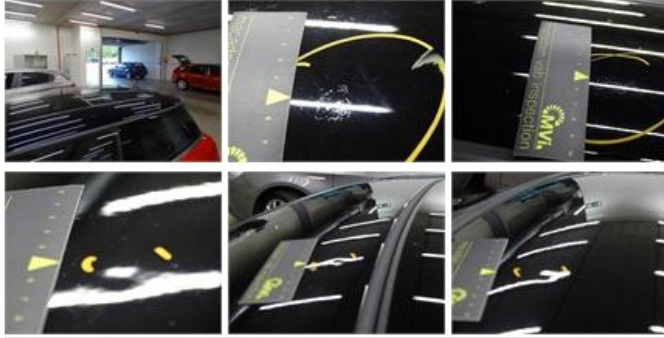
Roof, Hail damage, LI - Repair and paint (complete) 0,00
