SKODA OCTAVIA COMBI: 1JGR864

Limited Technical Inspection

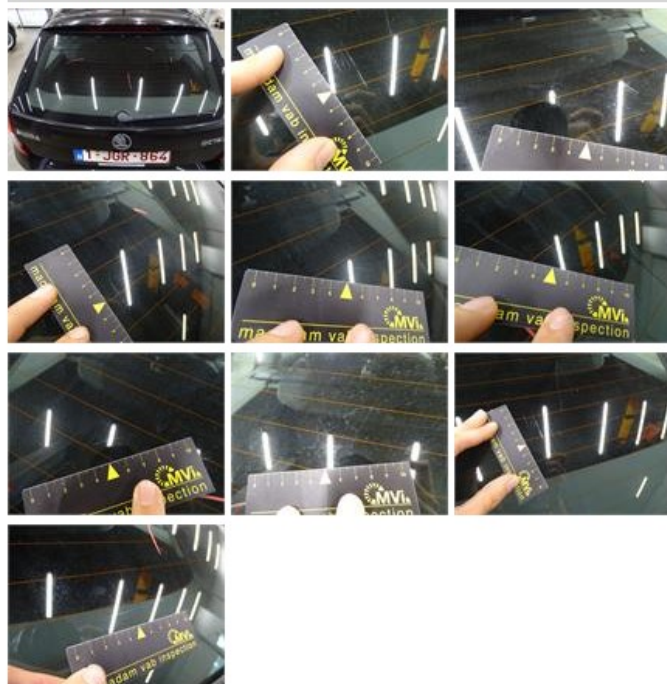
Rear window, Scratch(es), E - Replace 0,00

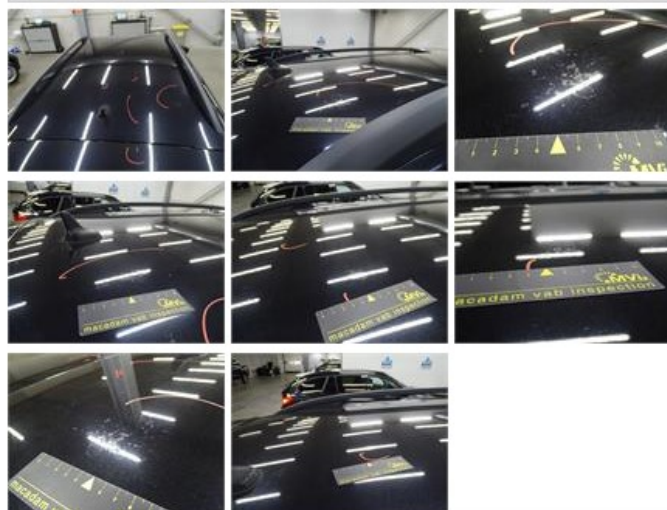
Roof, Chemical polution, LI - Repair and paint (complete) 481,50

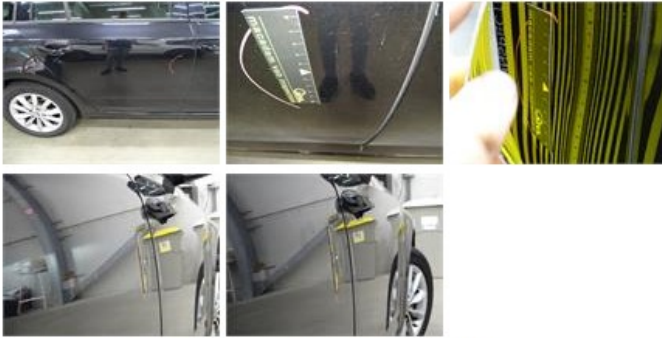
Door R R, Dent(s) and scratch(es), LI - Repair and paint (complete) 318,35

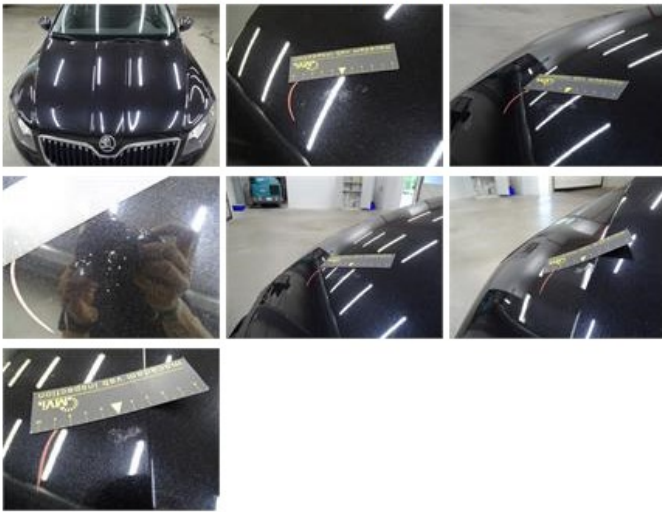
Bonnet, Chemical polition, LI - Repair and paint (complete) 290,08
