OPEL Insignia: 1HJK349

Vinnnumber:	WOLGM8ER9E1143196	Versionname:	INSIGNIA BRE ecoFLEX Edition 120PK
First Registrationdate:	1/08/2014	Fiscalpower:	
Expertise Mileage:	132270	Power Kw:	88
Bodytype:	Break	Body color:	Grey
Gearbox:	MAN 6 VIT	Paint type:	Metalic
Transmission:	Front	Rims summer:	Aluminium
Fueltype:	Diesel	Oil level:	OK
Battery functioning:	Yes	Parking lot:	1118
Number of doors:	5		
Number of seats:	5		
Number head rests:	5		
Rims summer:	Aluminium		
Category:	Passenger Car		
Oil level:	OK		
Registration Certificate Car (BE):	Yes

Limited Technical Inspection

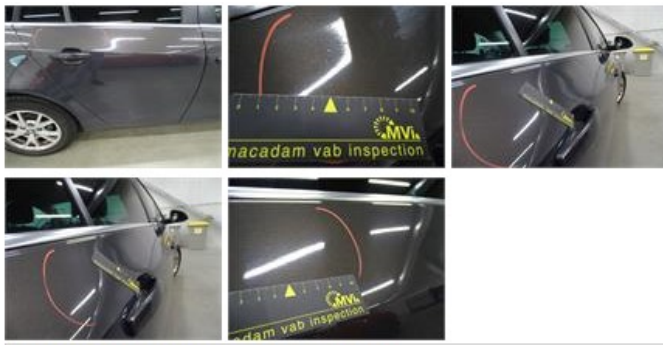
Total cost ex VAT	413,35
Door R R, Bad repair, Acceptable	0,00
