**BMW 3 TOURING: 1LGS722**

**Limited Technical Inspection**

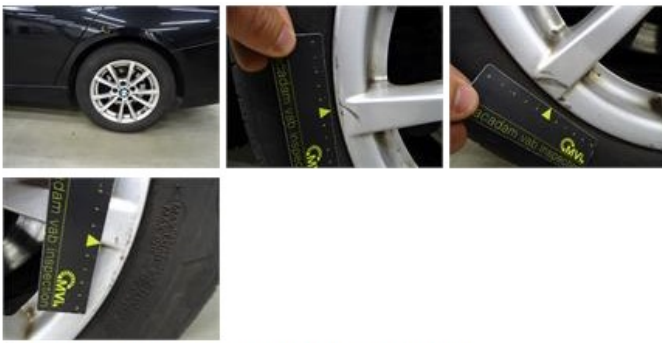
Repair kit	<b>Yes</b>	Compressor	<b>Yes</b>
Total cost ex VAT			<b>2389,63</b>
Alloy rim R L, Scratch(es), LI - Repair and paint (complete)			<b>95,00</b>

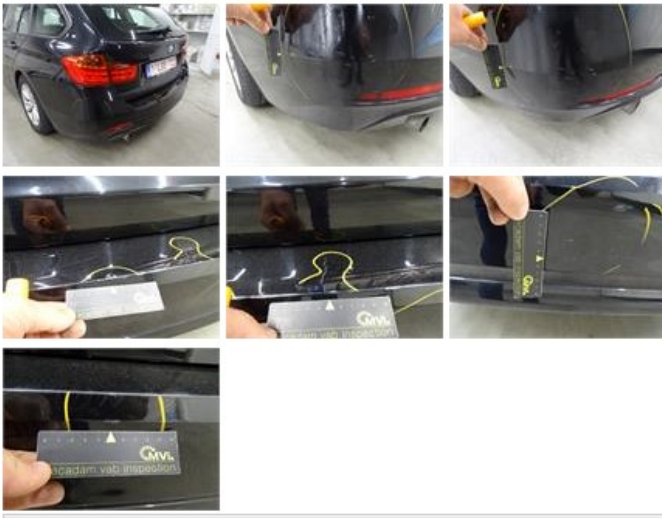
Bumper R, Scratch(es), LI - Repair and paint (complete) 211,80

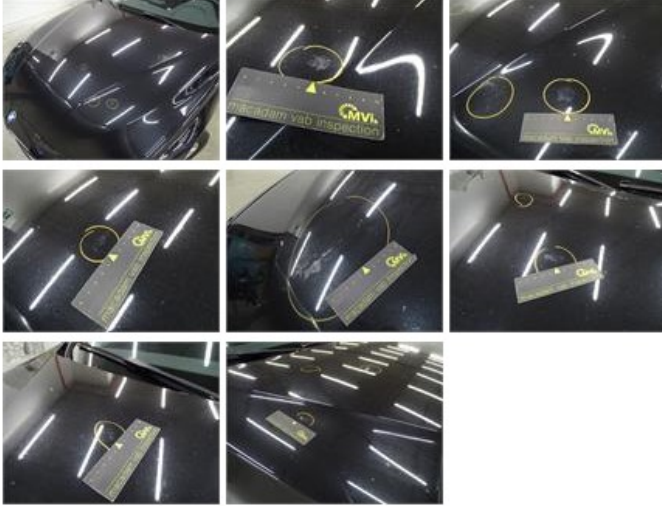
Bonnet, Chemical polution, LI - Repair and paint (complete) 290,08

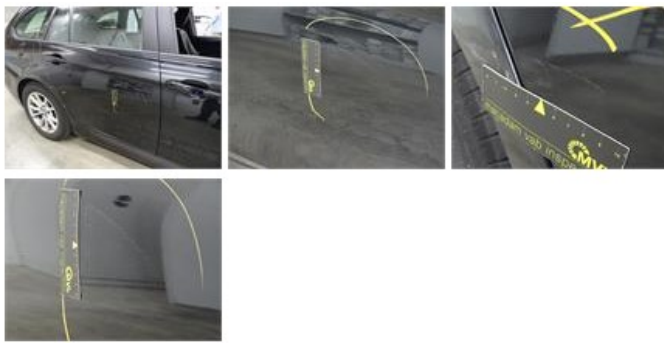
Door R R, Scratch(es), LI - Repair and paint (complete) 318,35

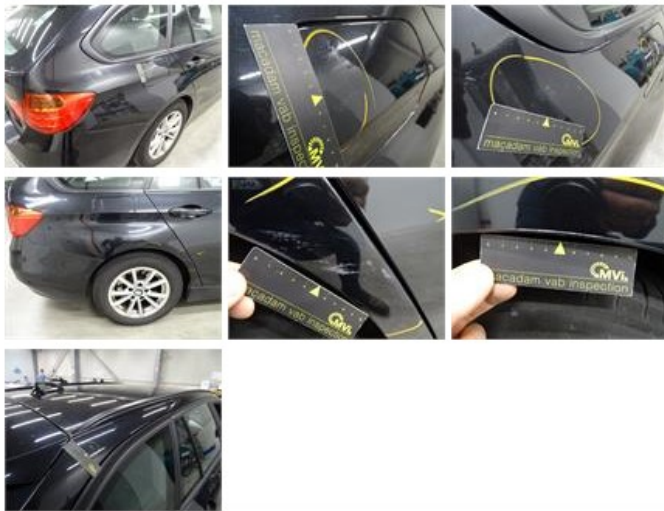
Wing R R, Chemical polution, LI - Repair and paint (complete) 308,20
