BMW 3 TOURING: 1LFJ013

Limited Technical Inspection

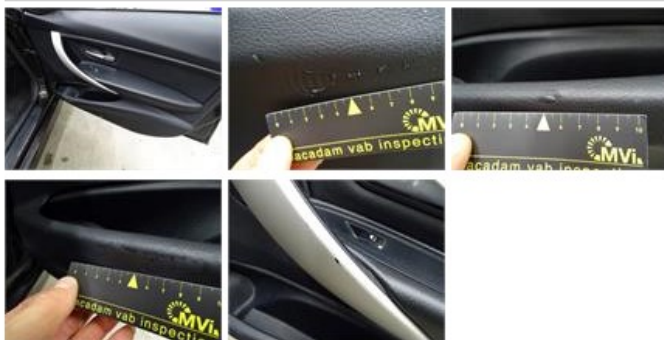
Door panel F R, Scratch(es), E - Replace 114,00

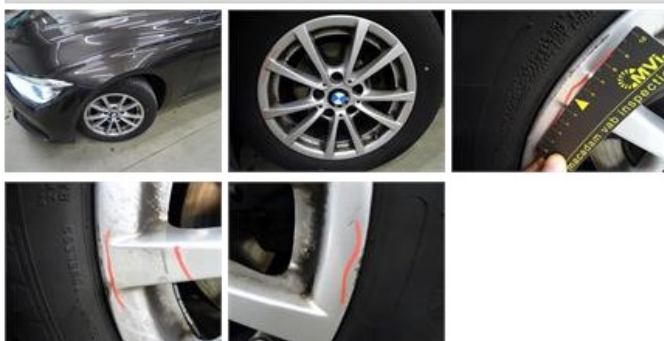
Alloy rim F L, Scratch(es), LI - Repair and paint (complete) 95,00

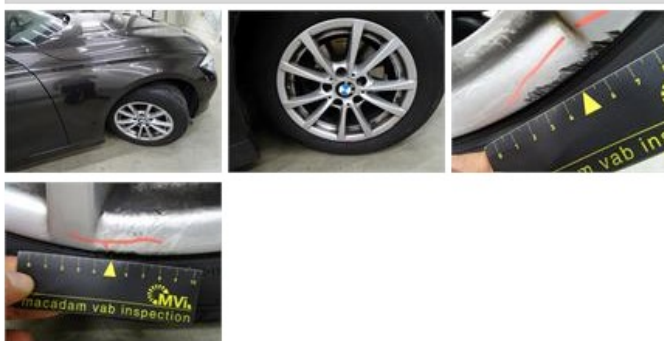
Alloy rim F R, Scratch(es), LI - Repair and paint (complete) 95,00

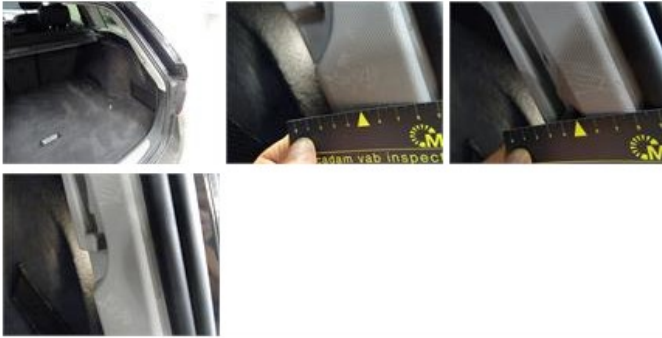
Internal Boot Lining R, Scratch(es), Smart repair

110,64

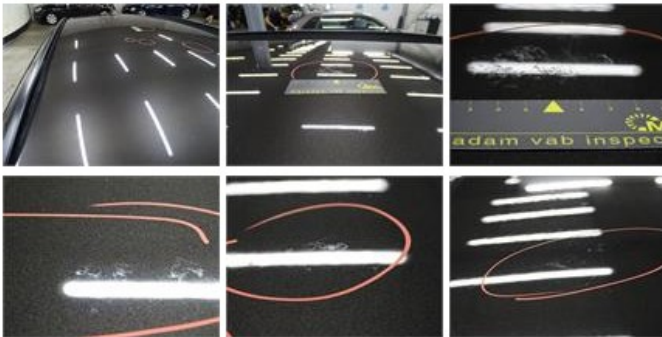
Roof, Chemical pollution, LI - Repair and paint (complete)

481,50
