**VOLKSWAGEN TIGUAN: 1LDZ733**

**Limited Technical Inspection**

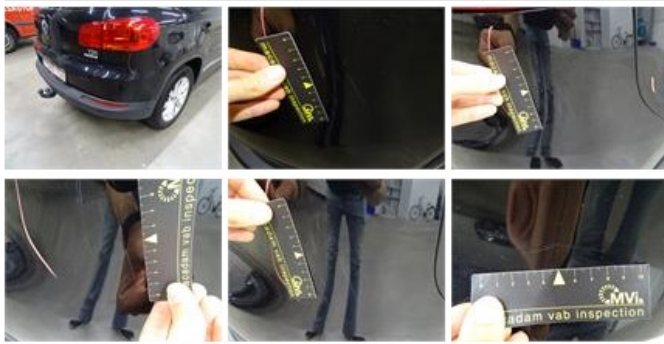
Bumper R, Scratch(es), LI - Repair and paint (complete) 211,80

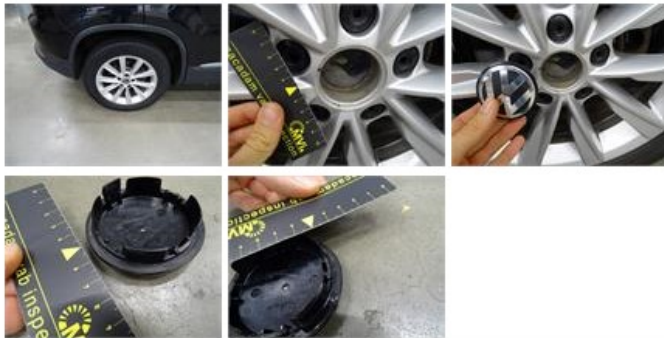
Roof, Dent(s), Acceptable	0,00
No pictures to display	
Door R R, Dent(s) and scratch(es), Acceptable	0,00
No pictures to display	
Wheel hub cap R R, Broken, E - Replace	20,00

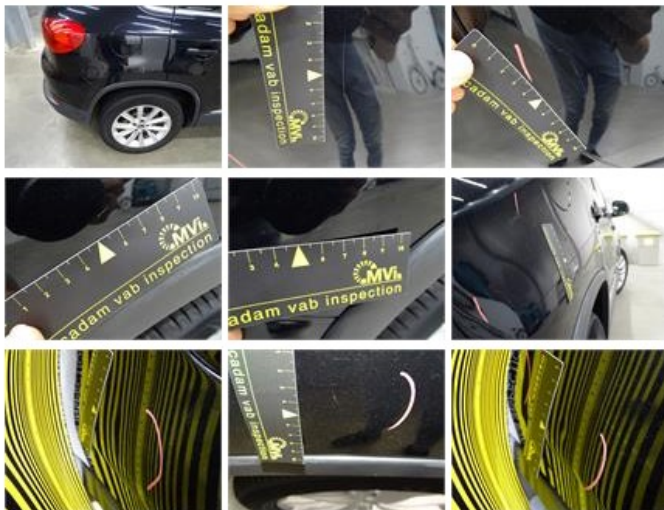
Wing R R, Dent(s) and scratch(es), LI - Repair and paint (complete)	308,20
---	--------

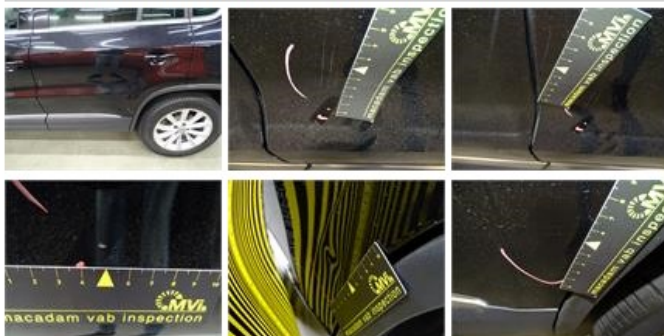
Door R L, Dent(s) and scratch(es), LI - Repair and paint (complete)	318,35
---	--------

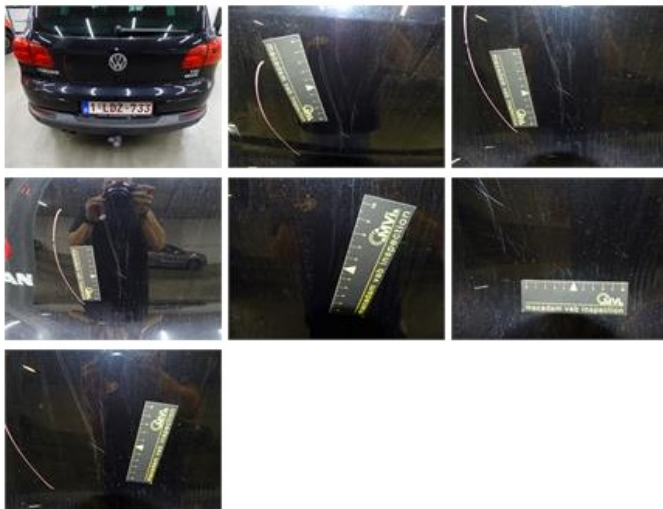
Tailgate, Scratch(es), LI - Repair and paint (complete)	301,68
---	--------

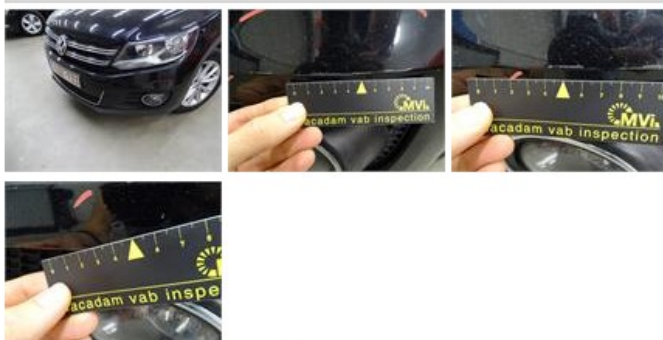
Bumper F, Scratch(es), LI - Repair and paint (complete)	211,80
---	--------
