VOLKSWAGEN PASSAT: 1SPT690

| Vinnumber: | WVWZZZ3CZFE508514 | Versionname: | 2.0 TDI HIGHLINE MSQ |

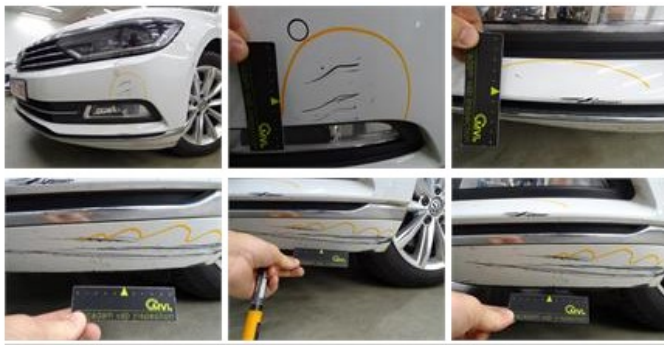
| Bumper F, Scratch(es), LI - Repair and paint (complete) | | | 211,80 |

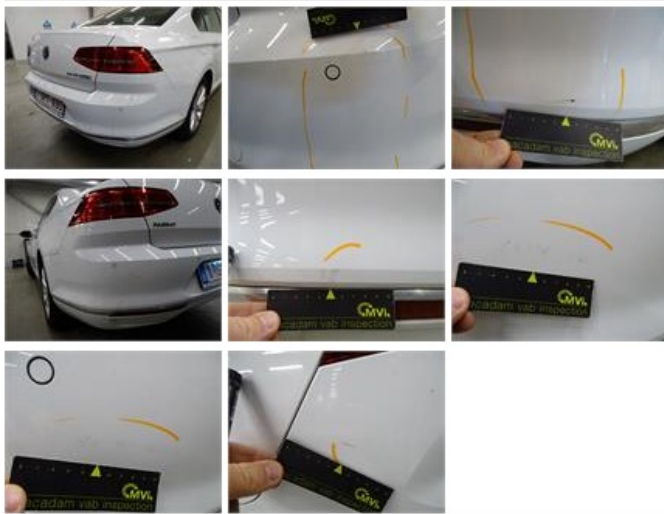
Bumper R, Scratch(es), LI - Repair and paint (complete)

211,80

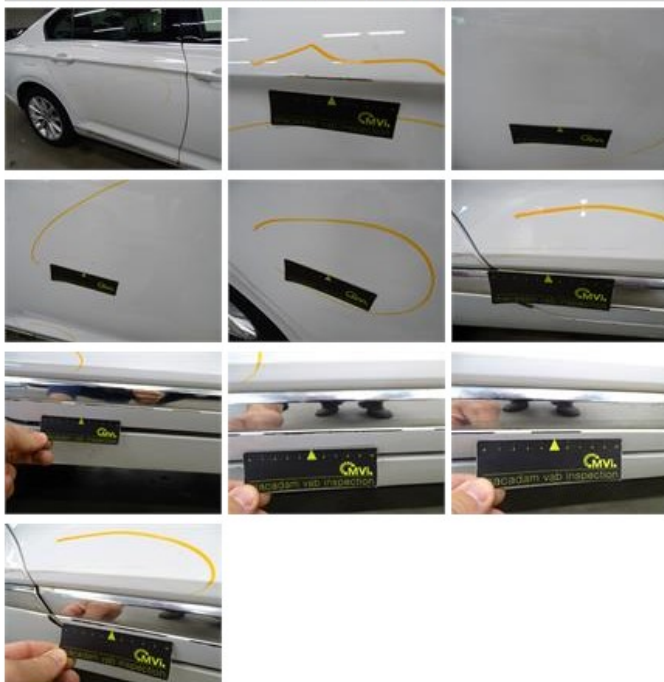
Door R R, Scratch(es), LI - Repair and paint (complete)
