VOLKSWAGEN GOLF VII: 1NJP519

Limited Technical Inspection

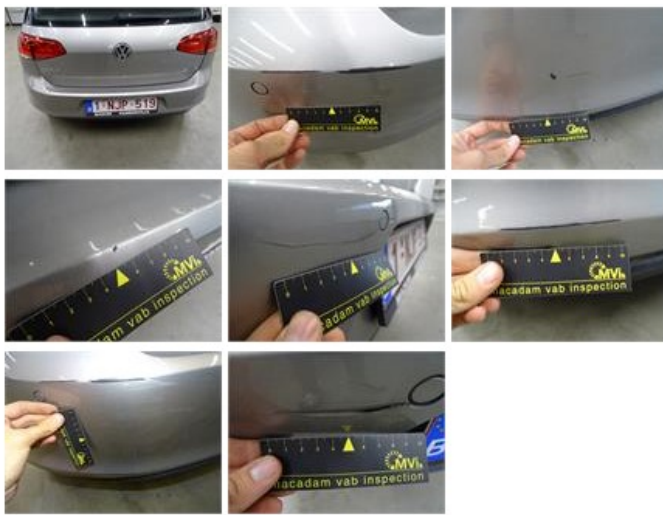
Total cost ex VAT	2670,91
Bumper R, Crack, Le - Replace and paint	651,00

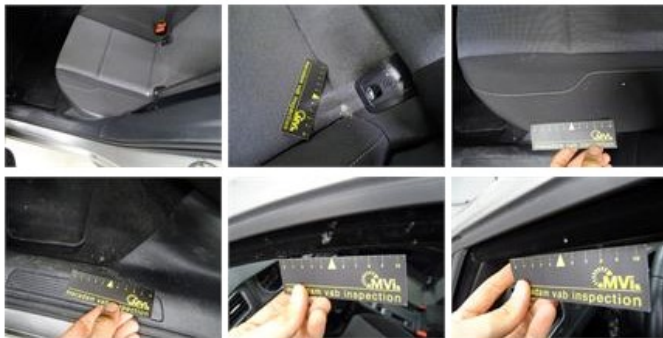
Interior, Smell, Ozone treatment

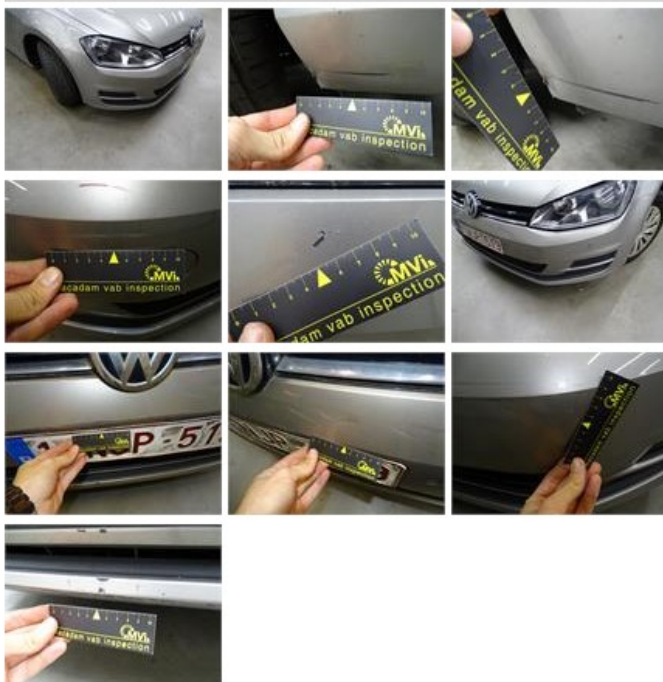
Bumper F, Dent(s) and scratch(es), LI - Repair and paint (complete)

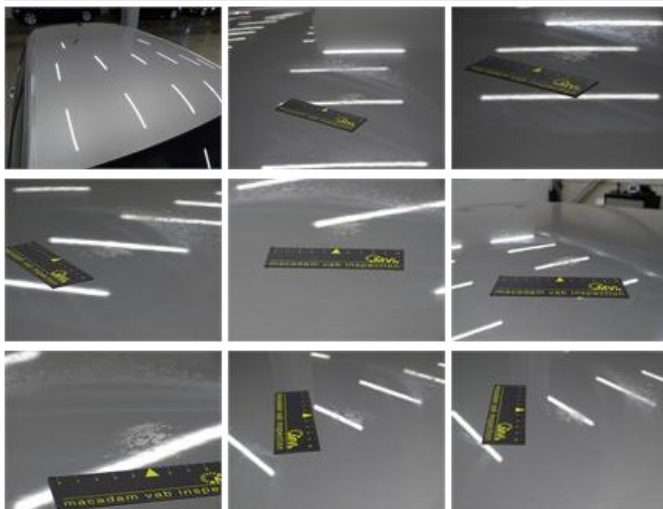
Roof, Chemical polution, LI - Repair and paint (complete)

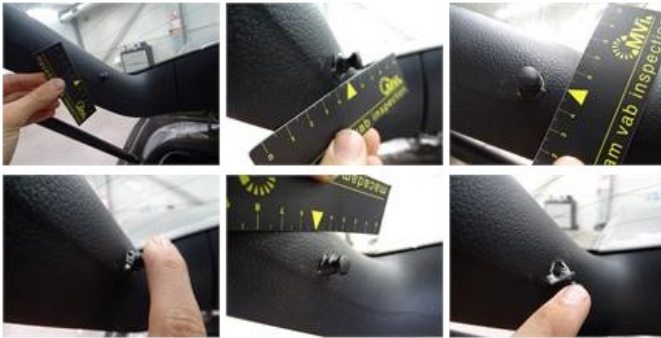
Trunk lid covering R, Broken, Smart repair

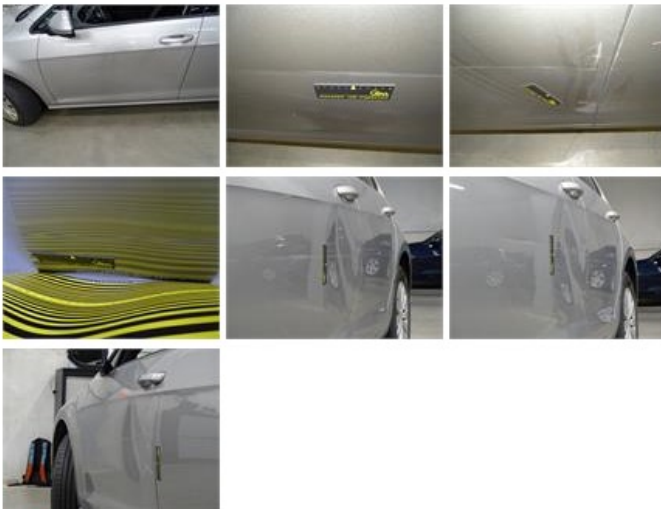
Door F L, Dent(s) and scratch(es), Le - Replace and paint

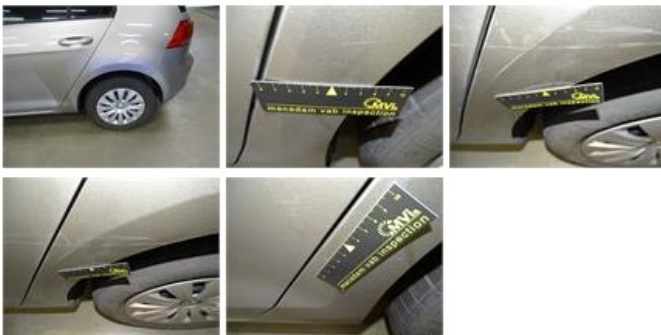
Wing R L, Scratch(es), LI - Repair and paint (complete)

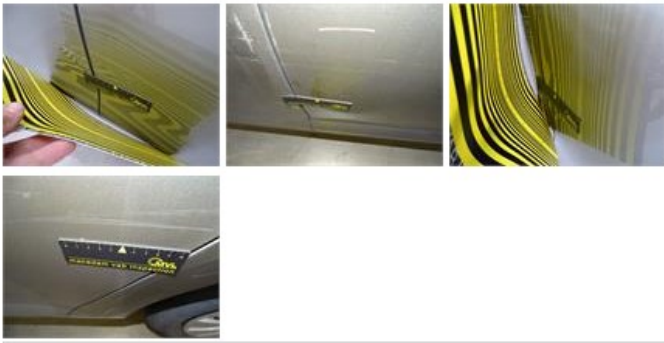
Door R L, Dent(s) and scratch(es), LI - Repair and paint (complete)

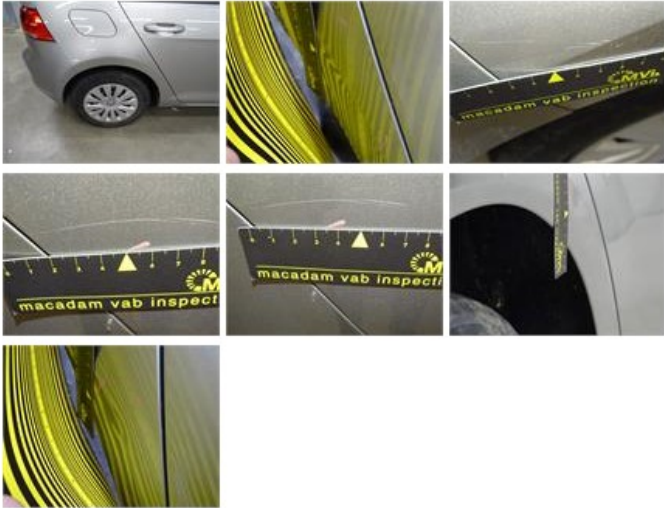
Wing R R, Dent(s) and scratch(es), LI - Repair and paint (complete)
