**BMW 4 Gran Coupe: 1HYT678**

**Limited Technical Inspection**

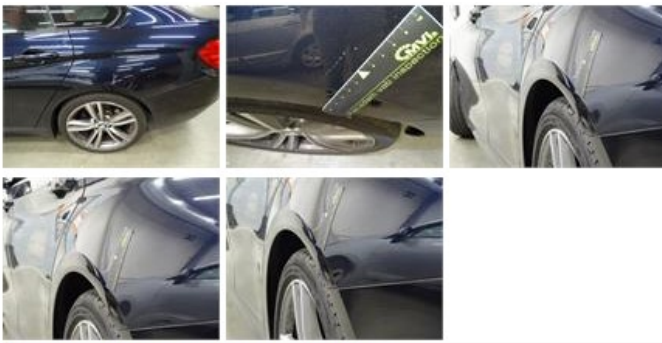
<b>Total cost ex VAT</b>	<b>1424,58</b>
<b>Wing R L, Dent(s) and scratch(es), LI - Repair and paint (complete)</b>	<b>369,84</b>

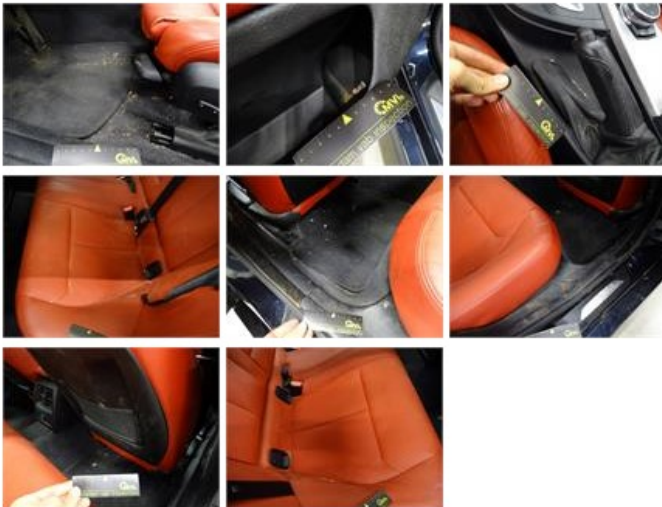
Interior, Dirty, Cleaning 50,00

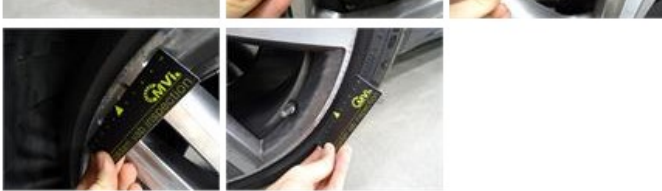
Alloy rim F L polished, Scratch(es), LI - Repair and paint (complete) 95,00

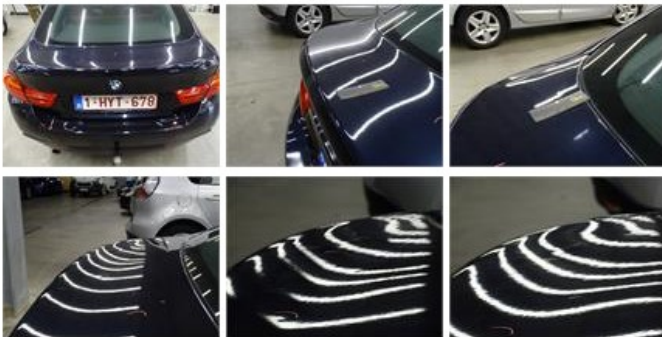
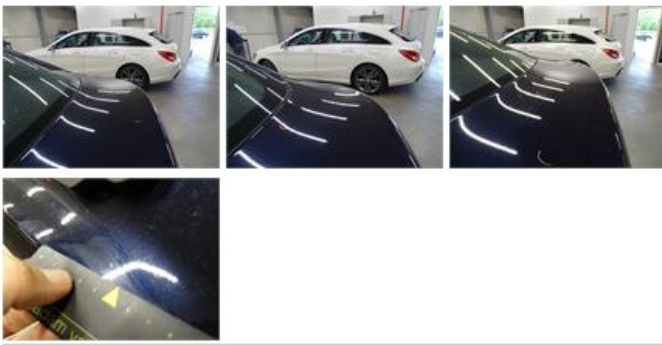
Tailgate, Bad repair, Acceptable 0,00

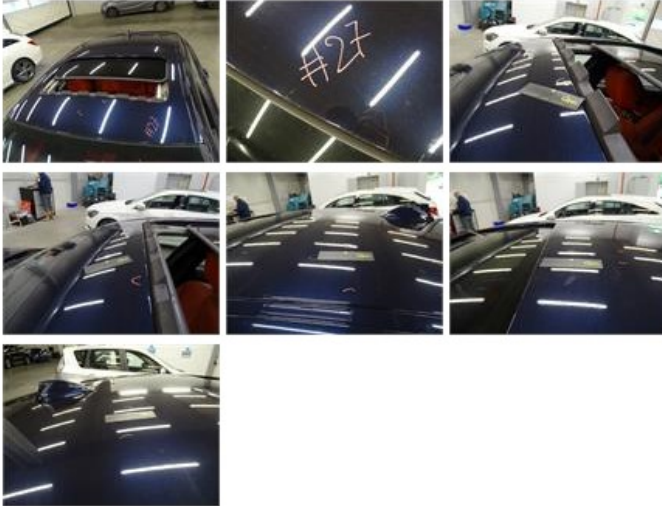
Roof, Hail damage, PDR - Hail 0,00

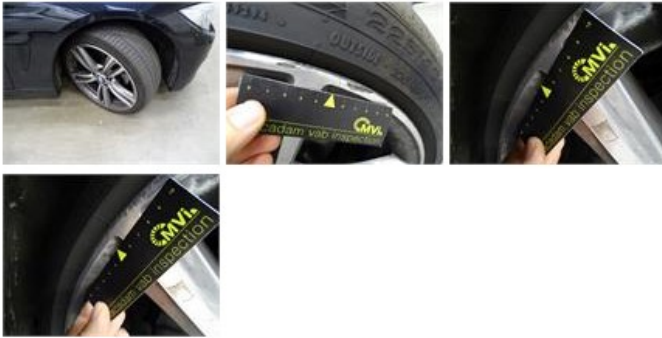
Alloy rim F R polished, Scratch(es), LI - Repair and paint (complete) 95,00

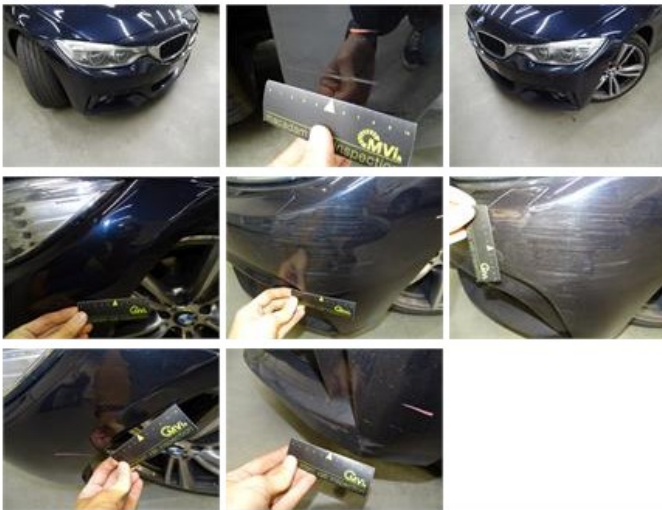
Bumper F, Scratch(es), LI - Repair and paint (complete) 254,16

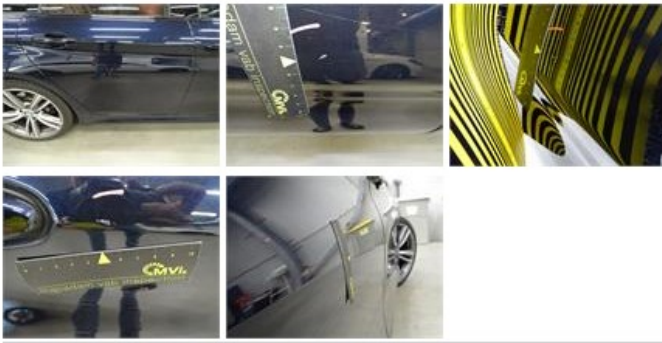
Door R R, Dent(s) and scratch(es), LI - Repair and paint (complete) 382,02

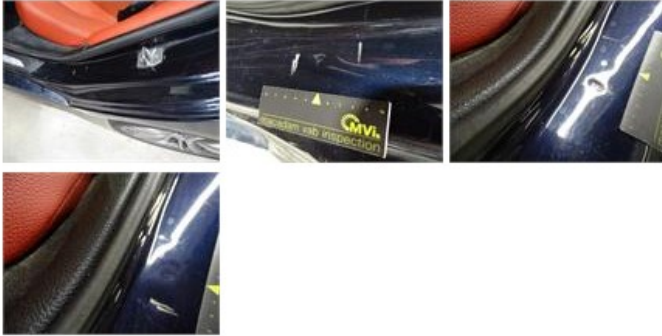
Door F R, Dent(s) and scratch(es), Acceptable	0,00
<i>No pictures to display</i>	
Rocker panel inner R L, Dent(s), LI - Repair and paint (complete)	115,56
