VOLVO XC60: 1LAH425

Limited Technical Inspection

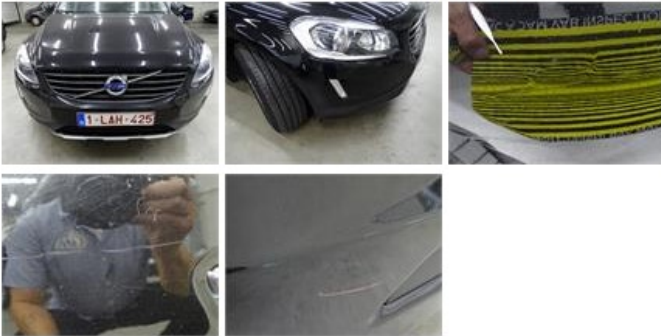
Bumper F, Dent(s) and scratch(es), LI - Repair and paint (complete) 254,16

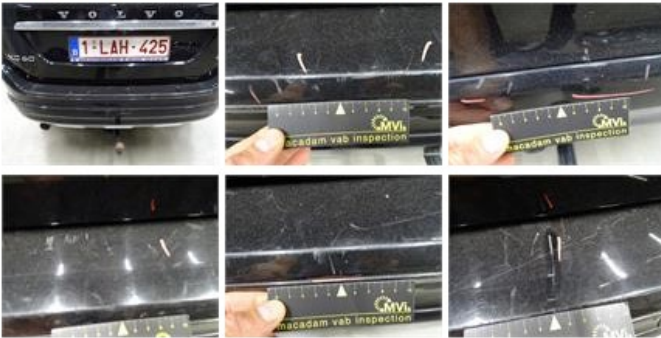
Bumper R, Scratch(es), LI - Repair and paint (complete) 254,16
