## VOLVO XC60: 1LGC017

## Limited Technical Inspection

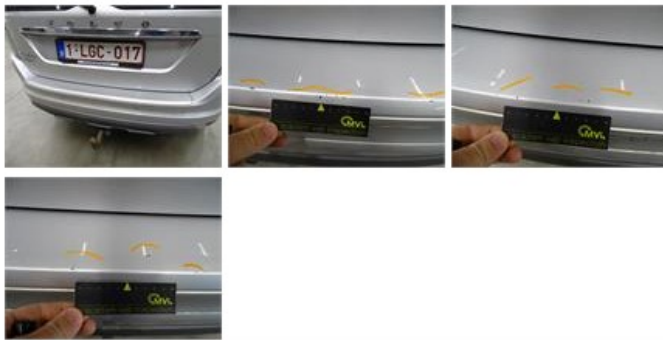
Bumper R, Scratch(es), LI - Repair and paint (complete)

211,80
