VOLKSWAGEN TOURAN: 1LUE169

Vinnnumber:	WVGZZZ1TZGW528400	Versionname:	1.6 TDI SCR 81KW BMT HIGHLINE
First Registrationdate:	7/12/2015	Fiscalpower:	
Expertise Mileage:	179890	Power Kw:	81
Bodytype:		Body color	Black
Gearbox:	MAN 6 VIT	Paint type	Metalic
Transmission:	Front	Rims summer	Aluminium
Fueltype:	Diesel	Oil level	OK
Maintenance	7400	Parking lot	3315
Maintenance	OK		
Maintenance	528 DAGEN		
Battery functioning	Yes		
Number of doors	5		
Number of seats	7		
Number head rests	7		
Rims summer	Aluminium		
Category	Passenger Car		
Oil level	OK		
Registration Certificate Car (BE)	Yes

Limited Technical Inspection

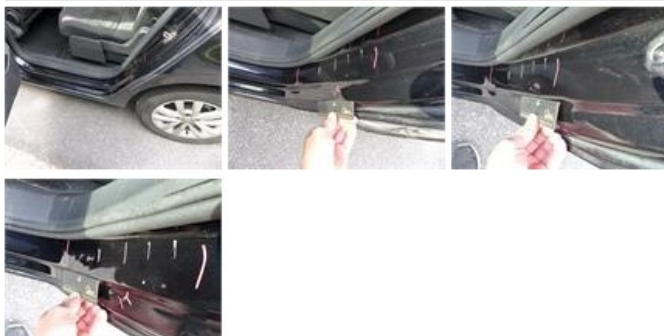
Door frame R L, Scratch(es), It - Spot repair

115,56
