BMW 1 HATCH: 1LSJ165

Limited Technical Inspection

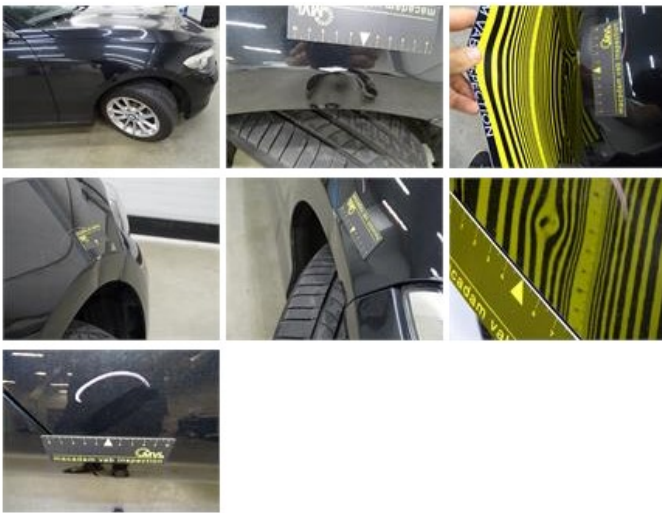
Total cost ex VAT	402,18
Wing F R, Dent(s) and scratch(es), LI - Repair and paint (complete)	244,18
