BMW 2 COUPE: 1LNP460

Limited Technical Inspection

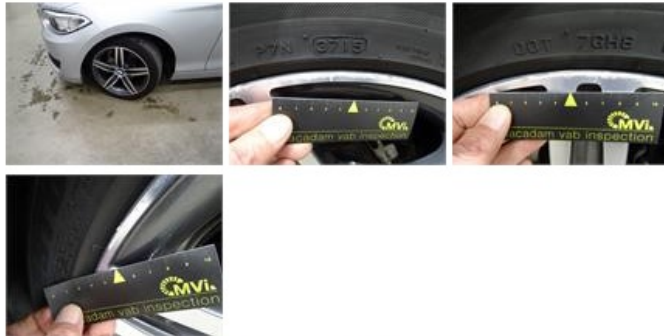
Alloy rim F L polished, Scratch(es), LI - Repair and paint (complete) 95,00

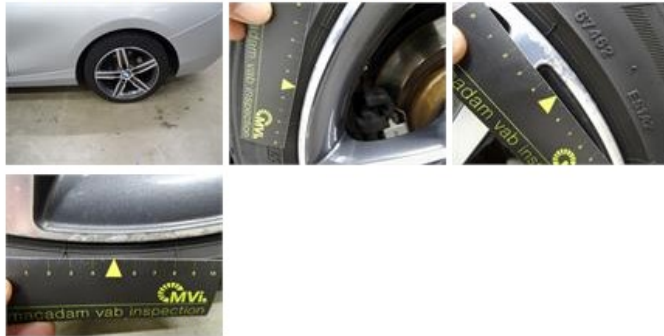
Alloy rim R L polished, Scratch(es), LI - Repair and paint (complete) 95,00
