**SKODA SUPERB COMBI: 1NEX111**

**Limited Technical Inspection**

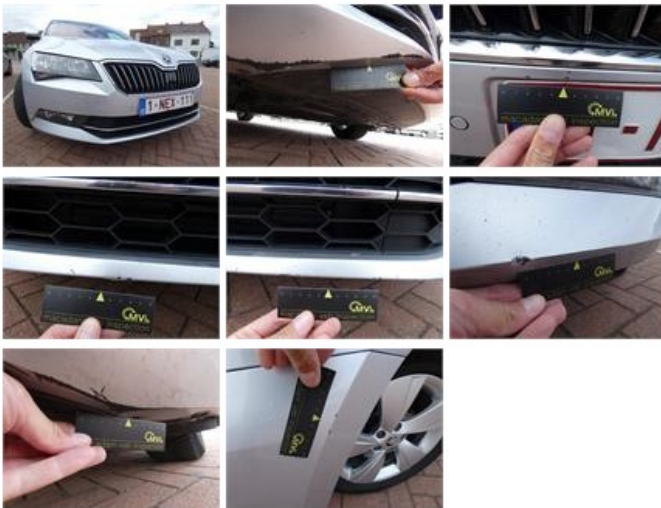
Bumper F, Scratch(es), LI - Repair and paint (complete)

254,16

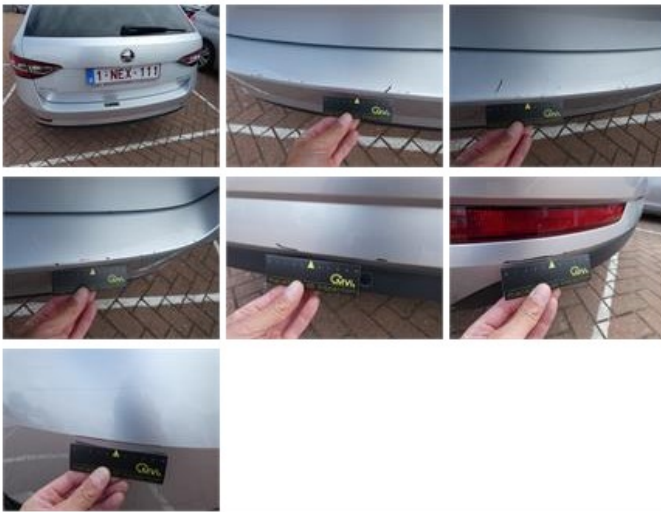
Bumper R, Scratch(es), LI - Repair and paint (complete) 254,16
