SKODA OCTAVIA COMBI: 1LJZ697

Limited Technical Inspection

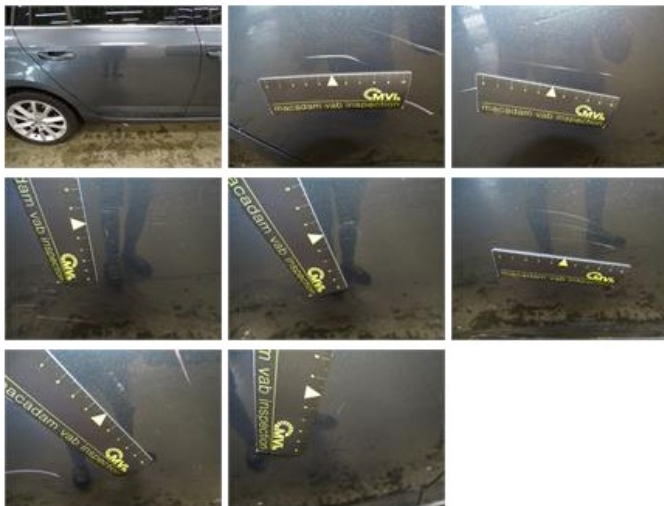
Door R R, Scratch(es), LI - Repair and paint (complete)

318,35

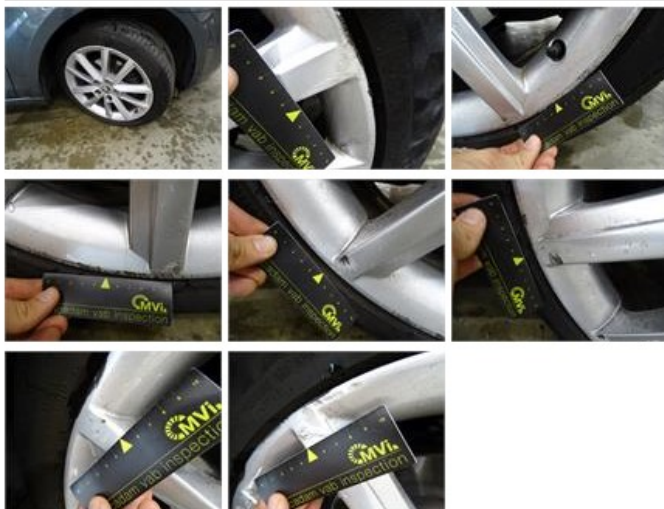
Alloy rim F R, Scratch(es), LI - Repair and paint (complete)

95,00

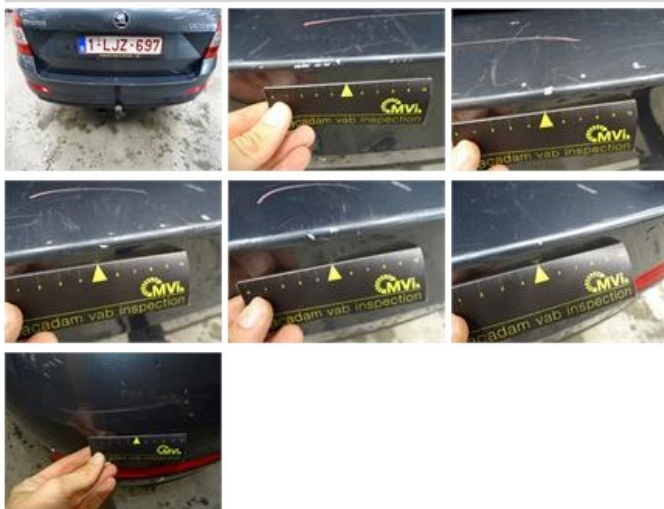
Bumper R, Scratch(es), LI - Repair and paint (complete)

211,80
