BMW 2 ACTIVE TOURER: 1LEF447

Limited Technical Inspection

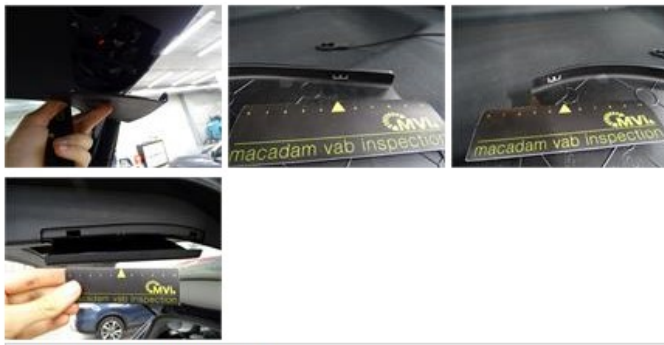
Total cost ex VAT	1673,81
Trunk lid covering R, Broken, E - Replace	30,00

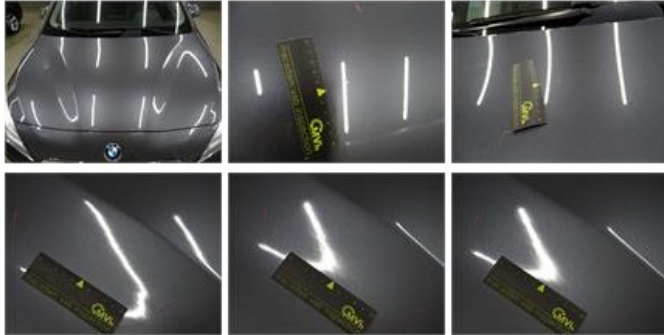
Bonnet, Bad repair, Acceptable

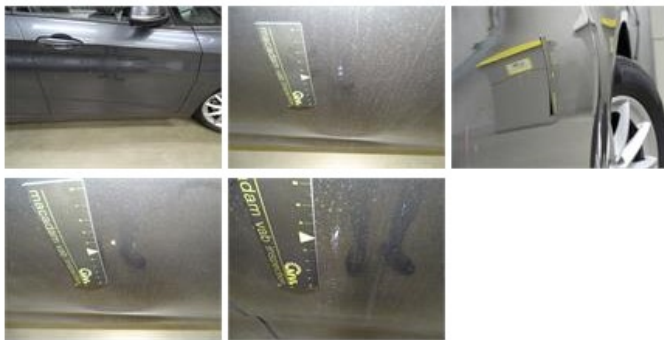
Door F R, Dent(s) and scratch(es), LI - Repair and paint (complete)

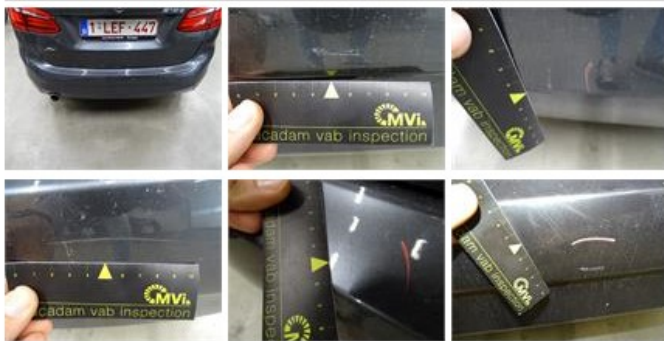
Bumper R, Scratch(es), LI - Repair and paint (complete)

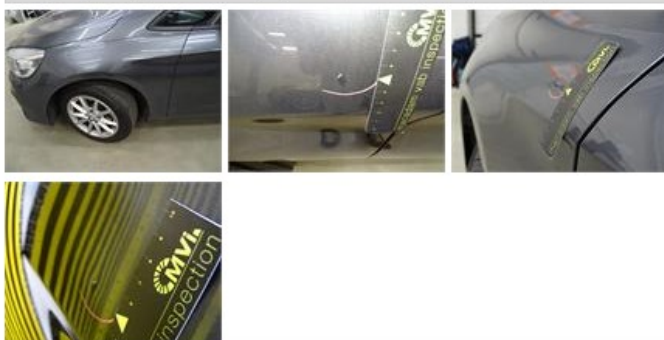
Wing F L, Dent(s) and scratch(es), LI - Repair and paint (complete)

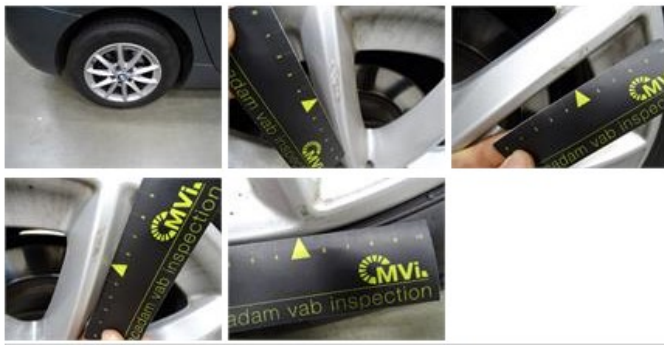
Alloy rim R R, Scratch(es), LI - Repair and paint (complete)

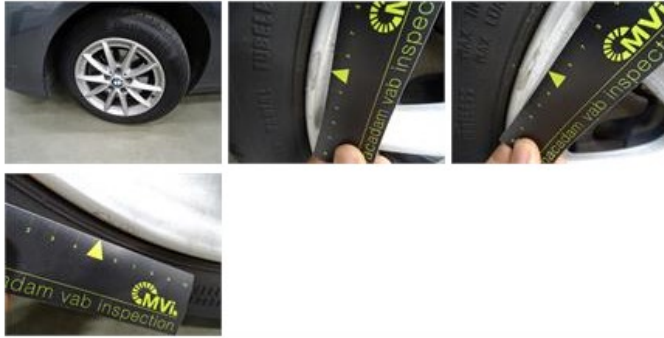
Alloy rim F L, Scratch(es), LI - Repair and paint (complete)

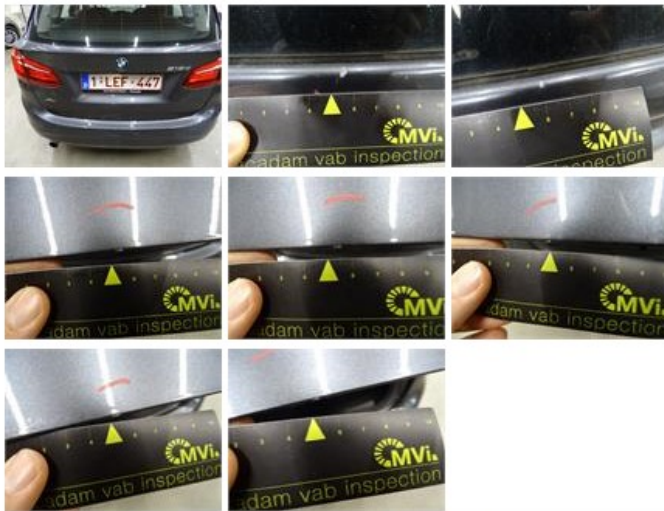
Tailgate, Scratch(es), LI - Repair and paint (complete)

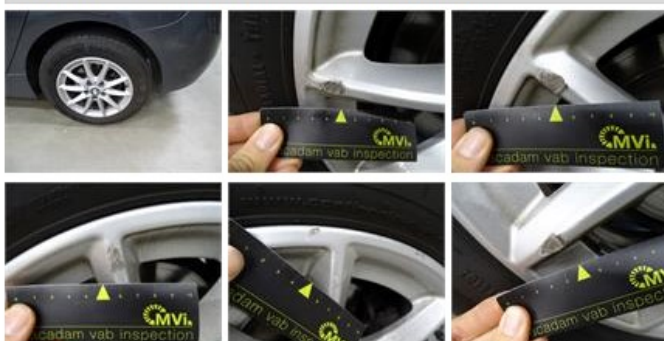
Alloy rim R L, Scratch(es), LI - Repair and paint (complete)

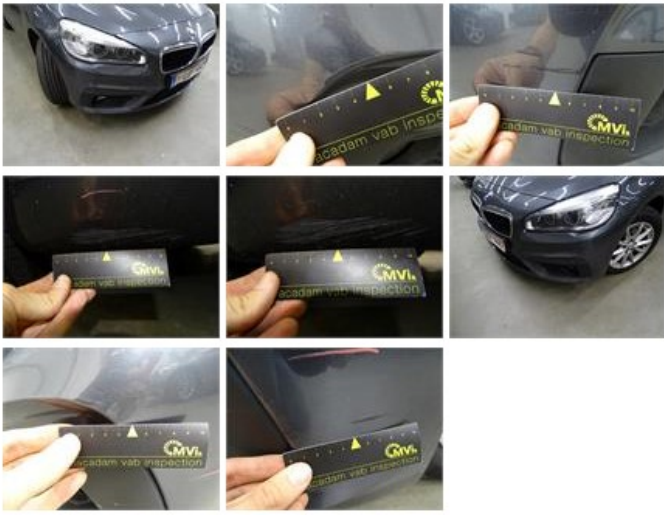
Bumper F, Scratch(es), LI - Repair and paint (complete)
