**BMW 5: 1HNS823**

**Limited Technical Inspection**

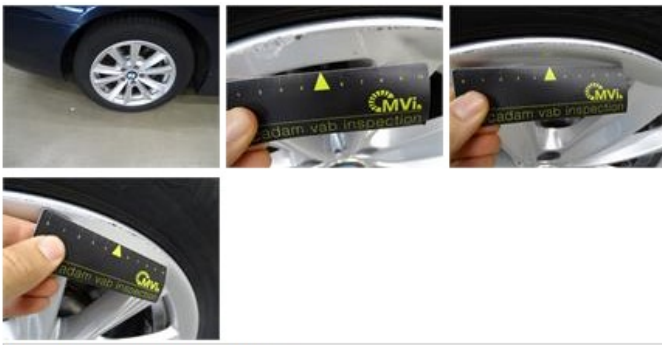
Total cost ex VAT	<b>808,56</b>
Alloy rim R R, Scratch(es), LI - Repair and paint (complete)	<b>95,00</b>

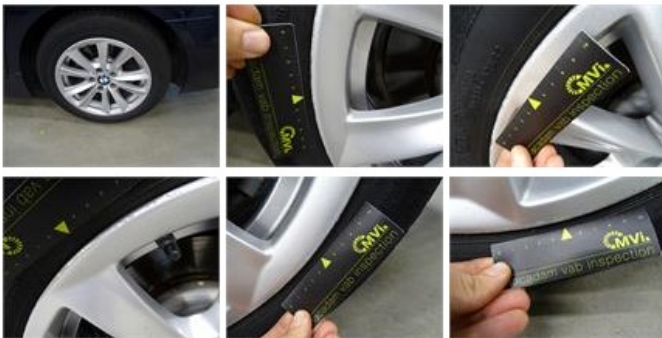
Alloy rim F R, Scratch(es), LI - Repair and paint (complete) 95,00

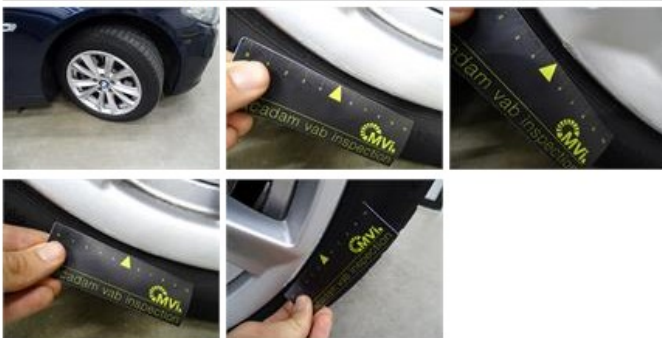
Alloy rim F L, Scratch(es), Acceptable 0,00
