**FORD Grand C-Max: 1JTK282**

**Limited Technical Inspection**

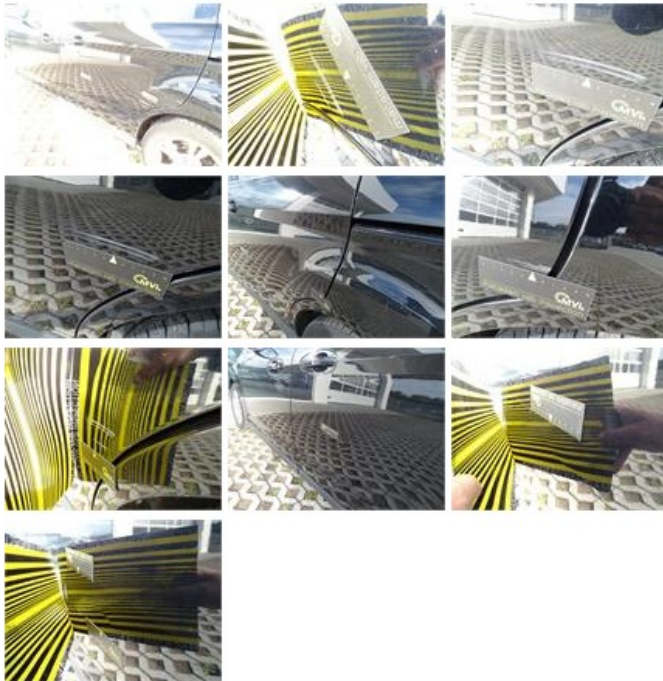
<i>No pictures to display</i>	
Rear bulkhead lining, Scratch(es), Acceptable	0,00
<i>No pictures to display</i>	
Door panel R L, Scratch(es), Acceptable	0,00
<i>No pictures to display</i>	
Maintenance book, Missing, Acceptable	0,00
<i>No pictures to display</i>	
Roof, Dent(s), Acceptable	0,00
<i>No pictures to display</i>	
Wing R R, Dent(s), Acceptable	0,00
<i>No pictures to display</i>	
Door R R, Scratch(es), Acceptable	0,00
<i>No pictures to display</i>	
Bonnet, Stone chip(s), Acceptable	0,00
<i>No pictures to display</i>	
Alloy rim R L polished, Scratch(es), Acceptable	0,00
<i>No pictures to display</i>	
Bumper spoiler F, Scratch(es), Acceptable	0,00
<i>No pictures to display</i>	
Door panel R R, Scratch(es), Acceptable	0,00
<i>No pictures to display</i>	
Door F L, Scratch(es), Acceptable	0,00
<i>No pictures to display</i>	
Door R L, Scratch(es), LI - Repair and paint (complete)	366,35
