**MERCEDES A: 1KAF596**

Vinnumber:	<b>WDD1760121V063881</b>	Versionname:	<b>1.5 A 180 CDI BLUE EFF. STYLE EDITION</b>
First Registrationdate:	<b>18/03/2015</b>	Fiscalpower:	
Expertise Mileage:	<b>186196</b>	Power Kw:	<b>80</b>
Bodytype:		Body color:	<b>Grey</b>
Gearbox:	<b>MAN 6 VIT</b>	Paint type:	<b>Metalic</b>
Transmission:	<b>Front</b>	Rims summer:	<b>Aluminium</b>
Fueltype:	<b>Diesel</b>	Oil level:	<b>OK</b>
Battery functioning:	<b>Yes</b>	Parking lot:	<b>1526</b>
Number of doors:	<b>5</b>		
Number of seats:	<b>5</b>		
Number head rests:	<b>5</b>		
Rims summer:	<b>Aluminium</b>		
Category:	<b>Passenger Car</b>		
Oil level:	<b>OK</b>		
Registration Certificate Car (BE):	<b>Yes</b>

**Limited Technical Inspection**

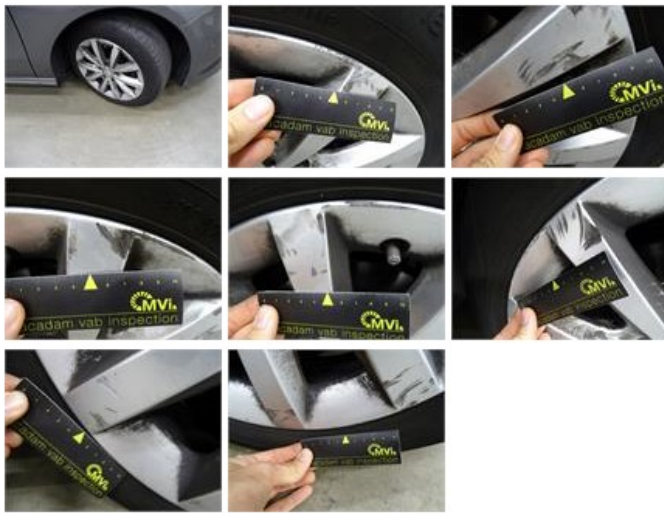
Total cost ex VAT		2033,47
Alloy rim F R, Scratch(es), LI - Repair and paint (complete)		95,00

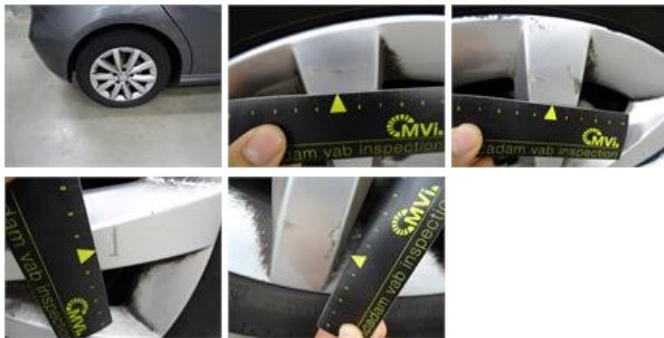
Alloy rim R R, Scratch(es), LI - Repair and paint (complete)

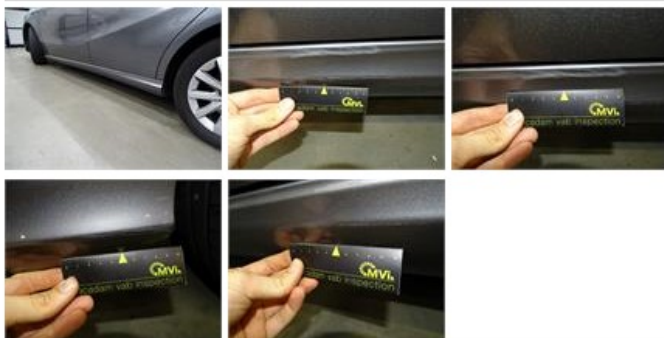
Sill outer L, Scratch(es), LI - Repair and paint (complete)

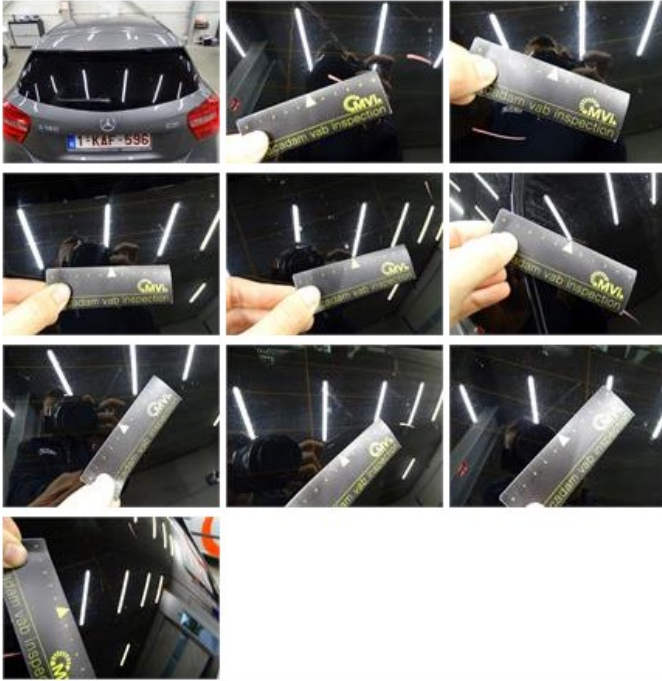
Rear window, Scratch(es), E - Replace 0,00

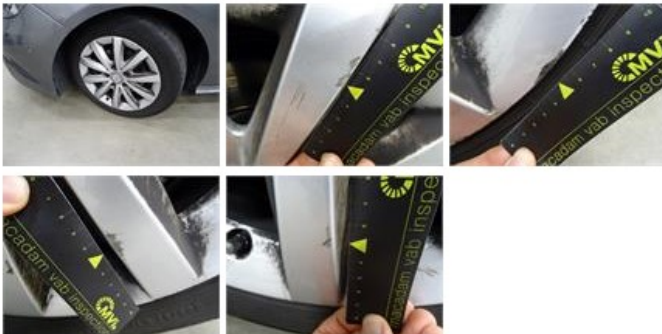
Alloy rim F L, Scratch(es), LI - Repair and paint (complete) 95,00

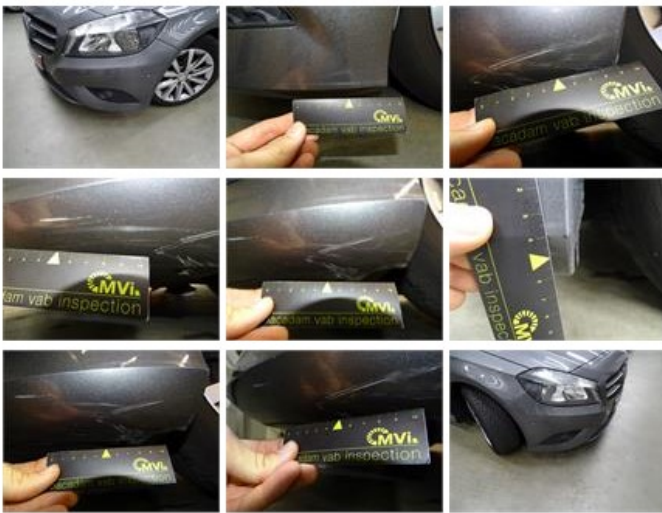
Bumper F, Scratch(es), LI - Repair and paint (complete) 211,80
