**LU Mercedes c Berline: CM7405**

Vinnumber:	<b>WDD2050041R119749</b>	Versionname:	<b>2.1 C 220 D AVANTGARDE</b>
First Registrationdate:	<b>30/10/2015</b>	Fiscalpower:	
Expertise Mileage:	<b>199775</b>	Power Kw:	<b>125</b>
Bodytype:	<b>Berline</b>	Body color:	<b>Grey</b>
Gearbox:	<b>Automatic</b>	Paint type:	<b>Metalic</b>
Transmission:	<b>Back</b>	Rims summer:	<b>Aluminium</b>
Fueltype:	<b>Diesel</b>	Oil level:	<b>OK</b>
Battery functioning:	<b>Yes</b>	Parking lot:	<b>3705</b>
Number of doors:	<b>4</b>		
Number of seats:	<b>5</b>		
Number head rests:	<b>5</b>		
Rims summer:	<b>Aluminium</b>		
Category:	<b>Passenger Car</b>		
Oil level:	<b>OK</b>

**Limited Technical Inspection**

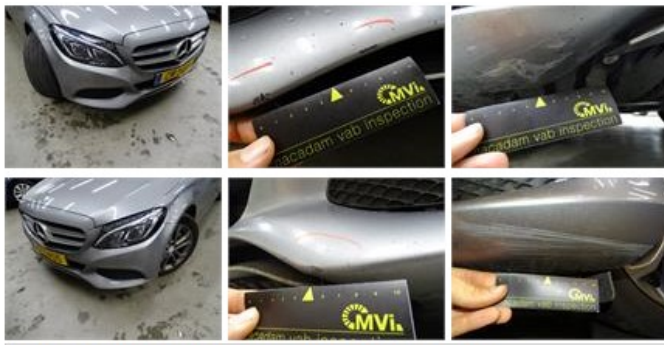
<b>Total cost ex VAT</b>	<b>1385,18</b>
<b>Bumper F, Scratch(es), LI - Repair and paint (complete)</b>	<b>211,80</b>

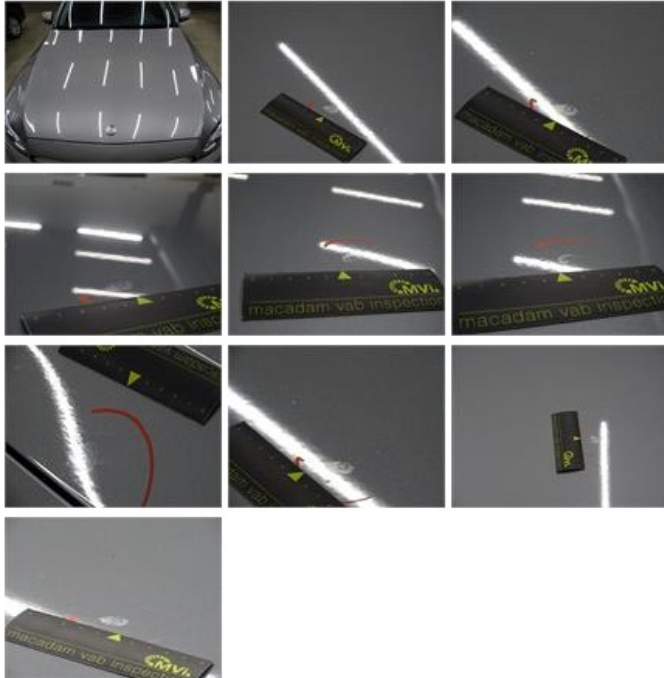
Bonnet, Chemical polution, LI - Repair and paint (complete)
