**MAZDA 3: 1HJS011**

**Limited Technical Inspection**

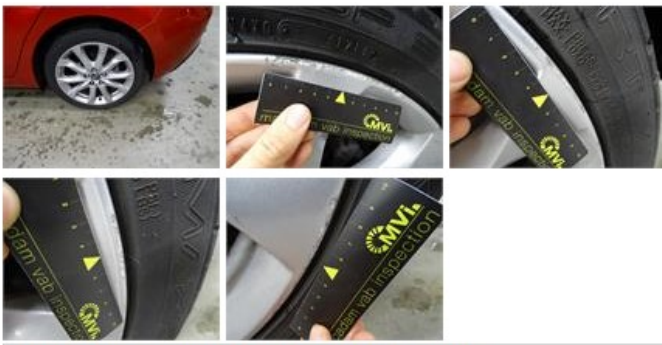
Total cost ex VAT	2031,34
Alloy rim R R, Scratch(es), LI - Repair and paint (complete)	95,00

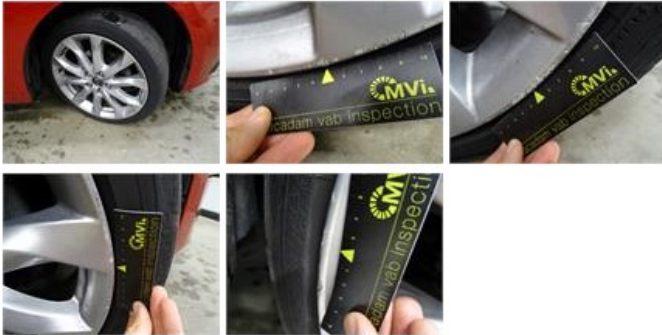
Alloy rim F R, Scratch(es), LI - Repair and paint (complete) 95,00

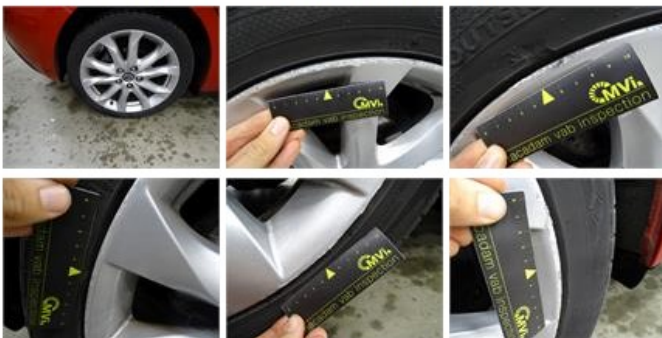
Alloy rim R R, Scratch(es), LI - Repair and paint (complete) 95,00

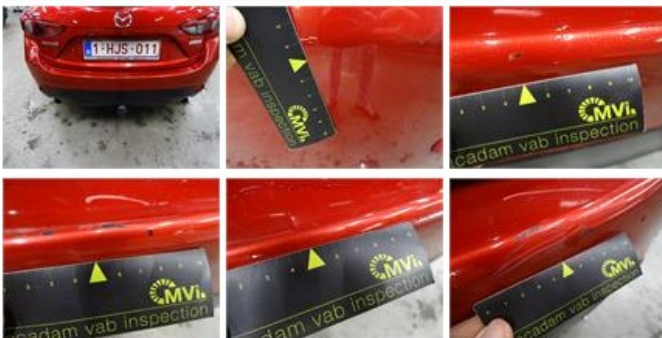
Bumper R, Scratch(es), LI - Repair and paint (complete) 211,80

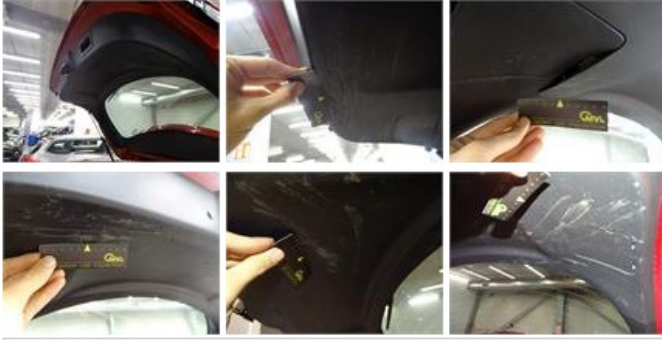
Trunk lid covering R, Broken, Smart repair
