**MINI 5D: 1SSX182**

Vinnumber:	<b>WMWXT310002B52452</b>	Versionname:	<b>Cooper D (85 kW)</b>
First Registrationdate:	<b>6/07/2017</b>	Fiscalpower:	
Expertise Mileage:	<b>52642</b>	Power Kw:	<b>85</b>
Bodytype:		Body color:	<b>Blue</b>
Gearbox:	<b>MAN 6 VIT</b>	Paint type:	<b>Metalic</b>
Transmission:	<b>Front</b>	Rims summer:	<b>Aluminium</b>
Fueltype:	<b>Diesel</b>	Oil level:	<b>OK</b>
Battery functioning:	<b>Yes</b>	Parking lot:	<b>1727</b>
Number of doors:	<b>5</b>		
Number of seats:	<b>5</b>		
Number head rests:	<b>5</b>		
Rims summer:	<b>Aluminium</b>		
Category:	<b>Passenger Car</b>		
Oil level:	<b>OK</b>		
Registration Certificate Car (BE):	<b>Yes</b>

**Limited Technical Inspection**

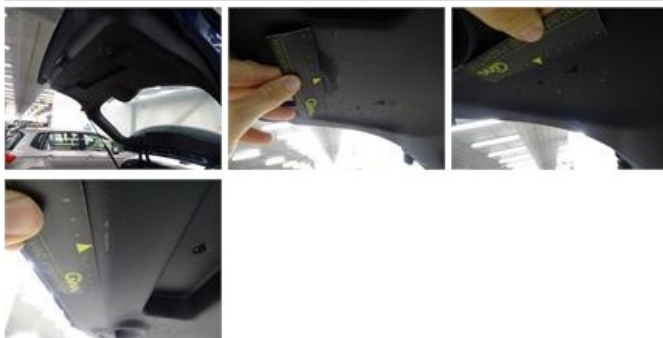
Trunk lid covering R, Scratch(es), Smart repair

110,64

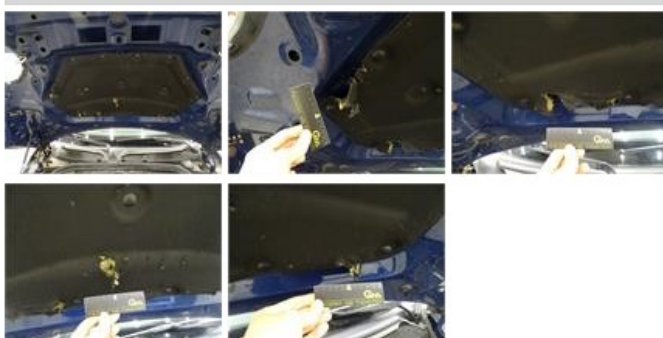
Protection plate M, Deformed / Strained, E - Replace

74,00

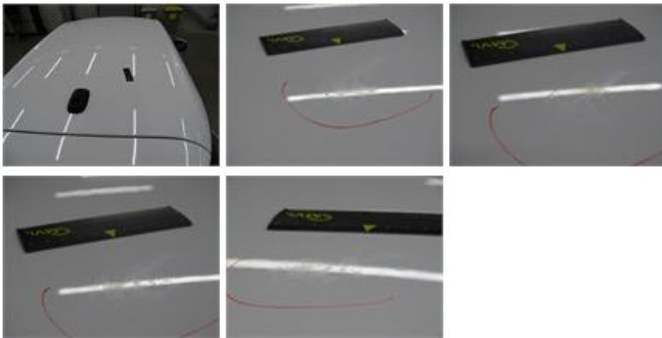
Roof, Chemical polution, LI - Repair and paint (complete) 481,50
