MINI : 1PCV152

Limited Technical Inspection

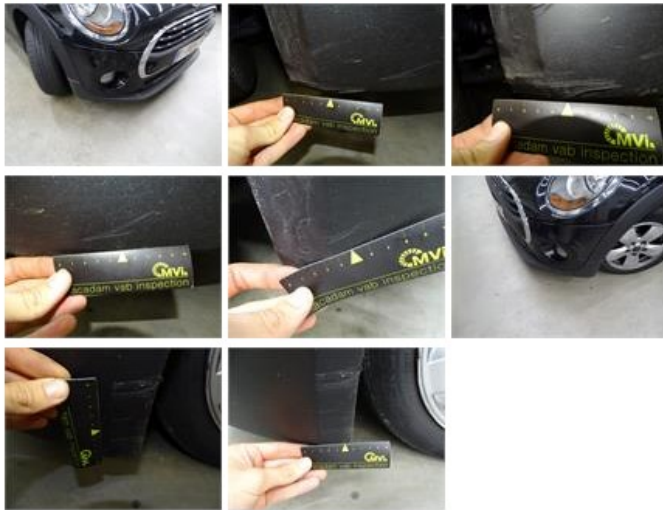
Bumper F M, Scratch(es), Smart repair

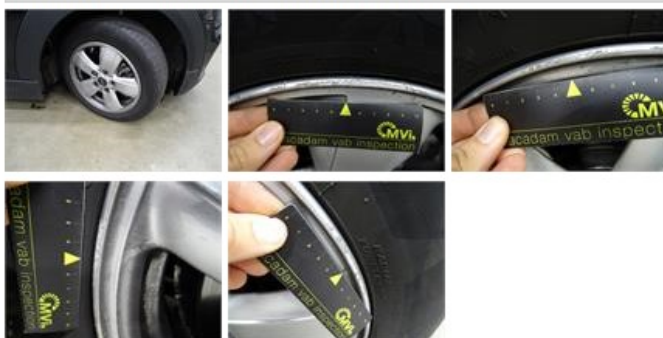
Alloy rim F R, Scratch(es), LI - Repair and paint (complete)

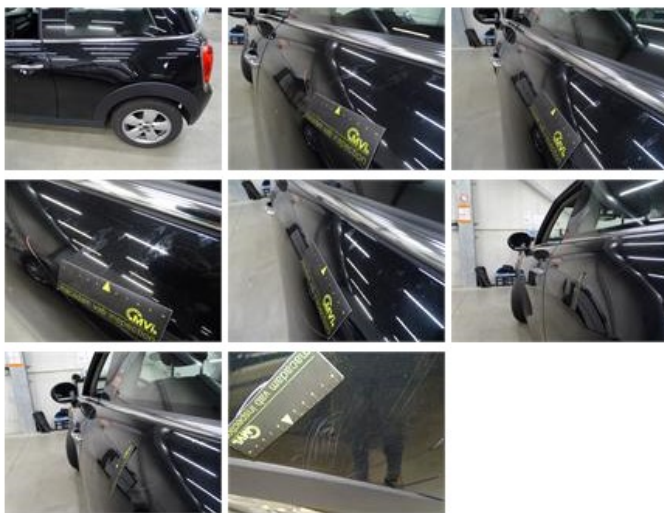
Wing R L, Chemical pollution, LI - Repair and paint (complete)

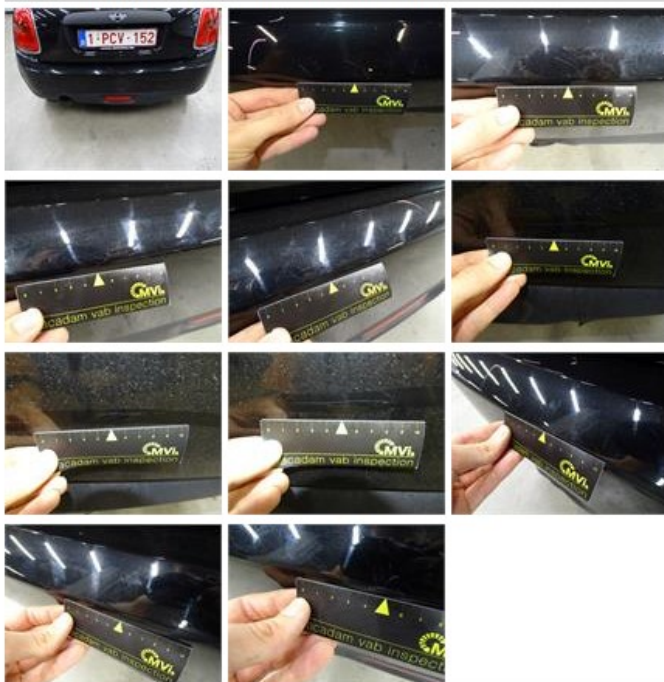
Bumper R, Scratch(es), LI - Repair and paint (complete)

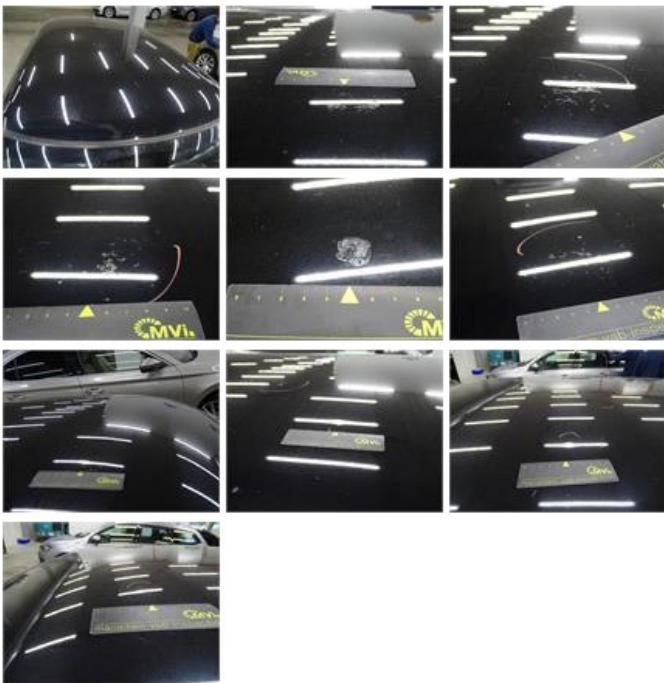
Roof, Chemical pollution, LI - Repair and paint (complete)

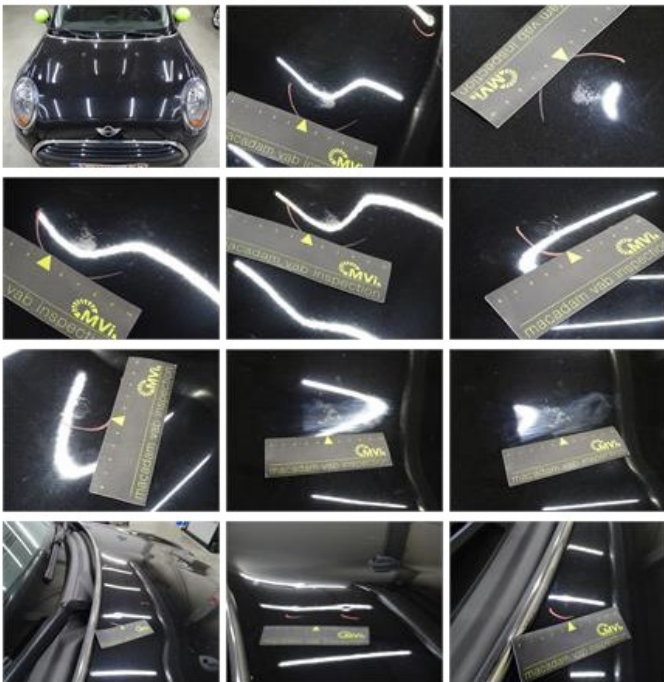
Bonnet, Chemical polution, LI - Repair and paint (complete) 338,08
