# PEUGEOT 308: 1HNG325

## Limited Technical Inspection

## Degree of wear

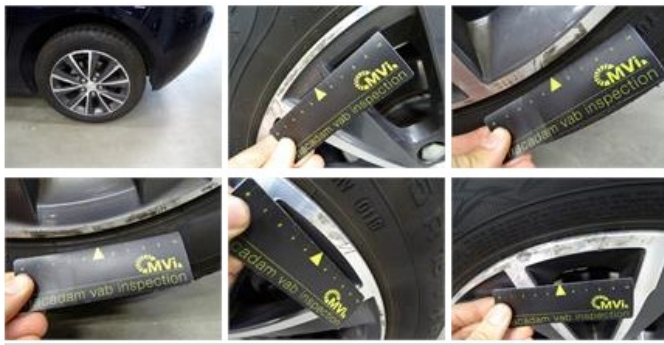
| Alloy rim R L polished, Scratch(es), LI - Repair and paint (complete) | 95,00 |

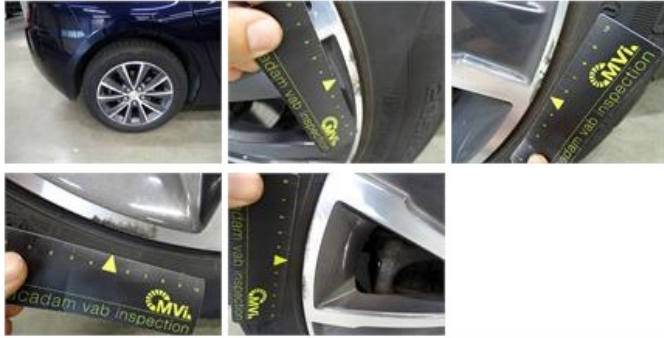
Alloy rim R R polished, Scratch(es), LI - Repair and paint (complete)

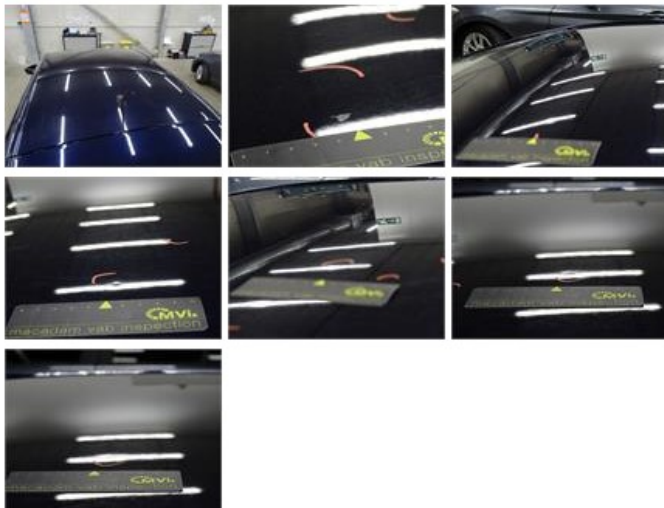
Roof, Chemical polution, LI - Repair and paint (complete)

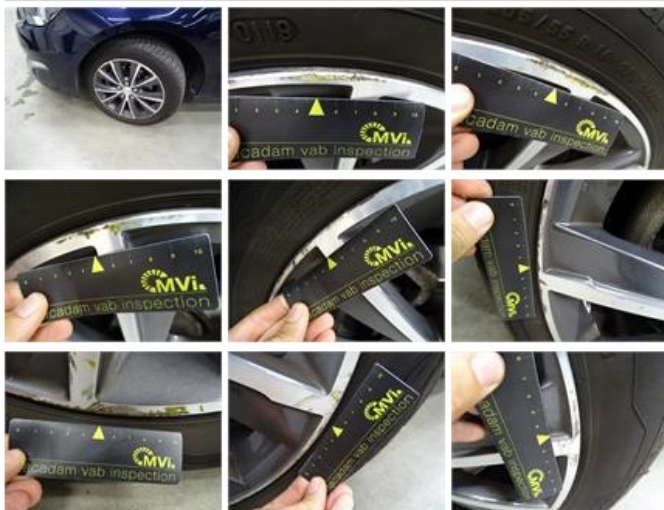
Alloy rim F L polished, Scratch(es), LI - Repair and paint (complete)

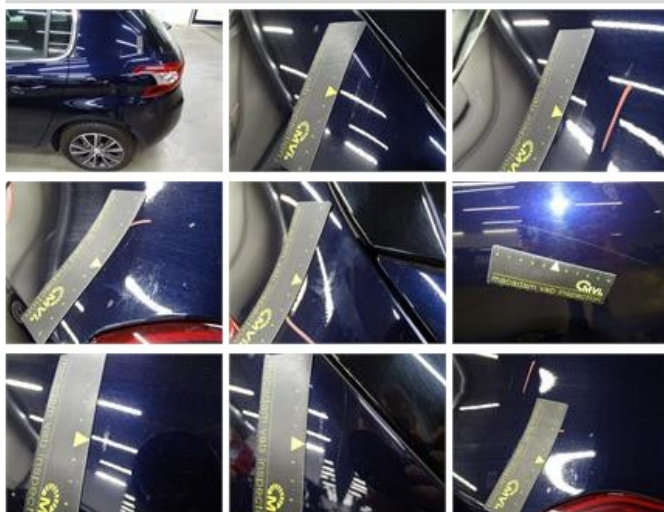
| Wing R L, Chemical polution, LI - Repair and paint (complete) | 308,20 |
