**OPEL ASTRA: FP9876**

**Limited Technical Inspection**

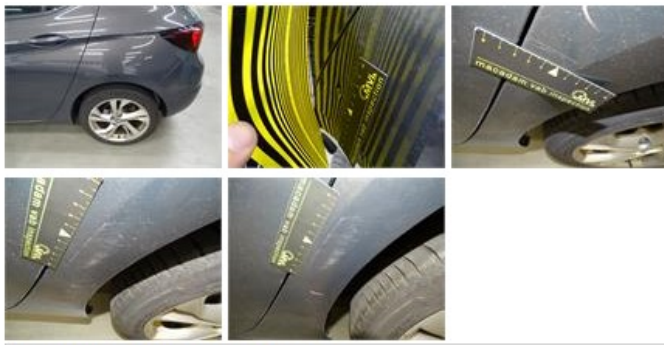
Total cost ex VAT	1464,46
Wing R L, Dent(s) and scratch(es), LI - Repair and paint (complete)	308,20

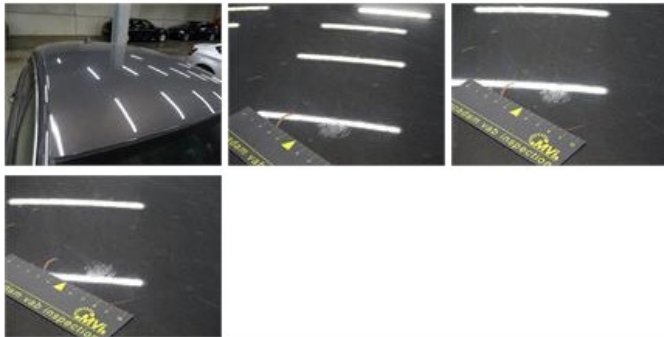
Roof, Chemical polution, LI - Repair and paint (complete) 481,50

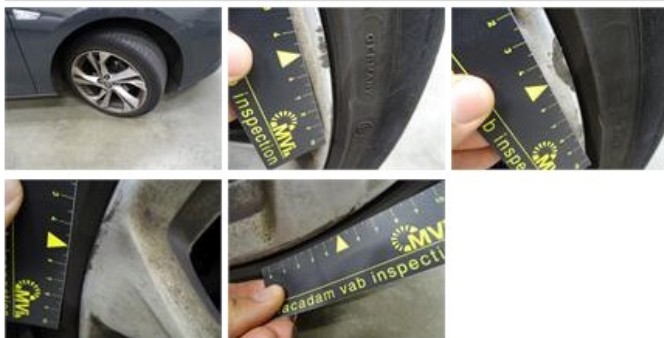
Alloy rim F R, Scratch(es), LI - Repair and paint (complete) 95,00

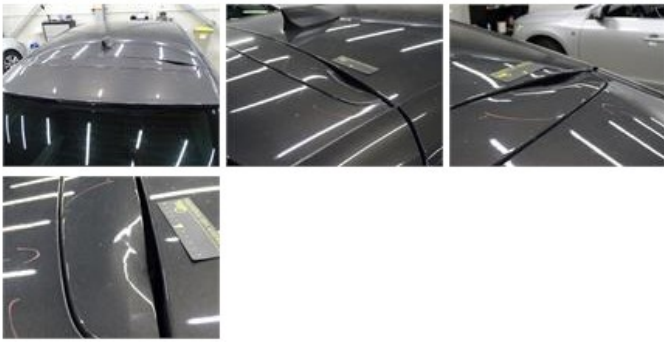
Rear spoiler, Deformed / Strained, LI - Repair and paint (complete) 187,56
