PEUGEOT 508: 1LGZ315

Limited Technical Inspection

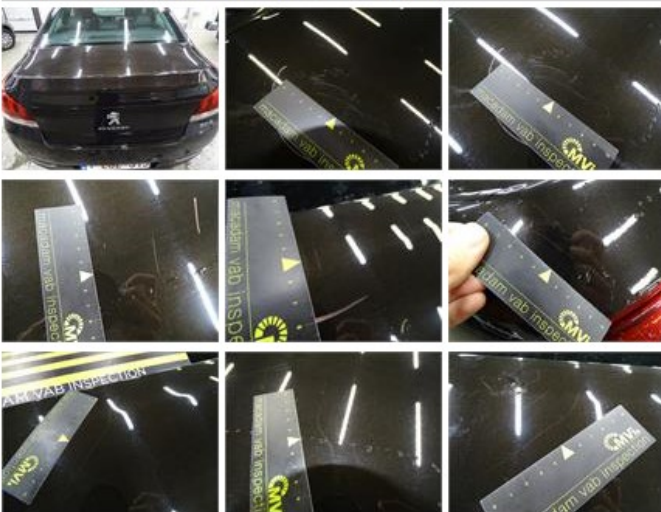
Tailgate, Scratch(es), LI - Repair and paint (complete) 301,68
