**SKODA Superb: 1GNJ697**

Vinnumber:	<b>TMBJJ73T5E9047012</b>	Versionname:	<b>SUPERB COMBI GreenLine Elegance 105PK</b>
First Registrationdate:	<b>18/03/2014</b>	Fiscalpower:	
Expertise Mileage:	<b>182013</b>	Power Kw:	<b>77</b>
Bodytype:	<b>Break</b>	Body color:	<b>Silver</b>
Gearbox:	<b>MAN 6 VIT</b>	Paint type:	<b>Metalic</b>
Transmission:	<b>Front</b>	Rims summer:	<b>Aluminium</b>
Fueltype:	<b>Diesel</b>	Oil level:	<b>OK</b>
Battery functioning:	<b>Yes</b>	Parking lot:	<b>1708</b>
Number of doors:	<b>5</b>		
Number of seats:	<b>5</b>		
Number head rests:	<b>5</b>		
Rims summer:	<b>Aluminium</b>		
Category:	<b>Passenger Car</b>		
Oil level:	<b>OK</b>		
Registration Certificate Car (BE):	<b>Yes</b>

**Limited Technical Inspection**

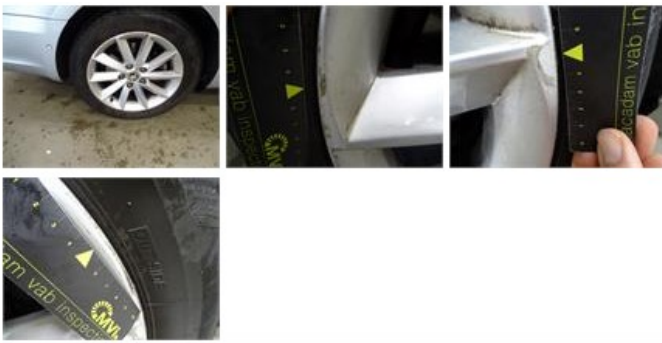
Total cost ex VAT		<b>1271,02</b>
Door R L, Dent(s) and scratch(es), Acceptable		<b>0,00</b>
<i>No pictures to display</i>		
Alloy rim R R, Scratch(es), LI - Repair and paint (complete)		<b>95,00</b>

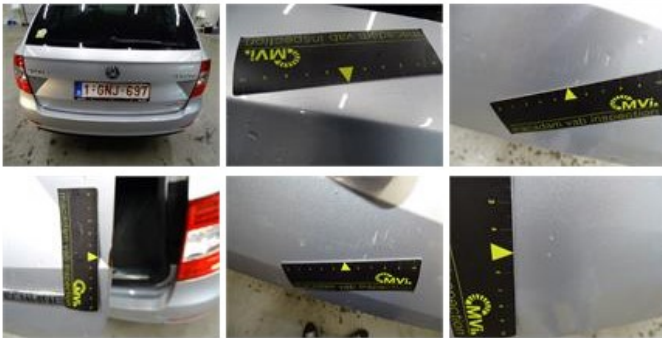
Tailgate, Scratch(es), LI - Repair and paint (complete) 362,02

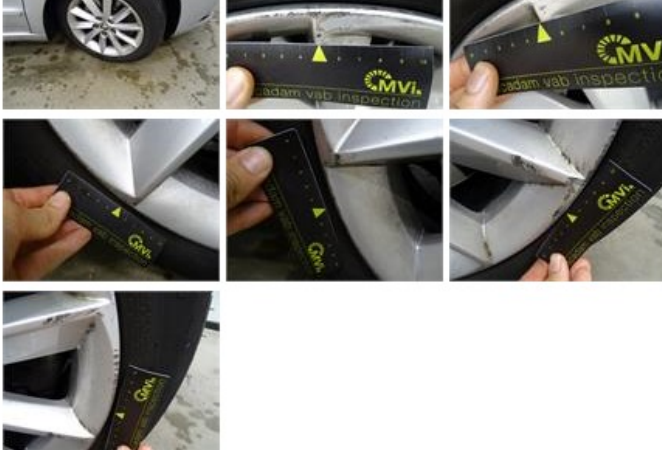
Alloy rim F R, Scratch(es), LI - Repair and paint (complete) 95,00

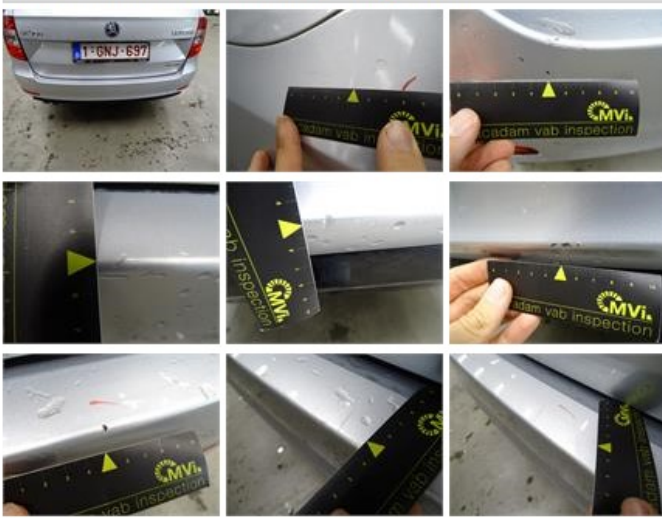
Bumper R, Scratch(es), LI - Repair and paint (complete) 254,16

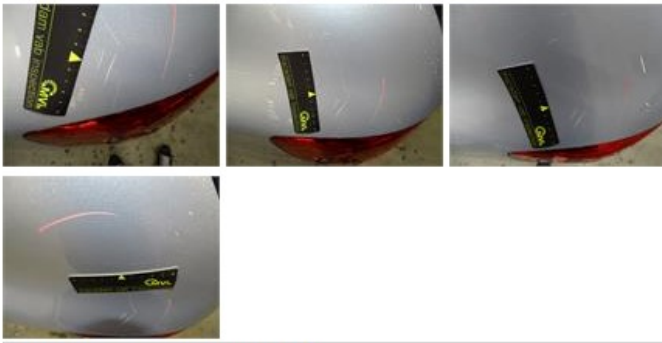
Wing R L, Scratch(es), LI - Repair and paint (complete) 369,84

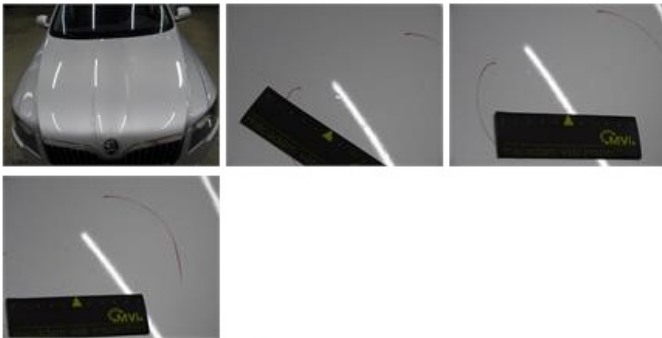
Bonnet, Bad repair, Acceptable 0,00

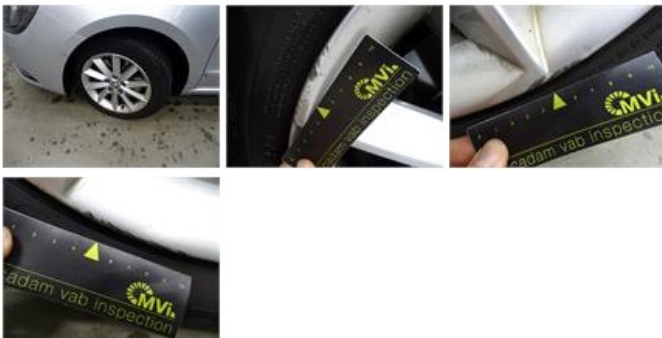
Alloy rim F L, Scratch(es), LI - Repair and paint (complete) 95,00
