<b>BMW 1: 1HCG156</b>			
Vinnumber:	<b>WBA1C91040J524533</b>	Versionname:	<b>1 HATCH 116d Eff.Dyn.Ed. 116PK</b>
First Registrationdate:	<b>17/06/2014</b>	Fiscalpower:	
Expertise Mileage:	<b>151306</b>	Power Kw:	<b>85</b>
Bodytype:		Body color:	<b>Blue</b>
Gearbox:	<b>MAN 6 VIT</b>	Paint type:	<b>Metalic</b>
Transmission:	<b>Back</b>	Rims summer:	<b>Aluminium</b>
Fueltype:	<b>Diesel</b>	Oil level:	<b>OK</b>
Battery functioning:	<b>Yes</b>	Parking lot:	<b>3711</b>
Number of doors:	<b>5</b>		
Number of seats:	<b>5</b>		
Number head rests:	<b>5</b>		
Rims summer:	<b>Aluminium</b>		
Category:	<b>Passenger Car</b>		
Oil level:	<b>OK</b>		
Registration Certificate Car (BE):	<b>Yes</b>

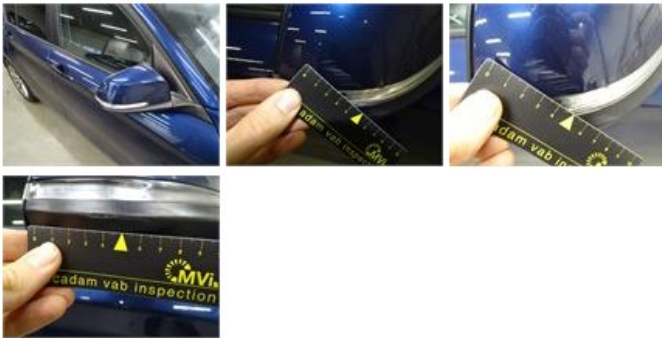
Rearview mirror housing R, Scratch(es), LI - Repair and paint (complete) 115,56

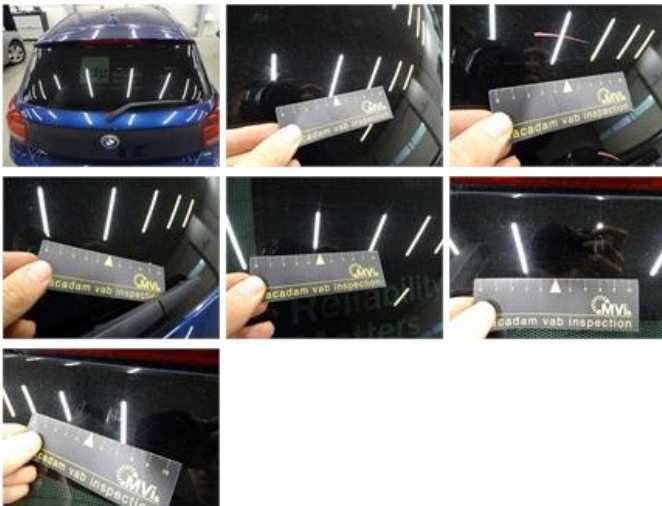
Rear window, Scratch(es), E - Replace 370,00

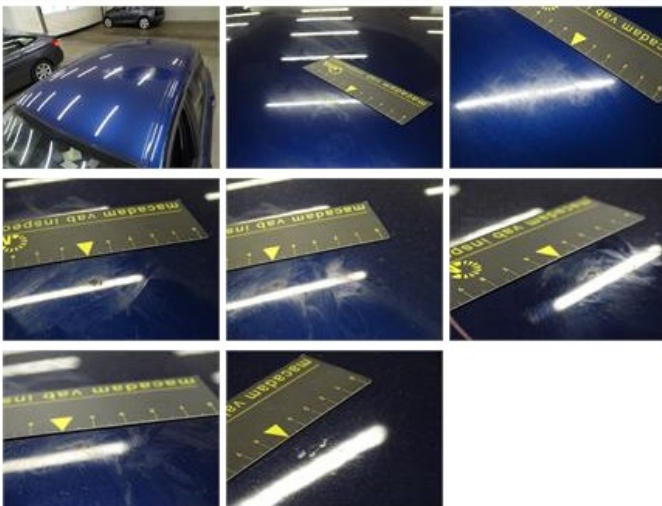
Roof, Chemical polution, LI - Repair and paint (complete) 481,50

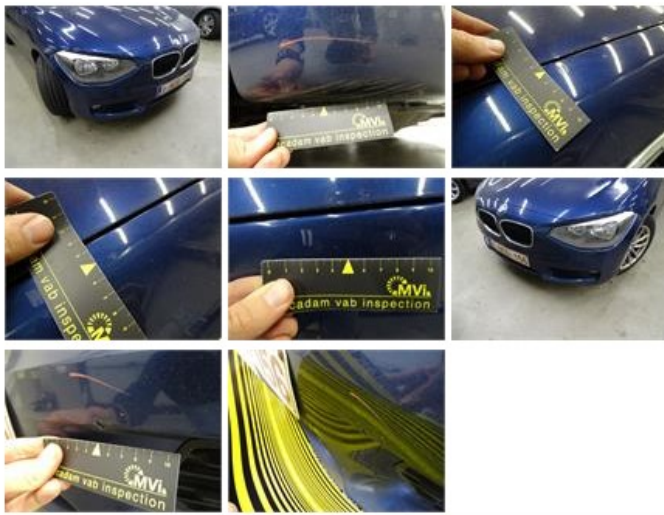
Bumper F, Dent(s) and scratch(es), LI - Repair and paint (complete) 211,80

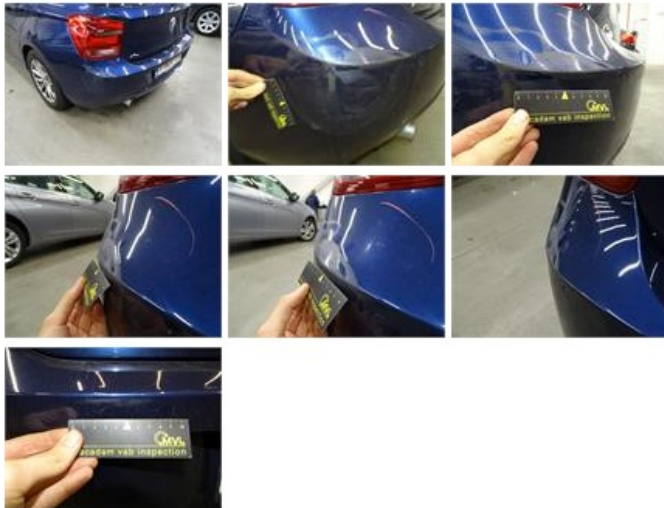
Bumper R, Dent(s) and scratch(es), LI - Repair and paint (complete)

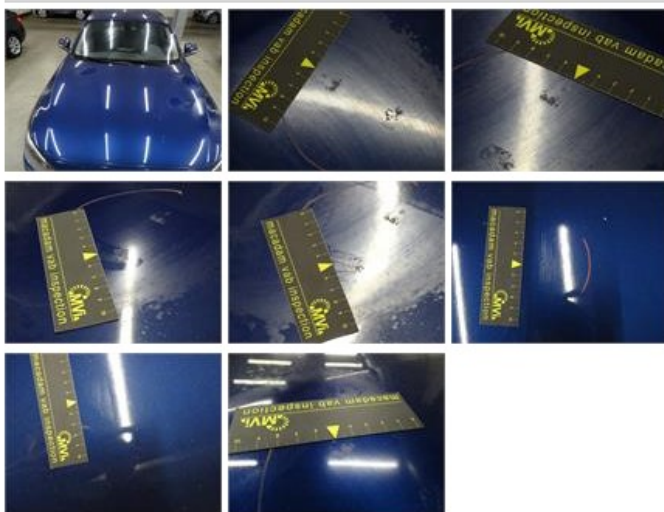
Bonnet, Chemical polution, LI - Repair and paint (complete)
