**AUDI A6: 1HRY443**

**Limited Technical Inspection**

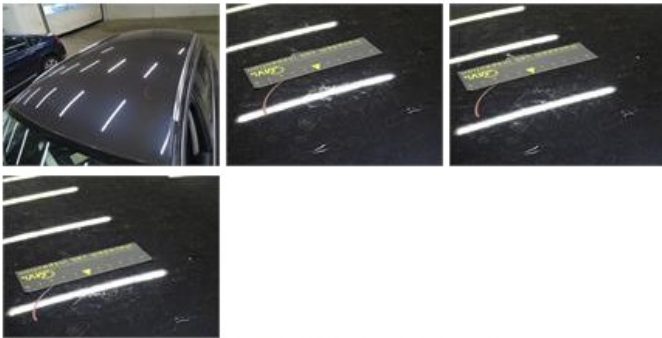
Roof, Chemical polution, LI - Repair and paint (complete)

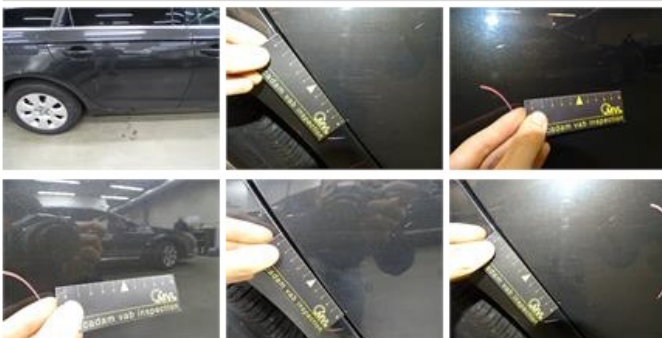
Door R R, Scratch(es), LI - Repair and paint (complete)

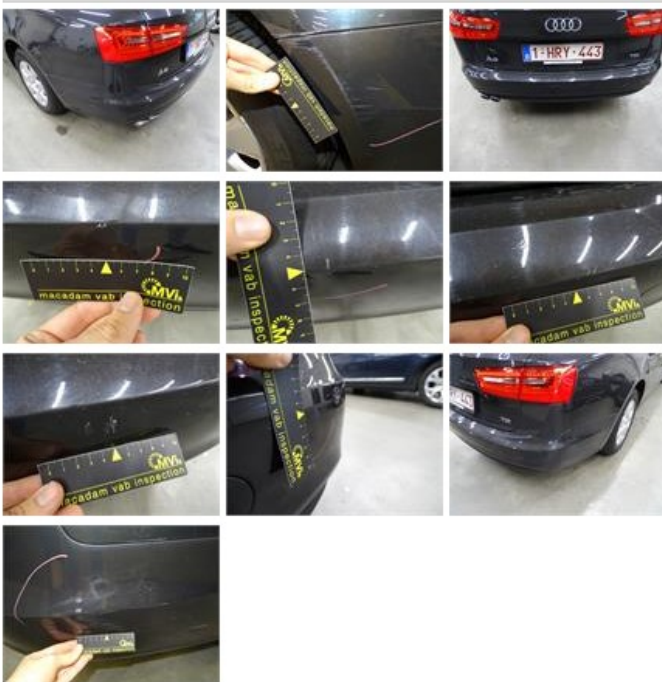
Bumper R, Dent(s) and scratch(es), LI - Repair and paint (complete)
