AUDI A1: 1HAB036

Limited Technical Inspection

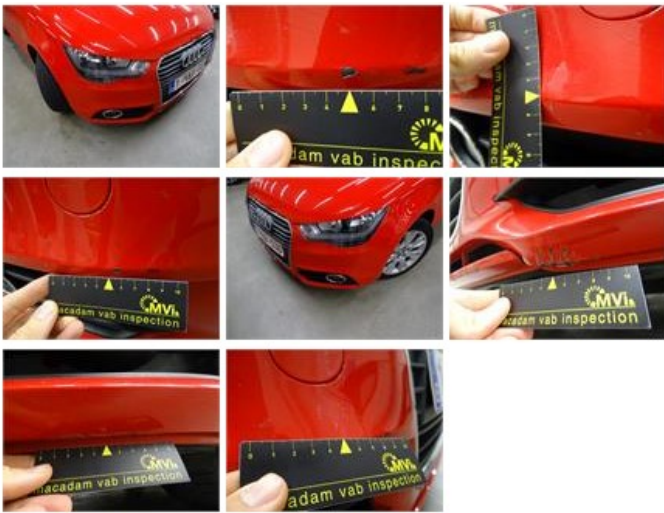
Total cost ex VAT	1186,20
Bumper F, Scratch(es), LI - Repair and paint (complete)	169,44

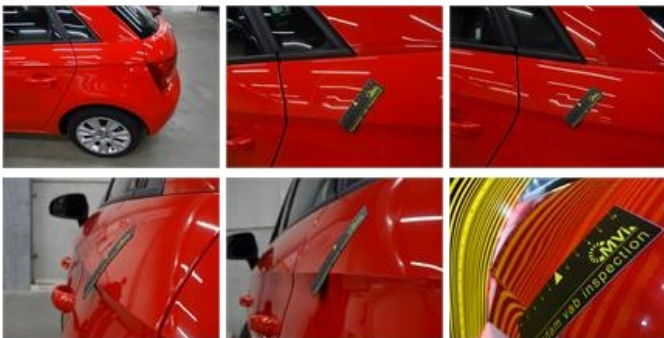
Wing R L, Dent(s), PDR - Paintless dent repair 63,00

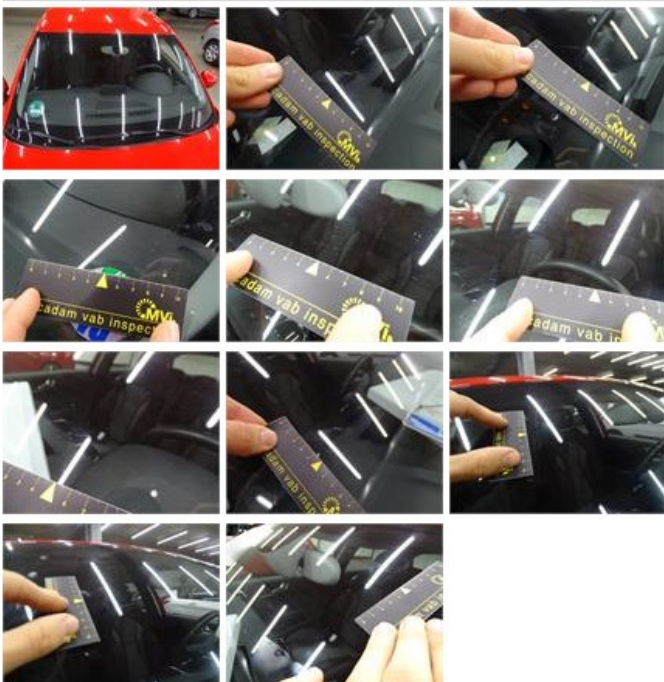
Windscreen, Scratch(es), E - Replace 0,00

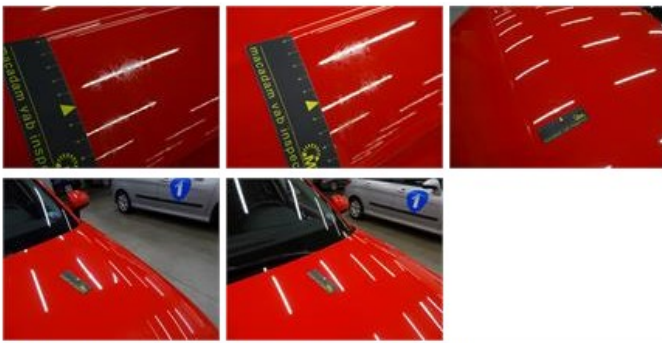
Bonnet, Chemical polution, LI - Repair and paint (complete) 232,06

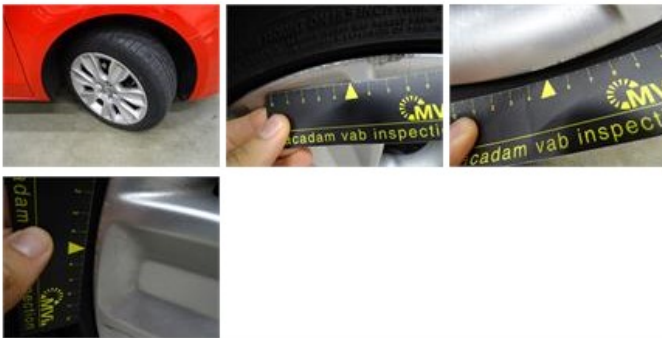
Alloy rim F R, Scratch(es), LI - Repair and paint (complete) 95,00

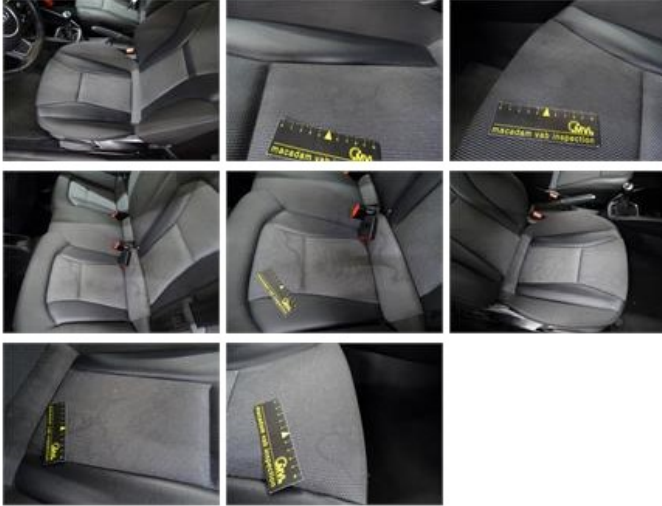
Interior, Stain, Cleaning 50,00

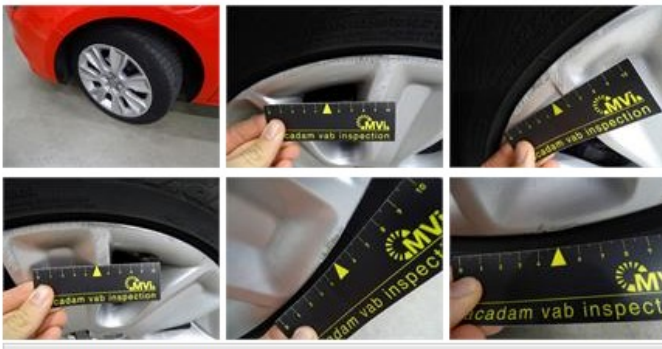
Alloy rim F L, Scratch(es), LI - Repair and paint (complete) 95,00

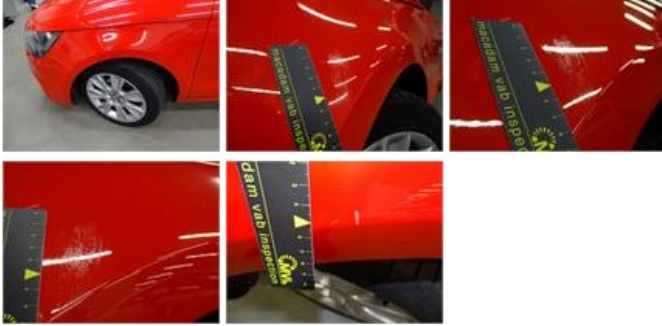
Wing F L, Chemical polution, LI - Repair and paint (complete) 176,14

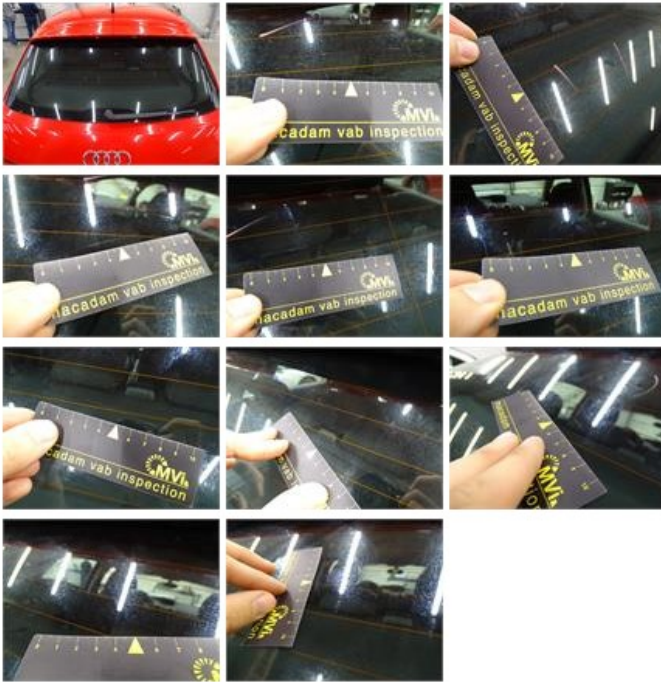
Rear window, Scratch(es), E - Replace	0,00
---------------------------------------	------

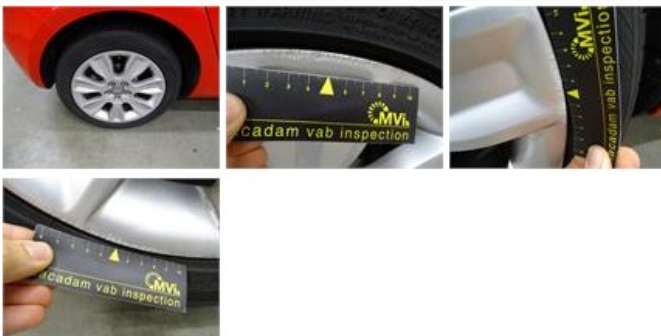
Door F R, Scratch(es), Acceptable	0,00
<i>No pictures to display</i>	
Alloy rim R R, Scratch(es), LI - Repair and paint (complete)	95,00
