BMW 1 HATCH: 1LGZ306

Limited Technical Inspection

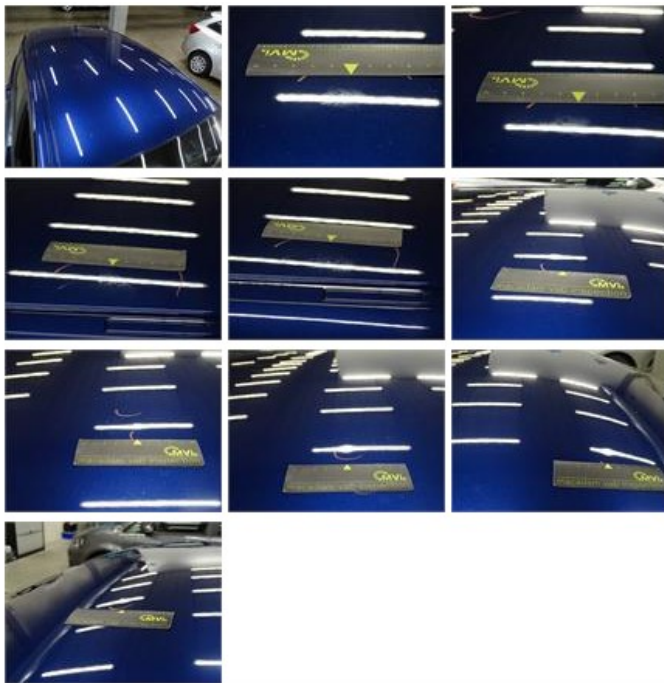
Total cost ex VAT	1249,65
Bonnet, Dent(s), Acceptable	0,00
<i>No pictures to display</i>	
Roof, Chemical polution, LI - Repair and paint (complete)	529,50

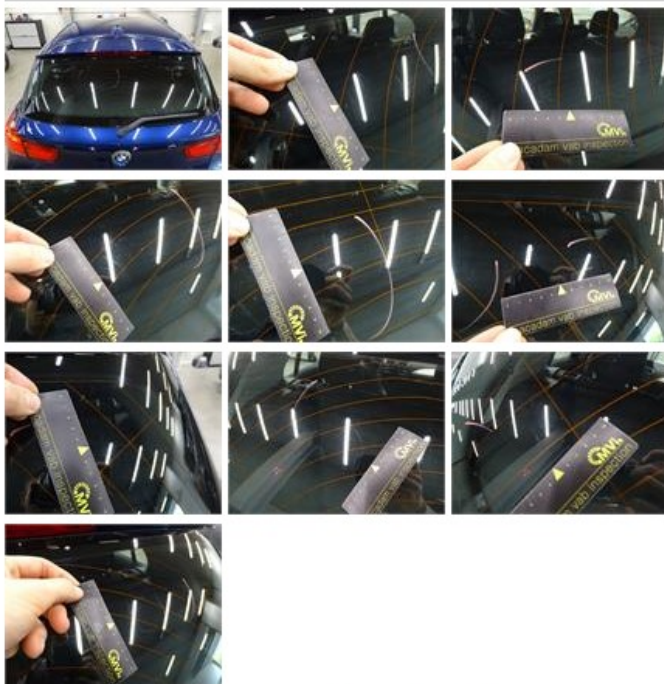
Rearview mirror housing L, Scratch(es), Acceptable	0,00
<i>No pictures to display</i>	
Alloy rim R L, Scratch(es), Acceptable	0,00
<i>No pictures to display</i>	
Rear window, Scratch(es), E - Replace	0,00

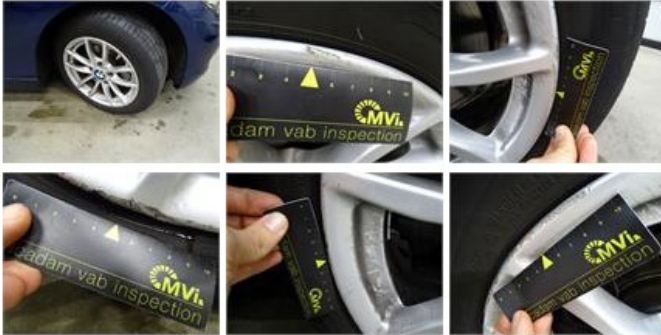
Alloy rim F R, Scratch(es), LI - Repair and paint (complete) 95,00

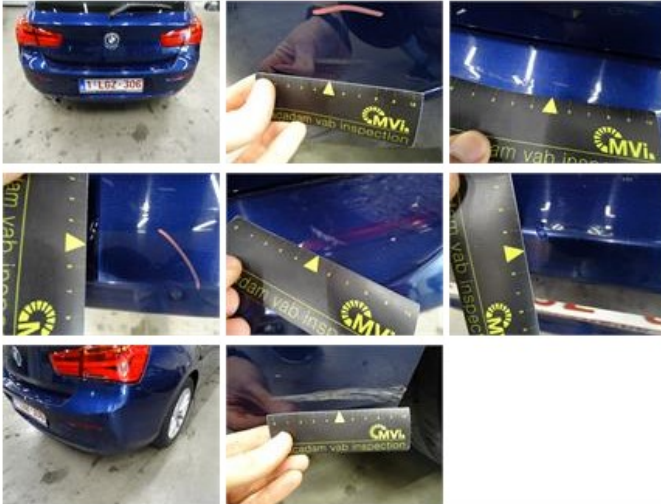
Bumper R, Scratch(es), LI - Repair and paint (complete) 211,80
