AUDI Q5: 1GGS319

Limited Technical Inspection

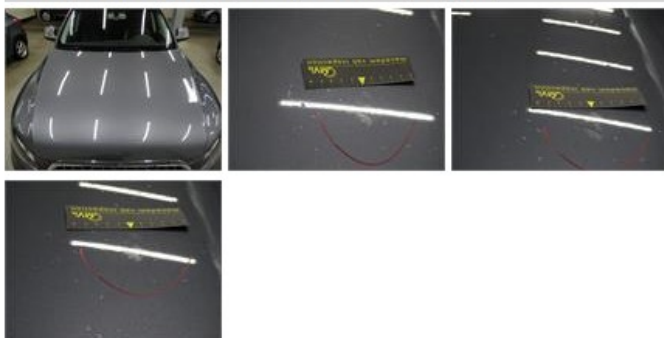
Bonnet, Chemical polution, LI - Repair and paint (complete)

348,09

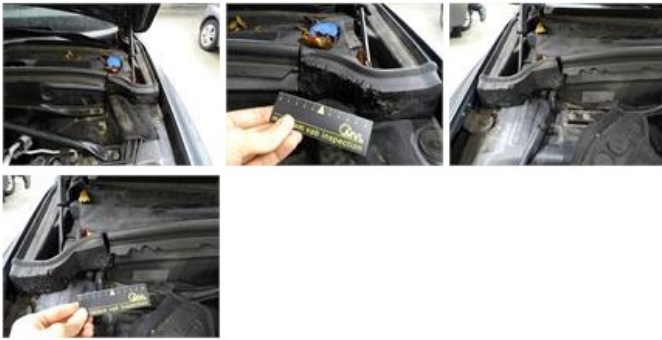
Protection plate M, Deformed / Strained, Acceptable

0,00
