**BMW 5 TOURING: 1KJG636**

Vinnumber:	<b>WBA5L11050D786076</b>	Versionname:	<b>2.0 518D (100KW) TOURING</b>
First Registrationdate:	<b>11/05/2015</b>	Fiscalpower:	
Expertise Mileage:	<b>186344</b>	Power Kw:	<b>100</b>
Bodytype:	<b>Break</b>	Body color:	<b>Black</b>
Gearbox:	<b>Automatic</b>	Paint type:	<b>Metalic</b>
Transmission:		Rims summer:	<b>Aluminium</b>
Fueltype:	<b>Diesel</b>	Oil level:	<b>OK</b>
Battery functioning:	<b>Yes</b>	Parking lot:	<b>2403</b>
Number of doors:	<b>5</b>		
Number of seats:	<b>5</b>		
Number head rests:	<b>5</b>		
Rims summer:	<b>Aluminium</b>		
Category:	<b>Passenger Car</b>		
Oil level:	<b>OK</b>		
Registration Certificate Car (BE):	<b>Yes</b>

**Limited Technical Inspection**

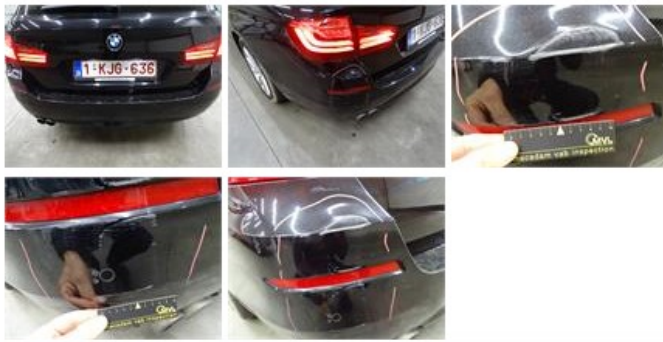
Bumper R, Dent(s) and scratch(es), LI - Repair and paint (complete)

254,16

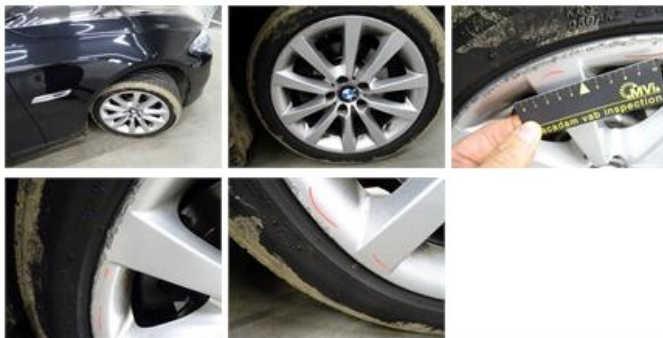
Alloy rim F R, Scratch(es), LI - Repair and paint (complete)

95,00

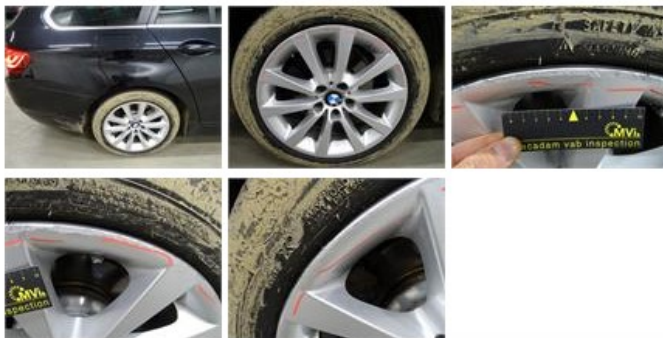
Alloy rim R R, Scratch(es), LI - Repair and paint (complete)

95,00

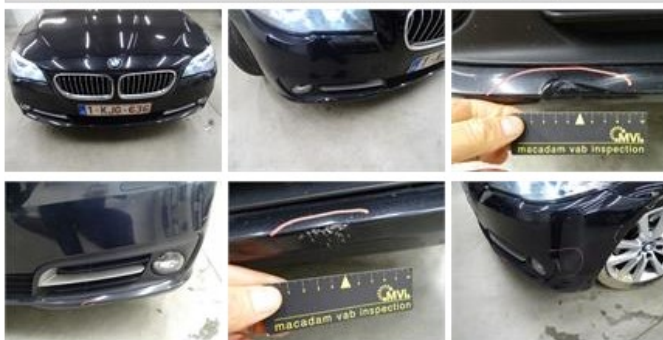
Bumper F, Dent(s) and scratch(es), LI - Repair and paint (complete)

254,16
