BMW X4: 1LCL250

Limited Technical Inspection

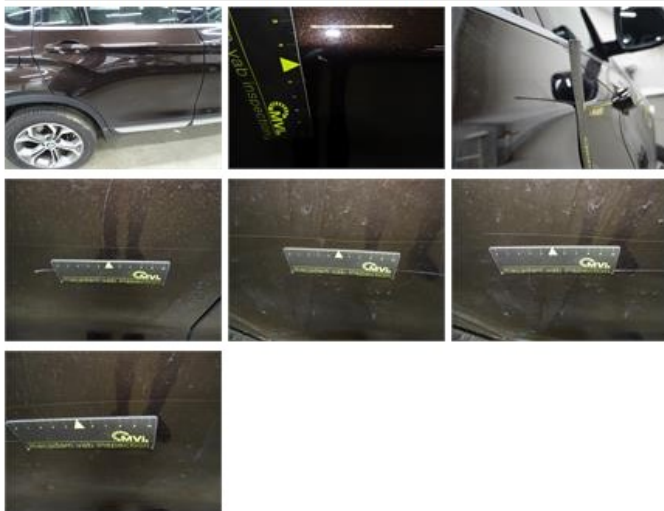
Door R R, Dent(s) and scratch(es), LI - Repair and paint (complete)

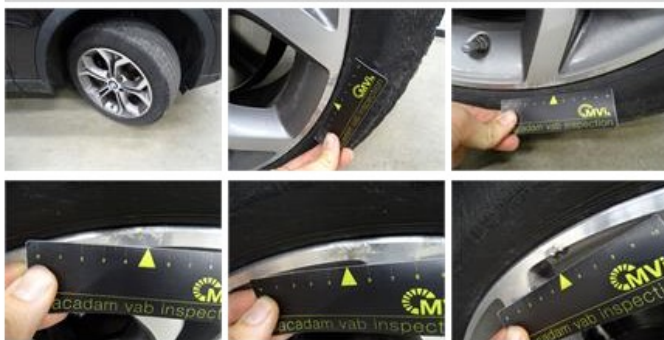
Alloy rim F R polished, Scratch(es), LI - Repair and paint (complete)

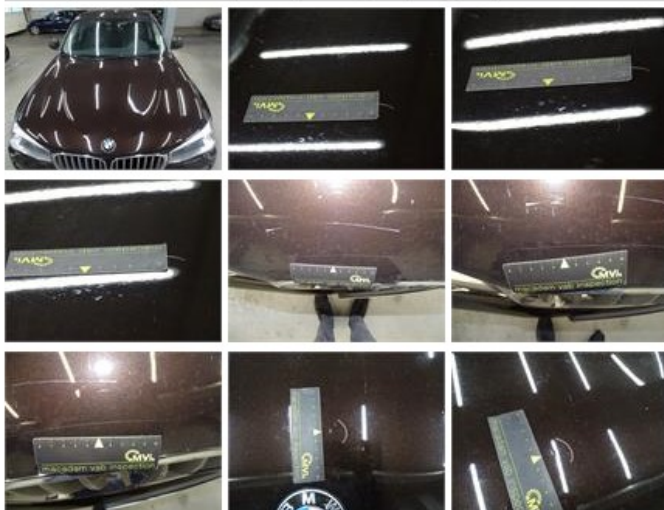
Bonnet, Chemical polution, LI - Repair and paint (complete)

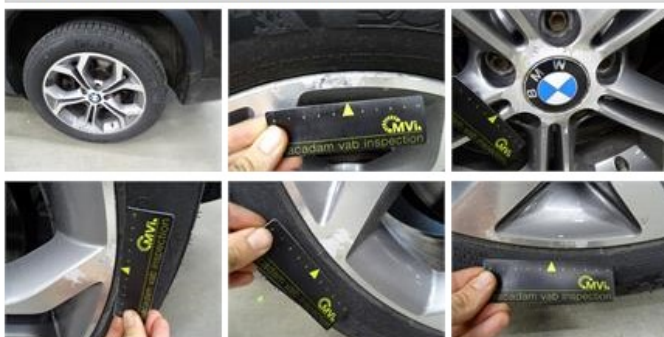
Alloy rim R L polished, Rust, Acceptable

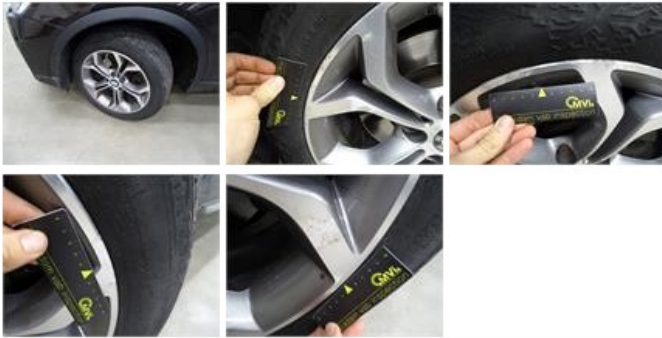
Alloy rim F L polished, Rust, Acceptable

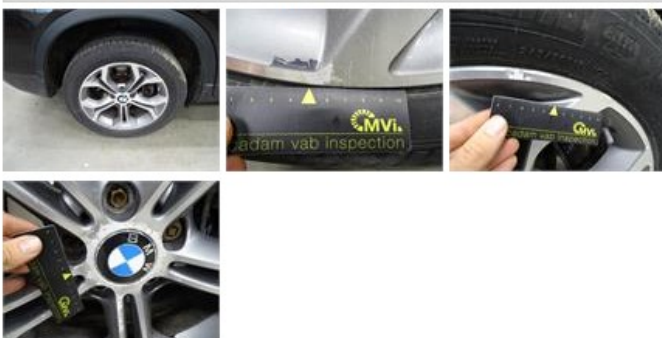
Alloy rim R R polished, Rust, Acceptable

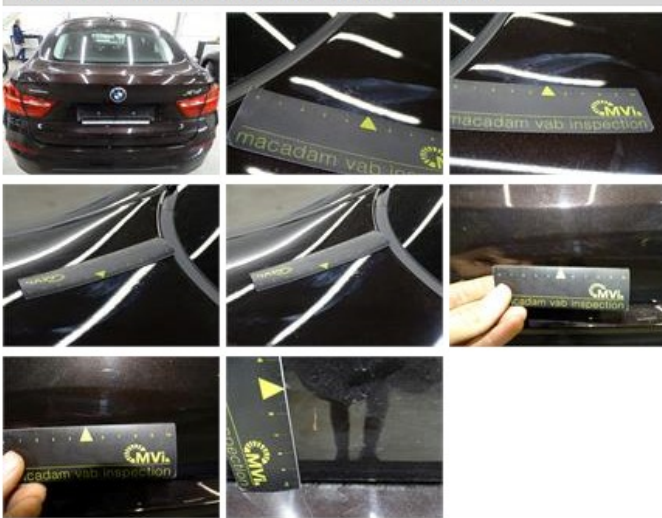
Tailgate, Chemical pollution, LI - Repair and paint (complete)

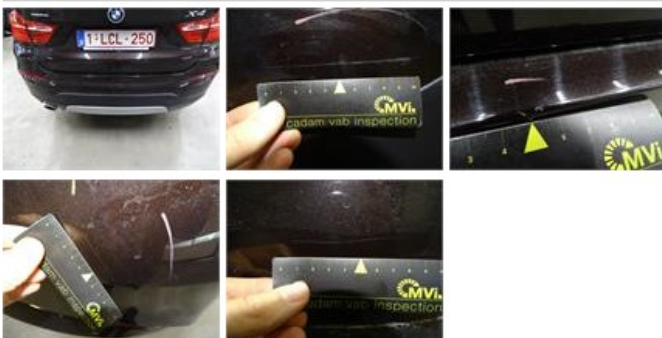
Bumper R, Scratch(es), LI - Repair and paint (complete)
