FIAT Doblo: 1CIM491

Limited Technical Inspection

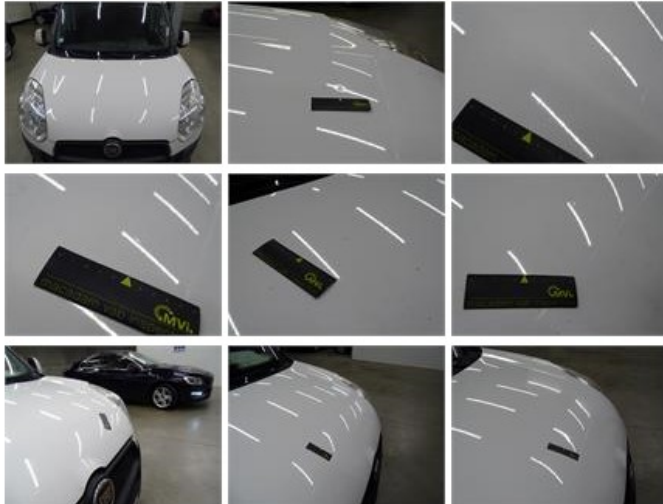
Bonnet, Bad repair, Acceptable

0,00

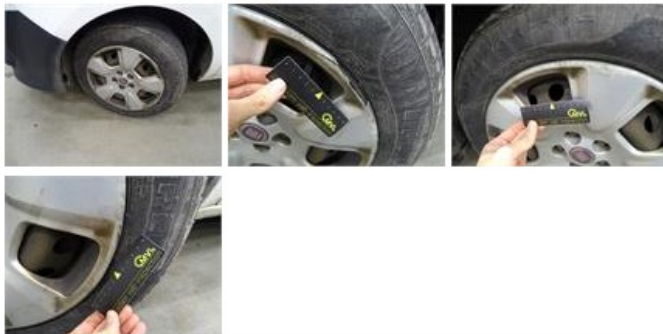
Wheel cover F L, Broken, E - Replace

22,50

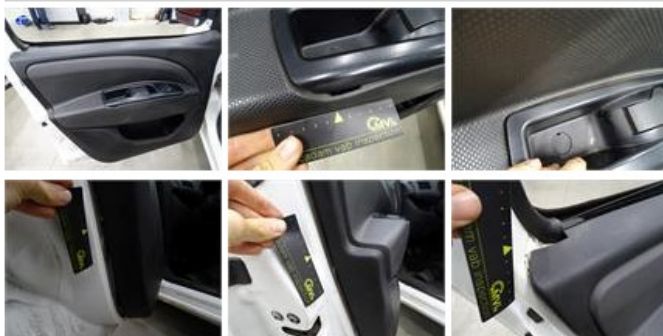
Door panel F L, Broken, E - Replace

91,50

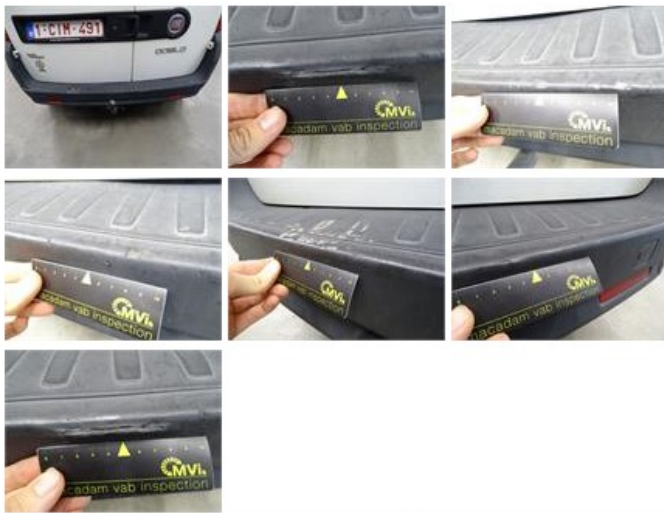
Bumper R, Broken, E - Replace

329,40

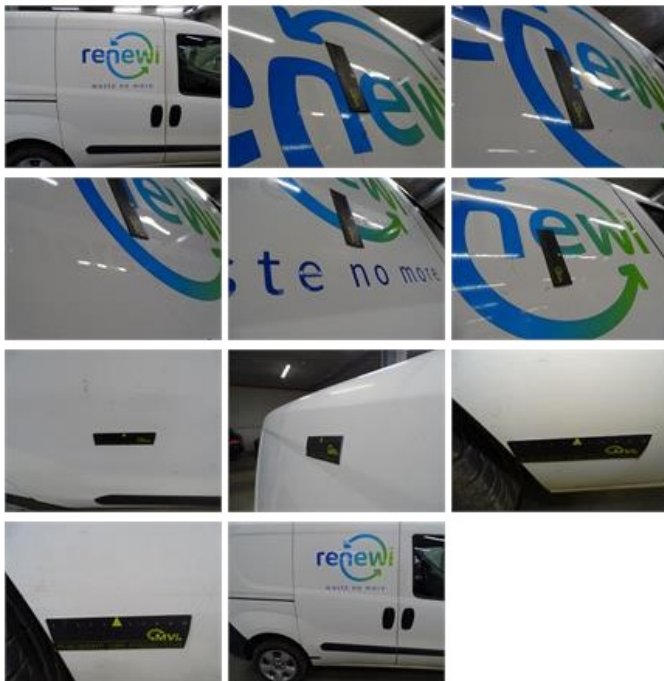
Door R R, Dent(s), LI - Repair and paint (complete)

238,76

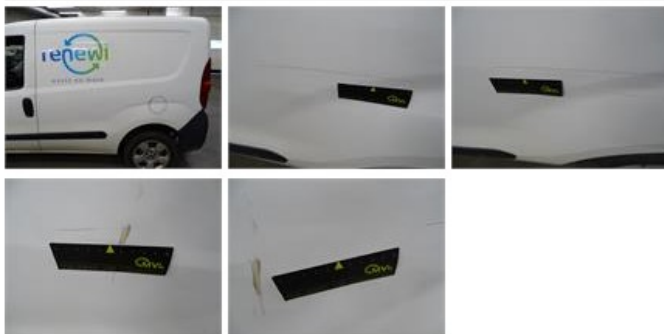
Wing R L, Scratch(es), LI - Repair and paint (complete)

231,15

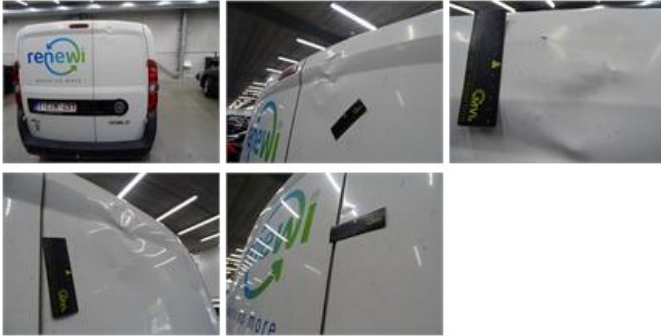
Trunk door R R, Dent(s) and scratch(es), It - Spot repair

187,56
