FORD C-MAX: 1GKM867

| Vinnumber: | WF0JXXWPBJEY53747 | Versionname: | C-MAX Trend St/St 95PK |

Limited Technical Inspection

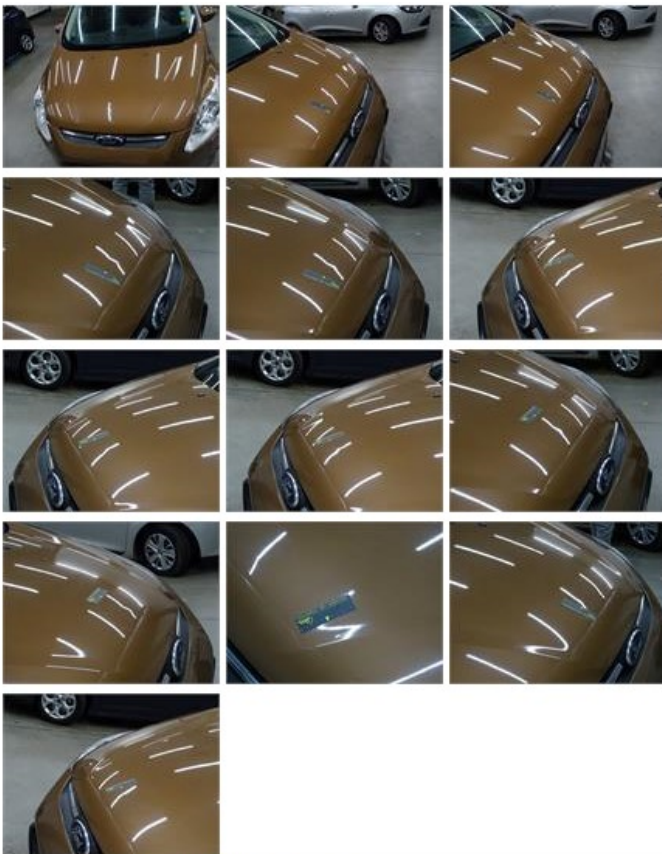
| Bonnet, Deformed / Strained, LI - Repair and paint (complete) | 290,08 |

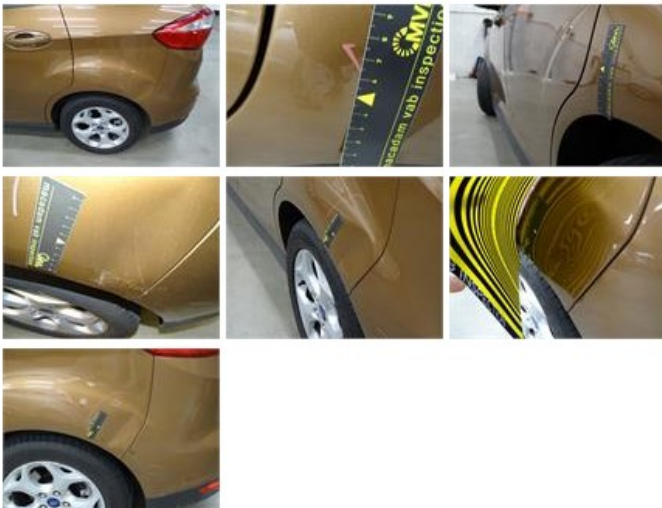
Wing R L, Dent(s) and scratch(es), LI - Repair and paint (complete) 356,20

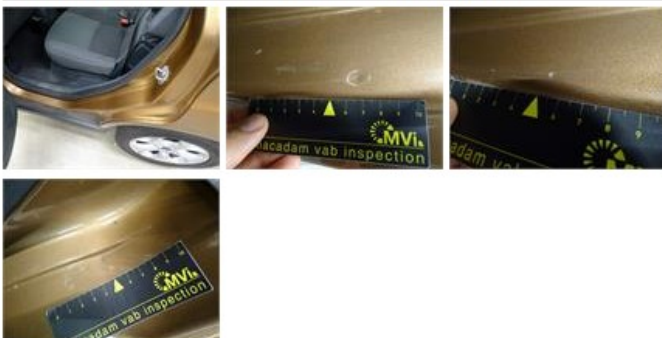
Rocker panel inner R L, Dent(s), LI - Repair and paint (complete) 115,56

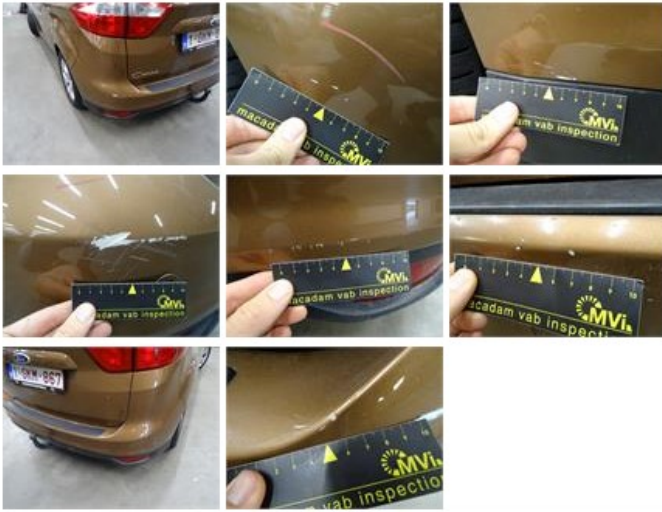
Bumper R, Scratch(es), LI - Repair and paint (complete)

211,80

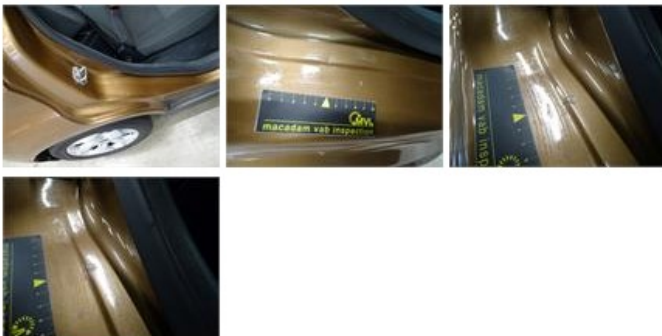
Rocker panel inner R R, Dent(s), LI - Repair and paint (complete)

115,56

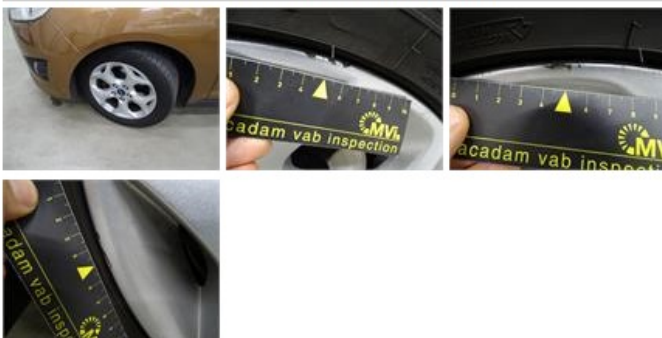
Alloy rim F L, Scratch(es), LI - Repair and paint (complete)

95,00

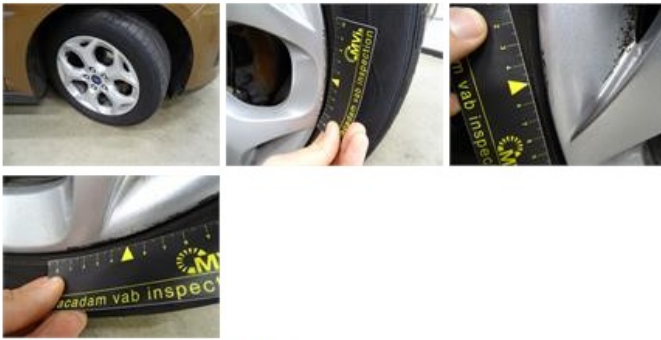
Alloy rim F R, Scratch(es), LI - Repair and paint (complete)

95,00

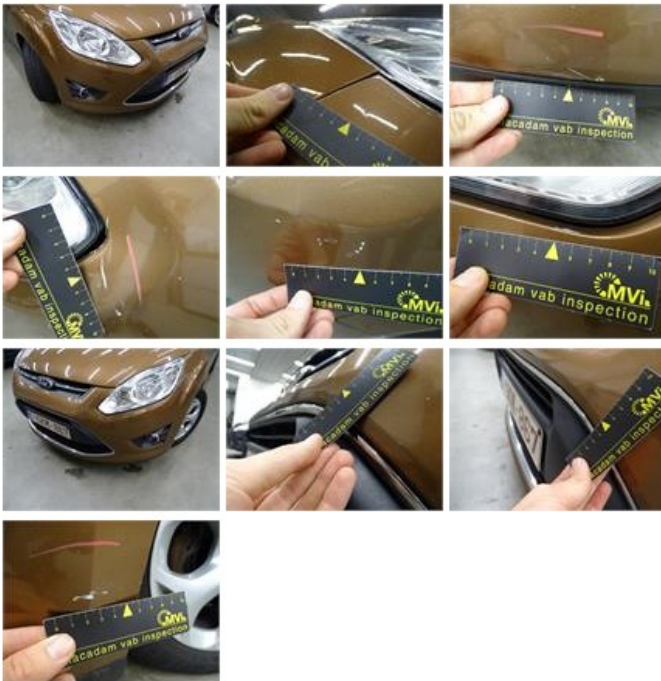
Bumper F, Dent(s) and scratch(es), LI - Repair and paint (complete)

211,80
