## Mercedes Vito: 1GTJ155

## Limited Technical Inspection

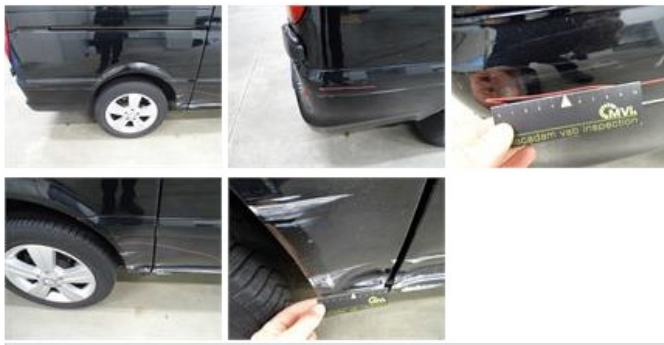
Total cost ex VAT	1582,45
Alloy rim F R, Scratch(es), Acceptable	0,00
<i>No pictures to display</i>	
Bonnet, Stone chip(s), Acceptable	0,00
<i>No pictures to display</i>	
Wing R R, Dent(s) and scratch(es), LI - Repair and paint (complete)	231,15

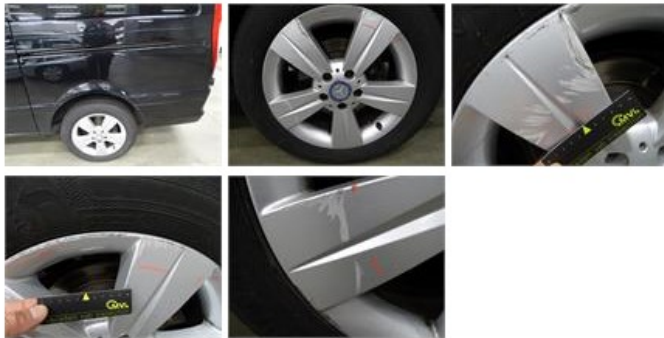
Alloy rim R L, Scratch(es), LI - Repair and paint (complete)

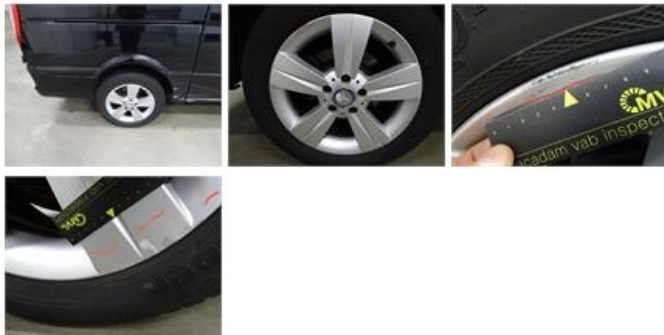
Alloy rim R R, Scratch(es), LI - Repair and paint (complete)

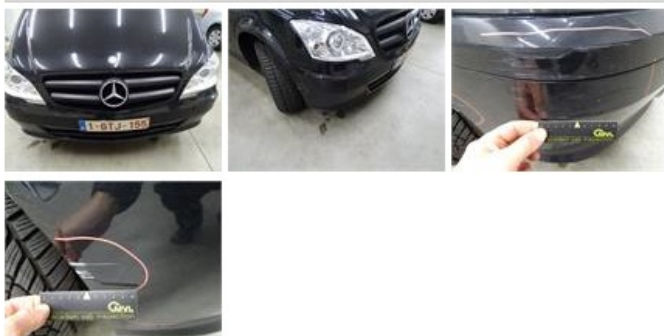
Bumper F, Scratch(es), LI - Repair and paint (complete)
