**PEUGEOT 308 SW: 1LAS063**

Vinnumber:	<b>VF3LCBHXHFS126351</b>	Versionname:	<b>1.6 BLUEHDI 85KW S/S ACTIVE</b>
First Registrationdate:	<b>4/08/2015</b>	Fiscalpower:	
Expertise Mileage:	<b>187446</b>	Power Kw:	<b>85</b>
Bodytype:		Body color:	<b>Black</b>
Gearbox:	<b>MAN 6 VIT</b>	Paint type:	<b>Metalic</b>
Transmission:	<b>Front</b>	Rims summer:	<b>Aluminium</b>
Fueltype:	<b>Diesel</b>	Oil level:	<b>OK</b>
Battery functioning:	<b>Yes</b>	Parking lot:	<b>3627</b>
Number of doors:	<b>5</b>		
Number of seats:	<b>5</b>		
Number head rests:	<b>5</b>		
Rims summer:	<b>Aluminium</b>		
Category:	<b>Passenger Car</b>		
Oil level:	<b>OK</b>		
Registration Certificate Car (BE):	<b>Yes</b>

**Limited Technical Inspection**

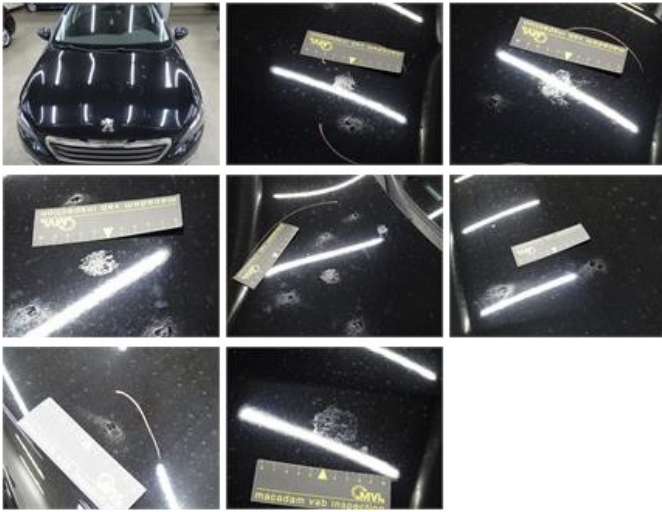
Bonnet, Chemical polution, LI - Repair and paint (complete)

290,08

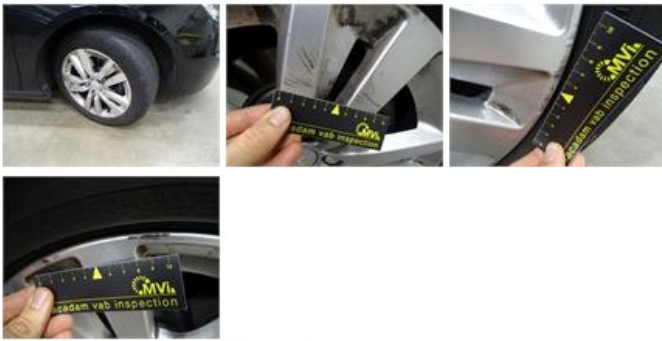
Alloy rim F R, Scratch(es), LI - Repair and paint (complete)

95,00

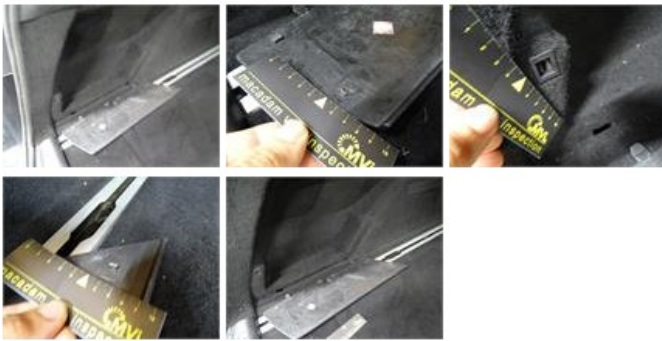
Internal Boot Lining L, Broken, E - Replace

40,00

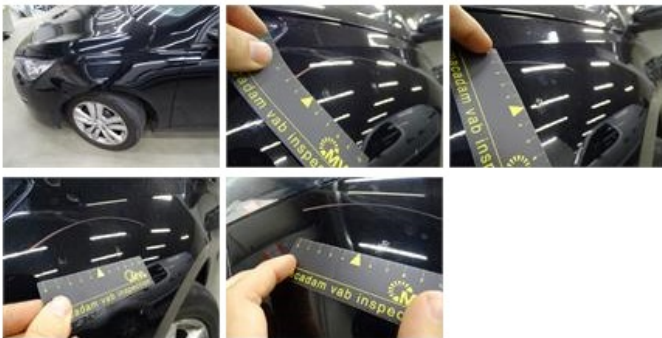
Wing F L, Chemical polution, LI - Repair and paint (complete)

220,18

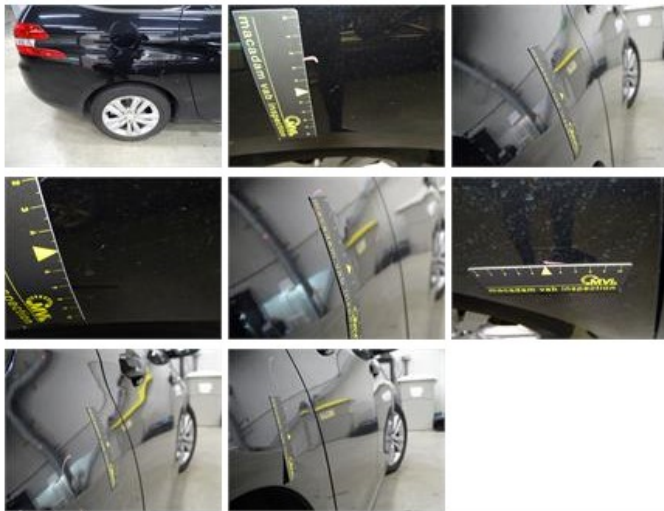
Wing R R, Dent(s) and scratch(es), LI - Repair and paint (complete)

308,20

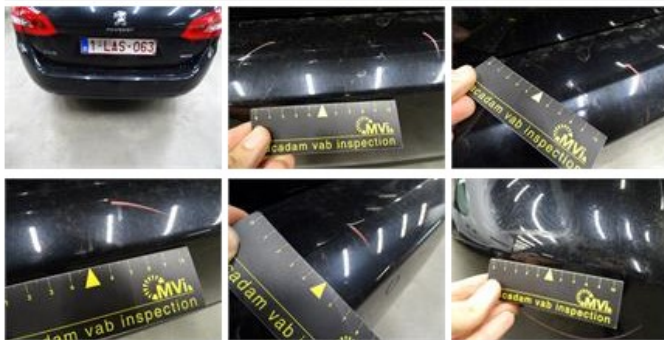
Bumper R, Scratch(es), LI - Repair and paint (complete)

211,80

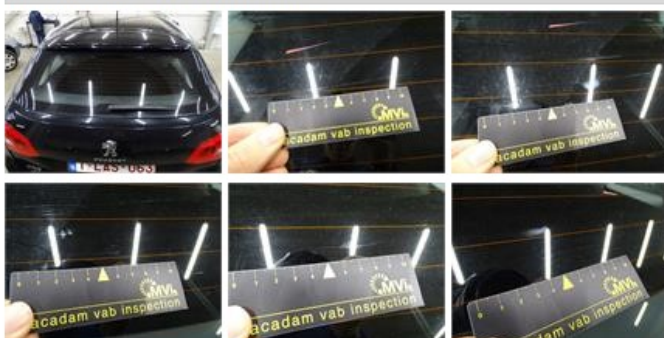
Rear window, Scratch(es), E - Replace

370,00

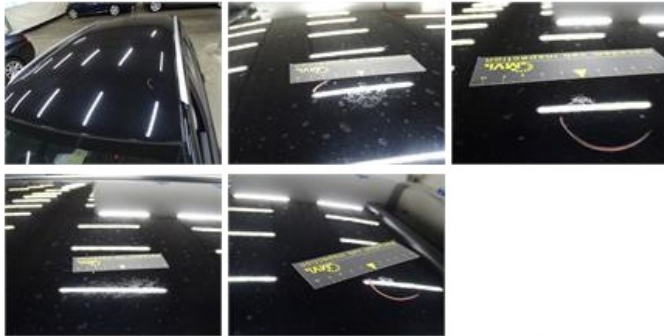
Roof, Chemical polution, LI - Repair and paint (complete)

481,50

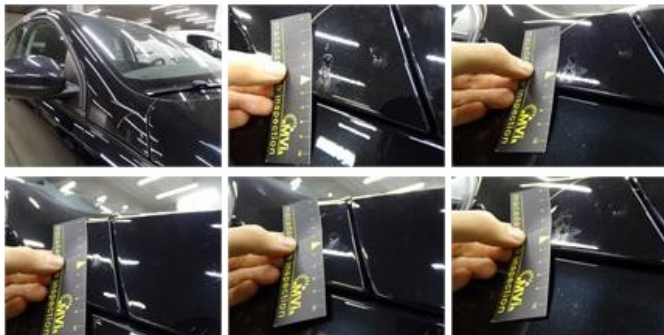
A-pillar right, Chemical polution, LI - Repair and paint (complete)

165,64

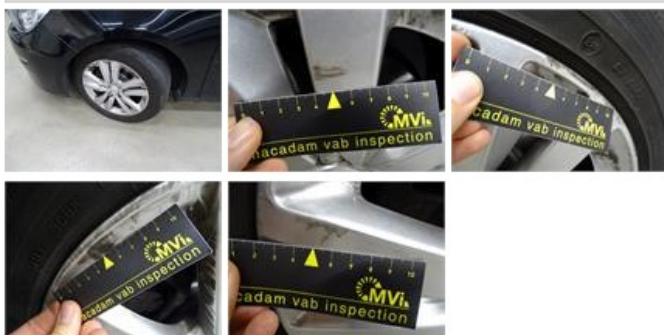
Alloy rim F L, Scratch(es), LI - Repair and paint (complete)

95,00
