**PEUGEOT 308: 1HUB001**

**Limited Technical Inspection**

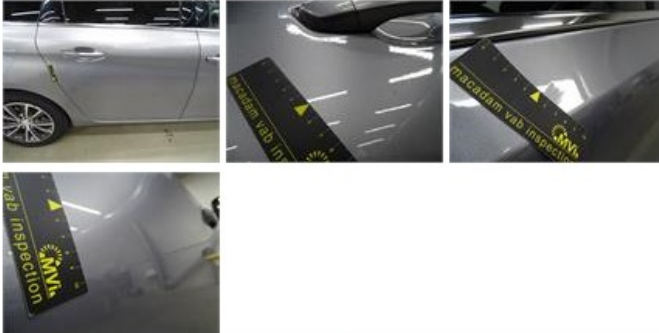
Door R R, Bad repair, Acceptable

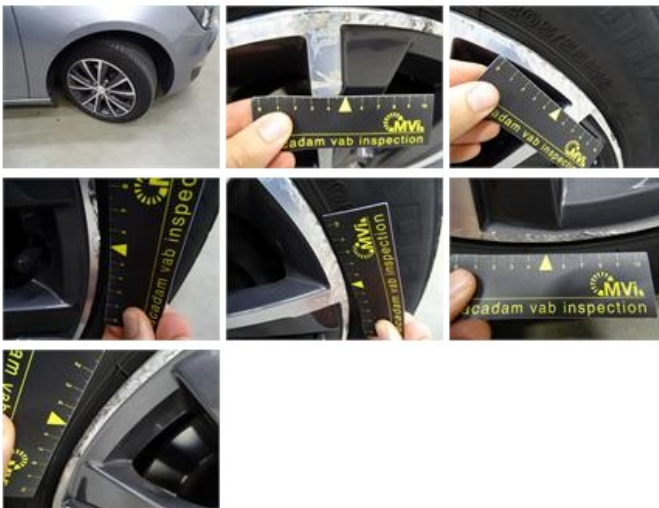
Alloy rim F R polished, Scratch(es), LI - Repair and paint (complete)

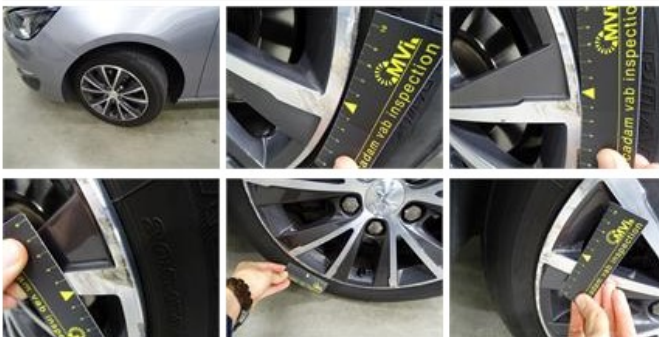
Alloy rim F L polished, Scratch(es), LI - Repair and paint (complete)

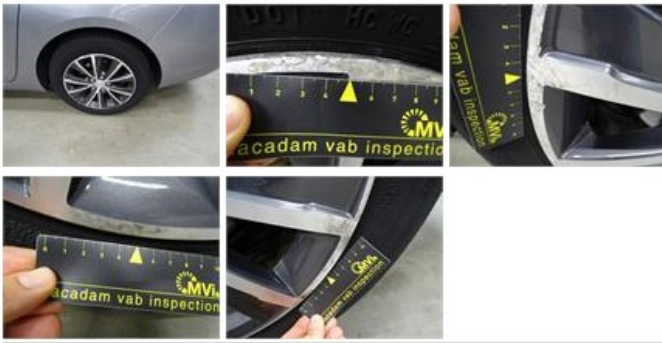
Alloy rim R L polished, Scratch(es), LI - Repair and paint (complete)

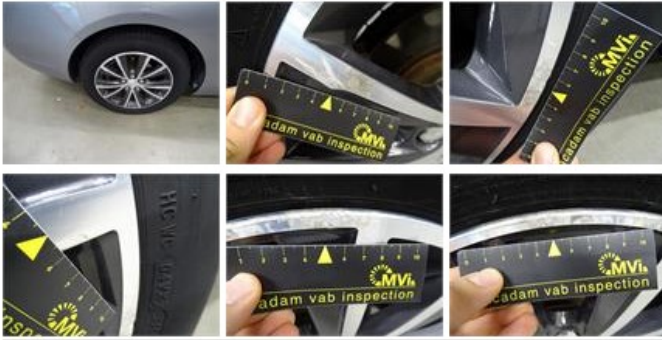
Alloy rim R R polished, Scratch(es), LI - Repair and paint (complete)
