PEUGEOT 2008: 1HTJ423

Limited Technical Inspection

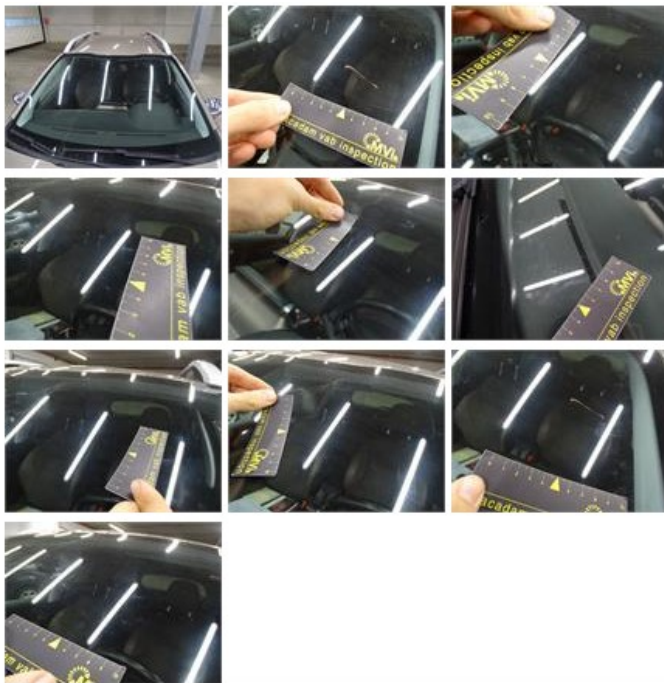
Total cost ex VAT	335,74
Windscreen, Scratch(es), E - Replace	0,00

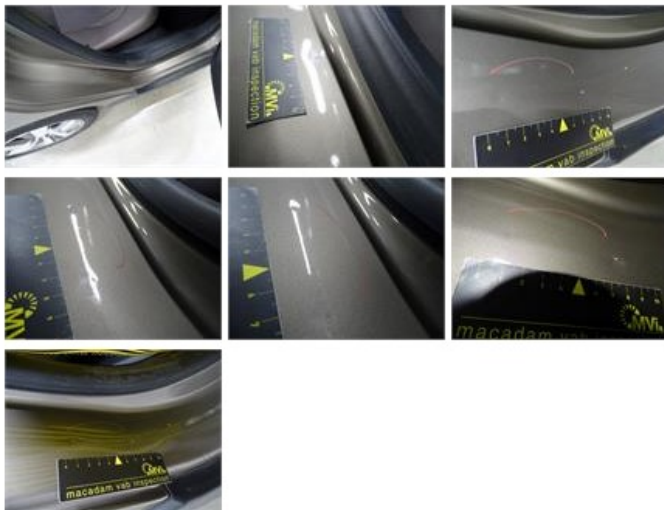
Rocker panel inner R R, Dent(s), LI - Repair and paint (complete) 115,56

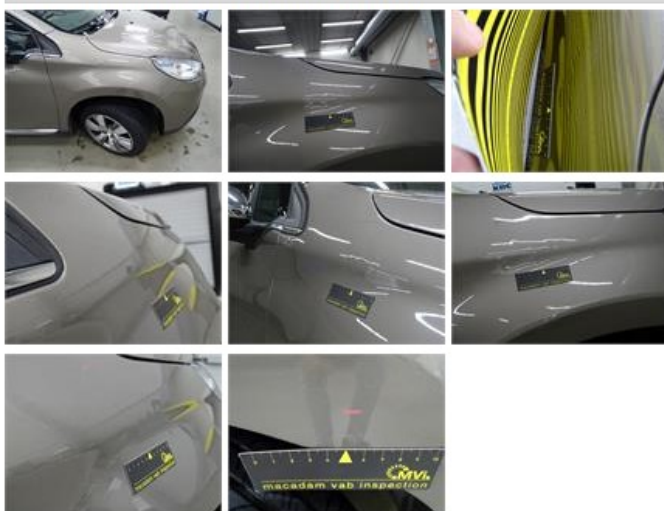
Wing F R, Dent(s), LI - Repair and paint (complete) 220,18

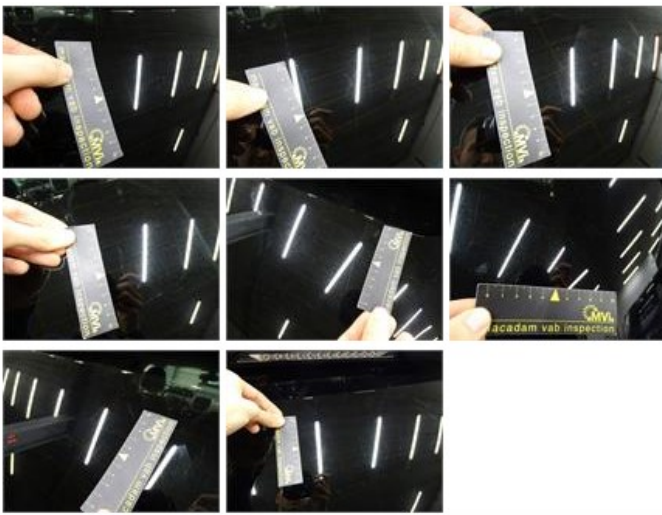
Rear window, Scratch(es), E - Replace 0,00
