**MERCEDES E BERLINE: 1LBR828**

**Limited Technical Inspection**

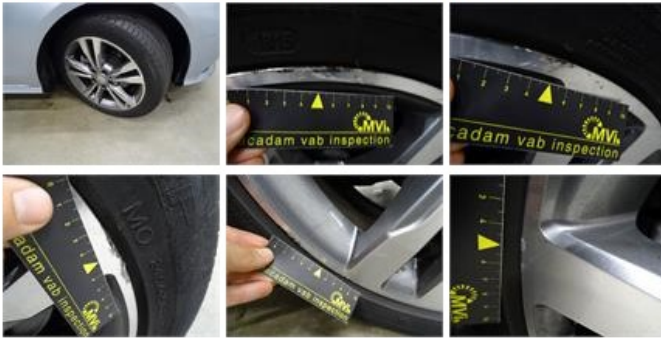
Alloy rim F R polished, Scratch(es), LI - Repair and paint (complete) 95,00

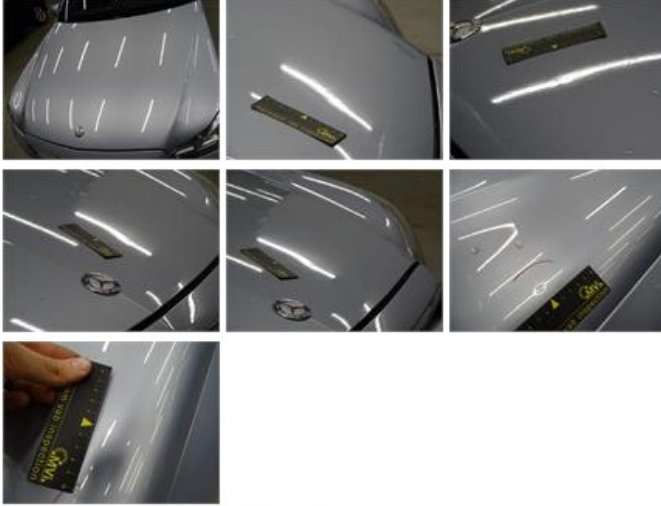
Bonnet, Dent(s), PDR - Paintless dent repair 102,60

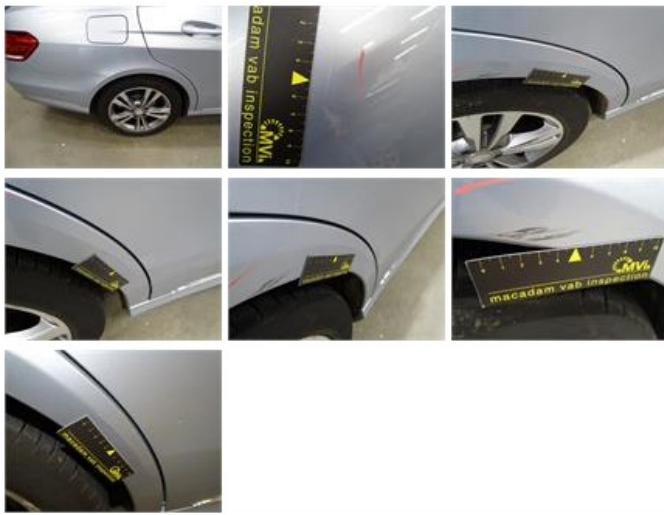
Wing R R, Scratch(es), LI - Repair and paint (complete) 369,84

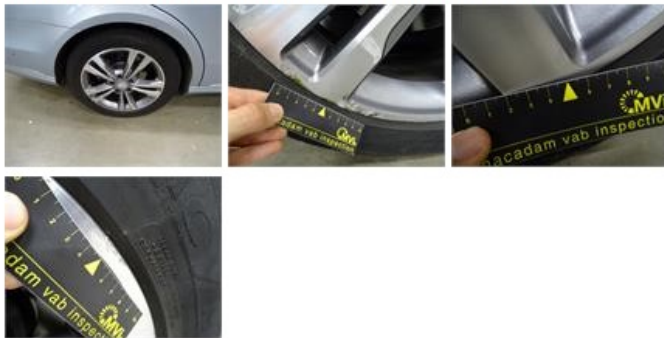
Alloy rim R R polished, Scratch(es), LI - Repair and paint (complete) 95,00

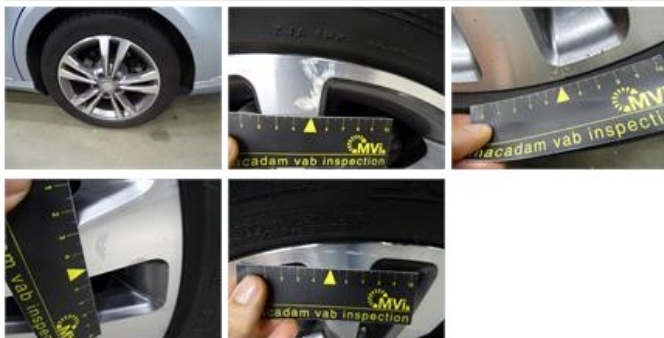
Alloy rim R L polished, Scratch(es), LI - Repair and paint (complete) 95,00

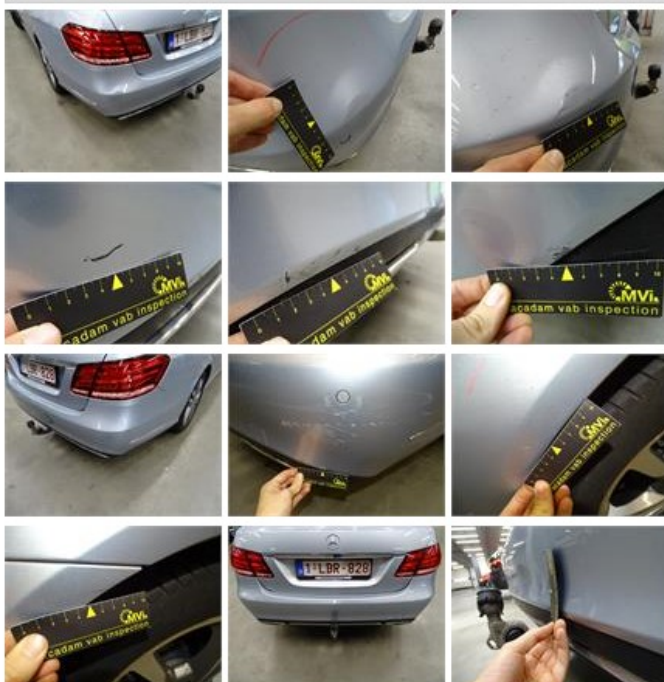
Bumper R, Dent(s) and scratch(es), LI - Repair and paint (complete) 254,16

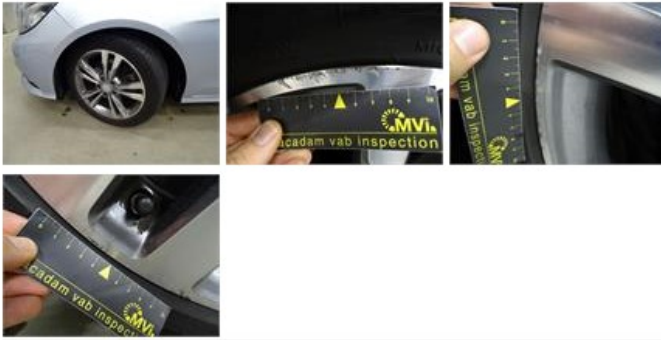
Alloy rim F L polished, Scratch(es), LI - Repair and paint (complete)

95,00
