**PEUGEOT 308 SW: 1LKA006**

**Limited Technical Inspection**

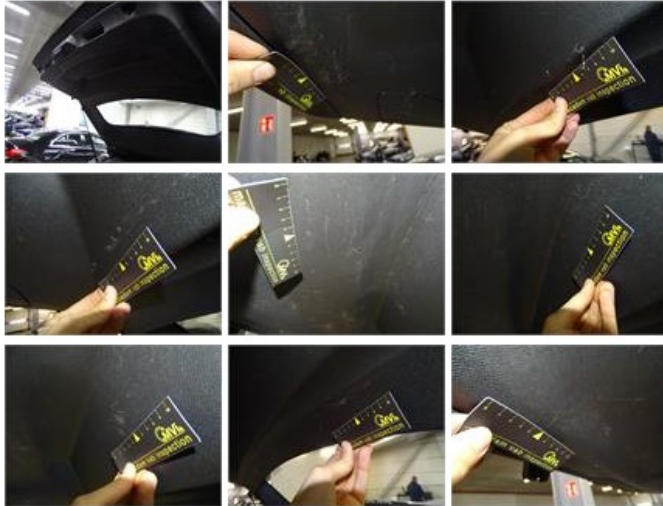
Trunk lid covering R, Scratch(es), Smart repair 110,64

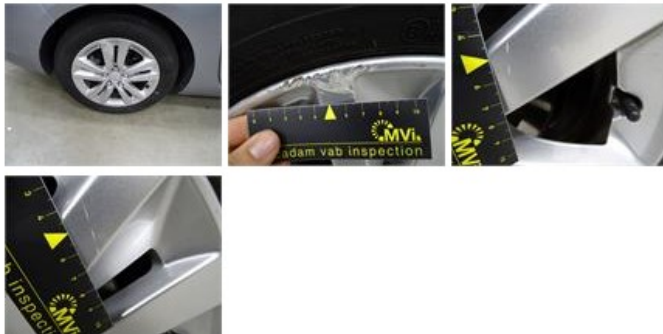
Alloy rim R R, Scratch(es), LI - Repair and paint (complete) 95,00

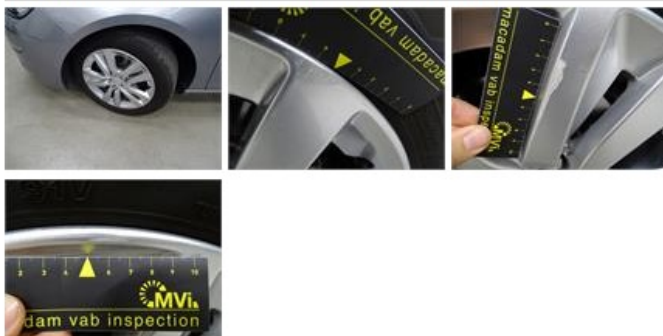
Alloy rim F L, Scratch(es), LI - Repair and paint (complete) 95,00

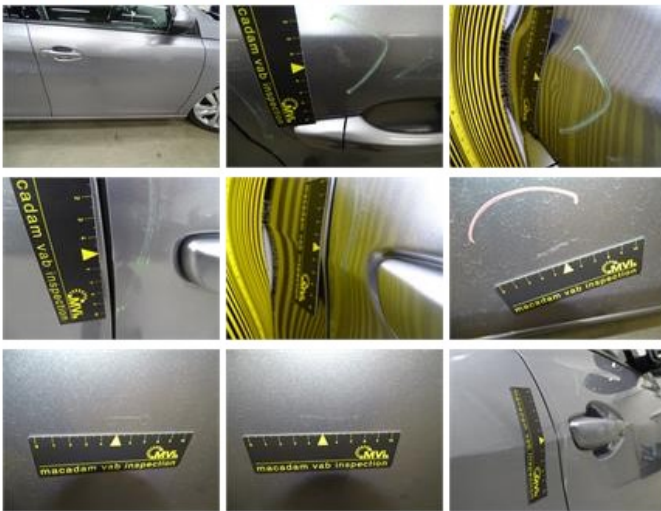
Door F R, Dent(s) and scratch(es), LI - Repair and paint (complete)

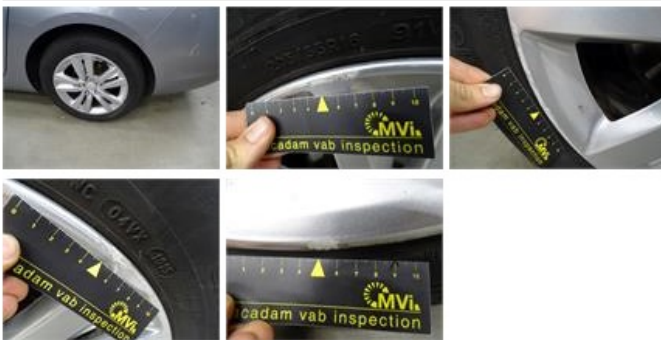
Alloy rim R L, Scratch(es), LI - Repair and paint (complete)

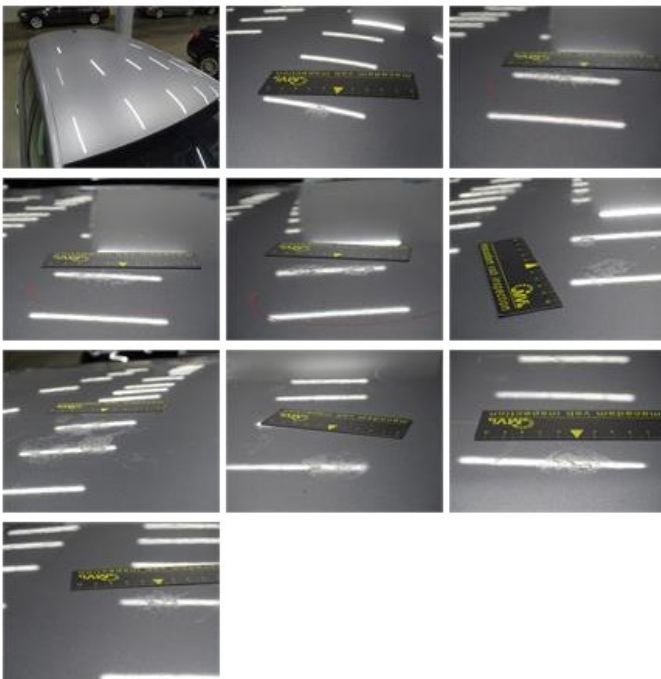
Roof, Chemical pollution, LI - Repair and paint (complete)

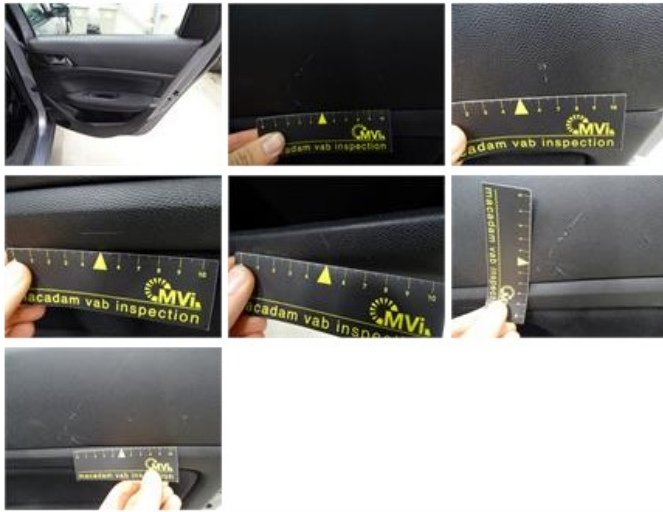
Door panel R R, Scratch(es), Smart repair

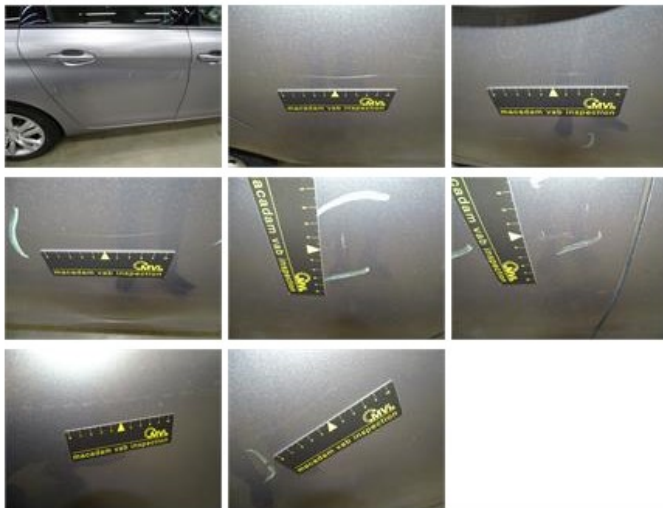
Door R R, Scratch(es), LI - Repair and paint (complete)

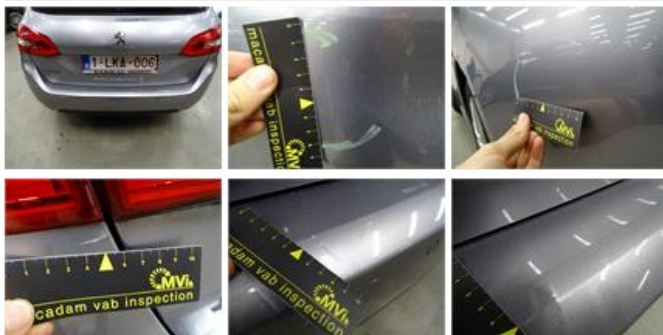
Bumper R, Scratch(es), LI - Repair and paint (complete)

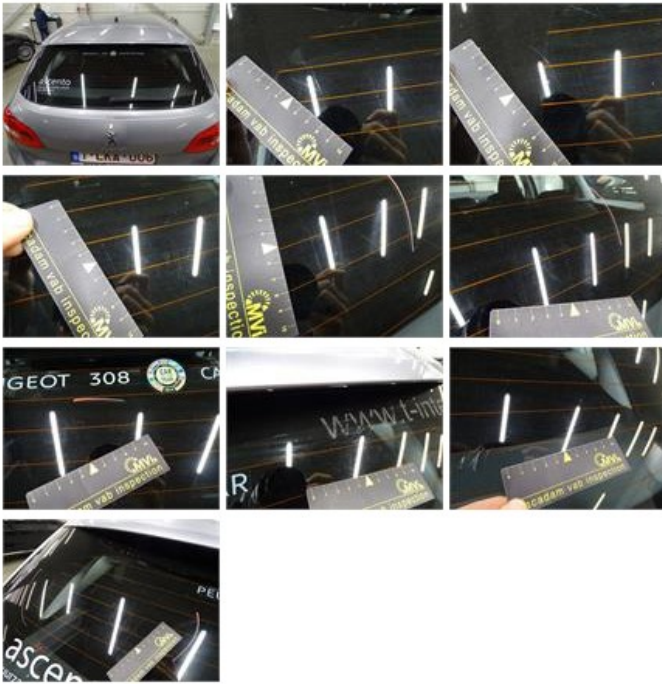
Rear window, Scratch(es), E - Replace
