**MERCEDES GLA: 1LCE789**

**Limited Technical Inspection**

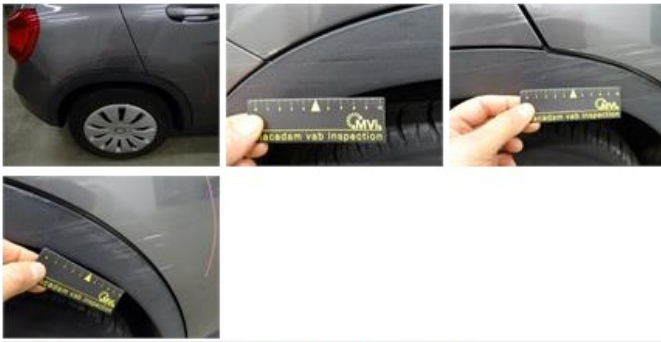
wing R R, Scratch(es), LI - spot repair

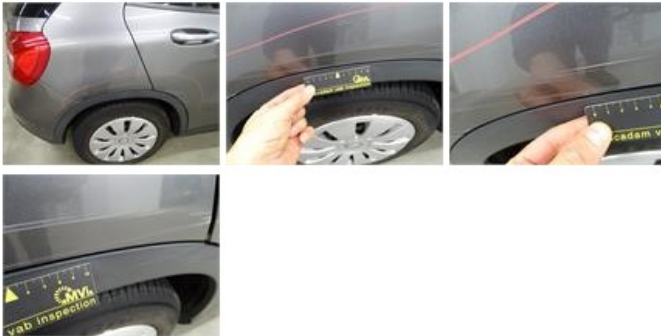
Wing R R, Scratch(es), LI - Repair and paint (complete)

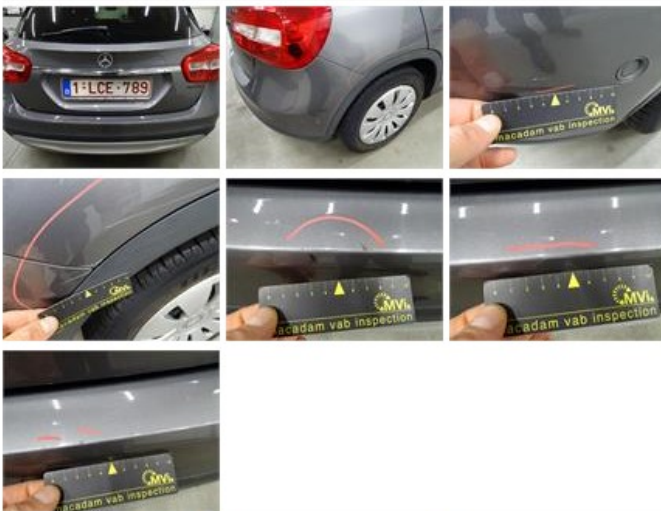
Bumper R, Scratch(es), LI - Repair and paint (complete)
