**BMW 1 HATCH: HL8270**

**Limited Technical Inspection**

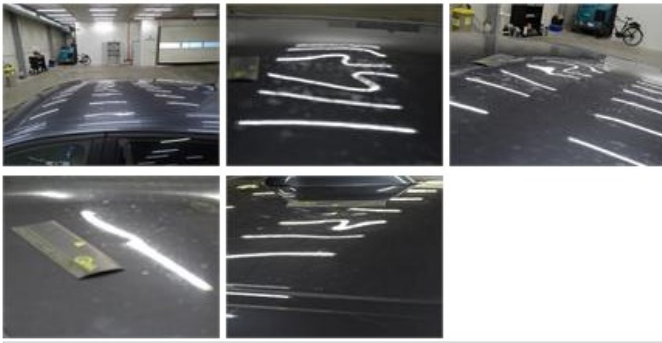
Total cost ex VAT	943,85
Alloy rim F L, Scratch(es), Acceptable	0,00
<i>No pictures to display</i>	
Roof, Dent(s), LI - Repair and paint (complete)	625,50
