## SKODA Octavia: 1GVJ808

## Limited Technical Inspection

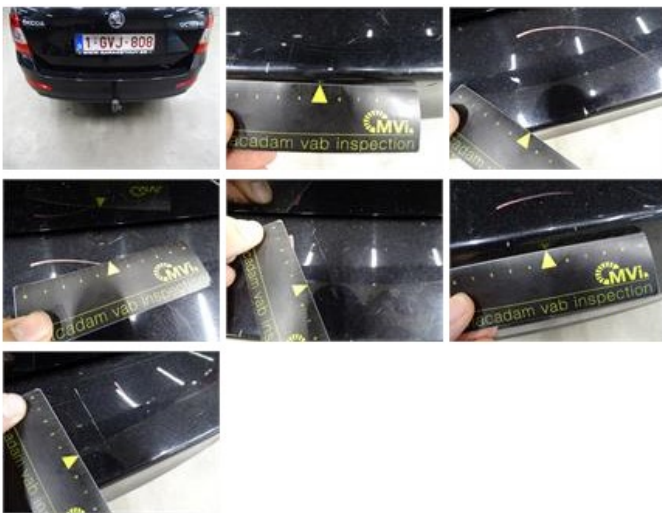
Total cost ex VAT	3605,67
Bumper R, Scratch(es), LI - Repair and paint (complete)	211,80

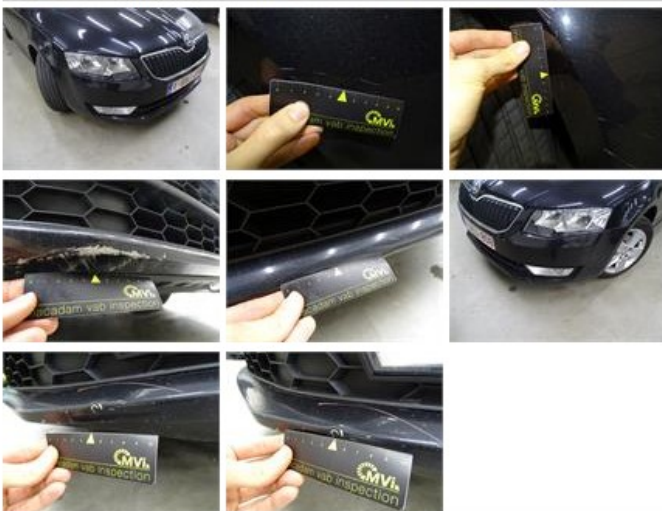
Bumper F, Dent(s) and scratch(es), LI - Repair and paint (complete)

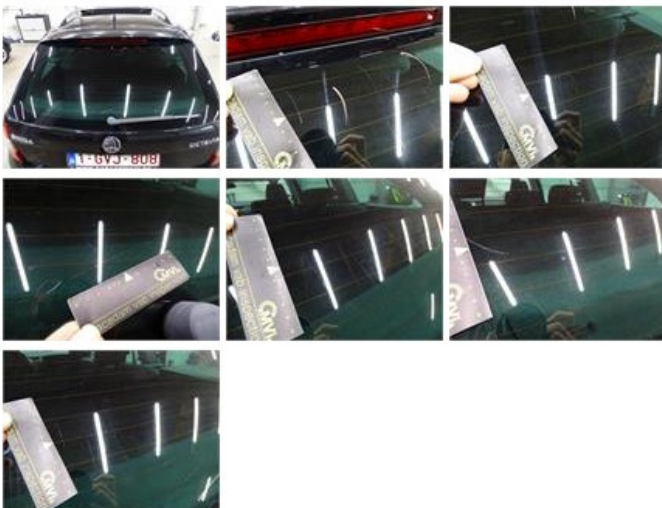
Rear window, Scratch(es), E - Replace

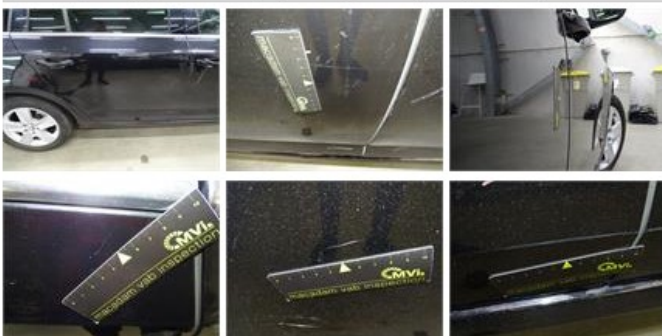
Door R R, Dent(s) and scratch(es), LI - Repair and paint (complete)

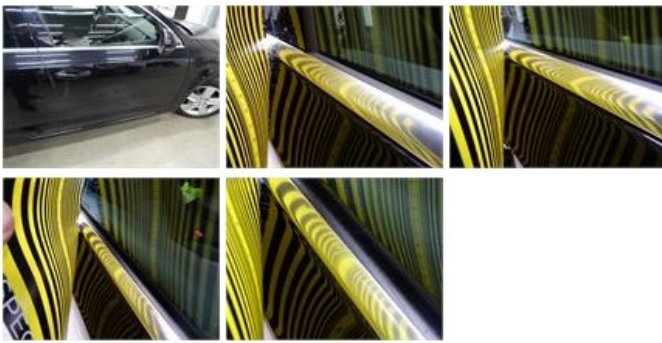
Door trim F R, Dent(s), E - Replace

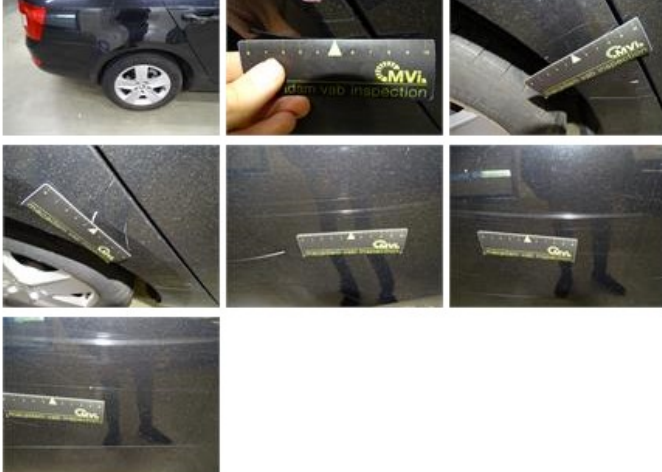
Wing R R, Dent(s) and scratch(es), LI - Repair and paint (complete) 308,20

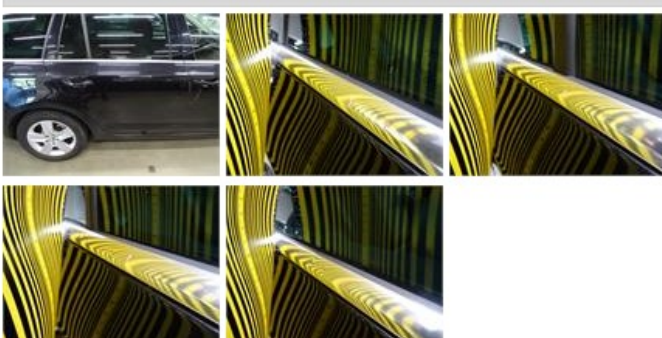
Door trim R R, Dent(s), E - Replace 114,00

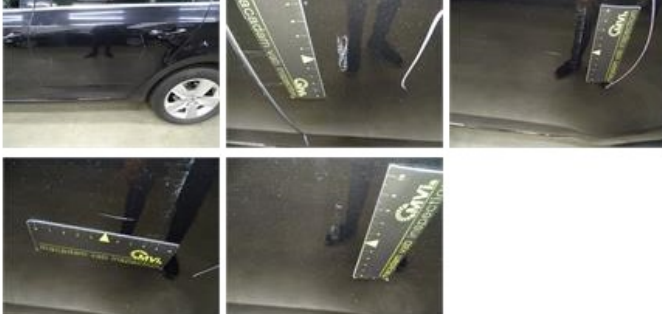
Door R L, Scratch(es), LI - Repair and paint (complete) 318,35

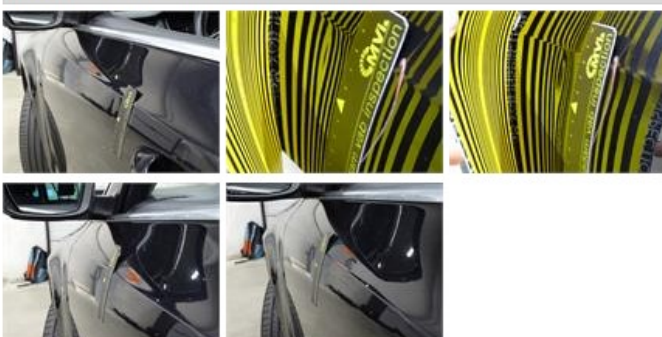
Door F L, Dent(s), PDR - Paintless dent repair 82,80

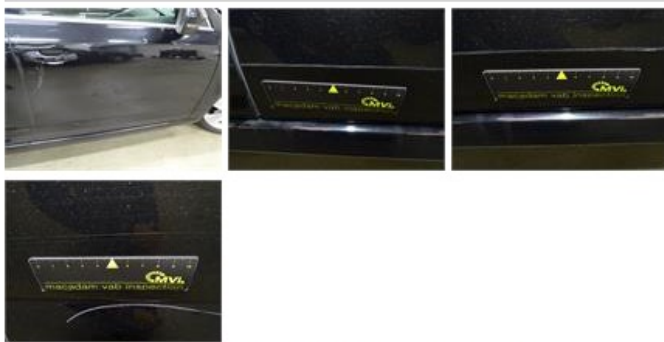
Door L, Scratch(es), LI - Repair and paint (complete)

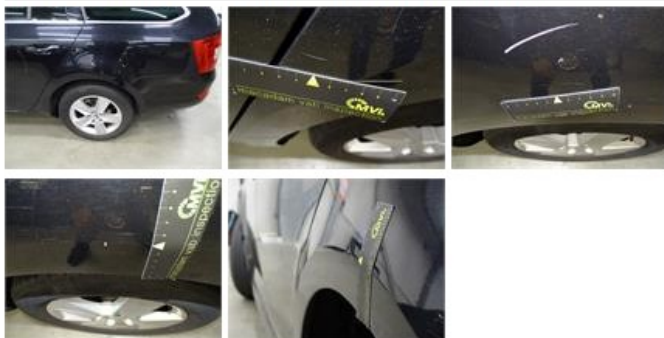
Wing R L, Dent(s) and scratch(es), LI - Repair and paint (complete)

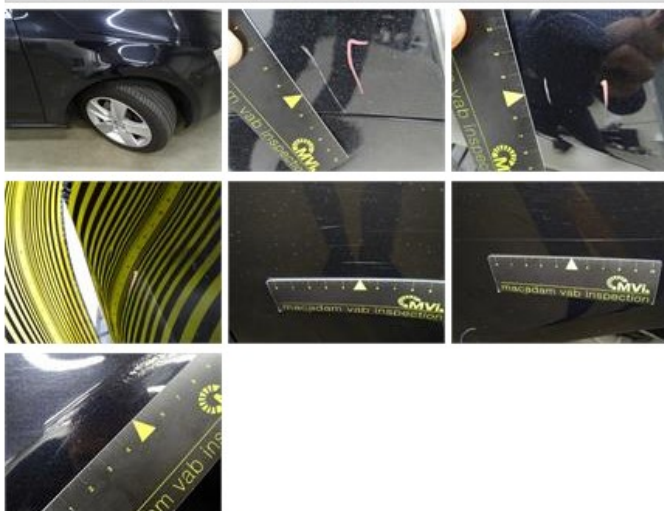
Wing F R, Dent(s) and scratch(es), LI - Repair and paint (complete)

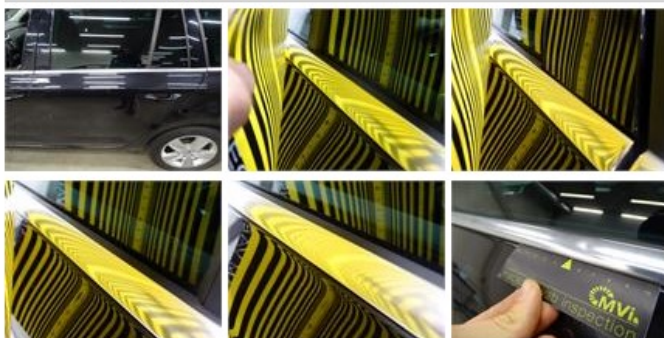
Door trim R L, Dent(s), E - Replace

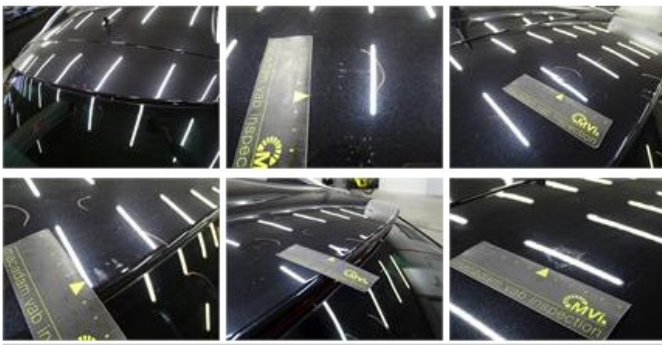
Rear spoiler, Dent(s) and scratch(es), LI - Repair and paint (complete)

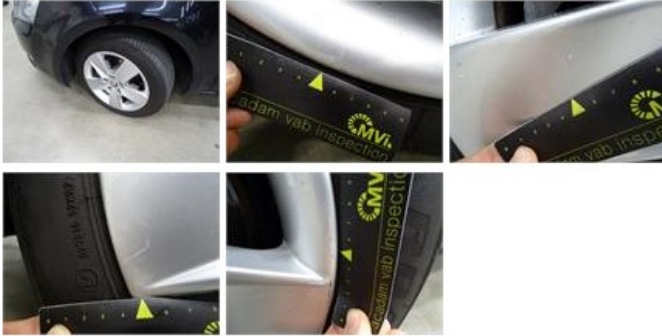
Alloy rim F L, Scratch(es), LI - Repair and paint (complete) 95,00

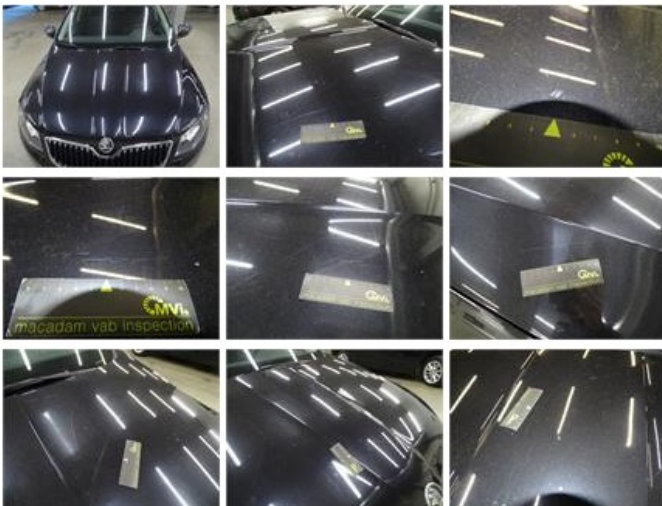
Bonnet, Scratch(es), LI - Repair and paint (complete) 290,08
