VOLVO V40: 1HJH632

Limited Technical Inspection

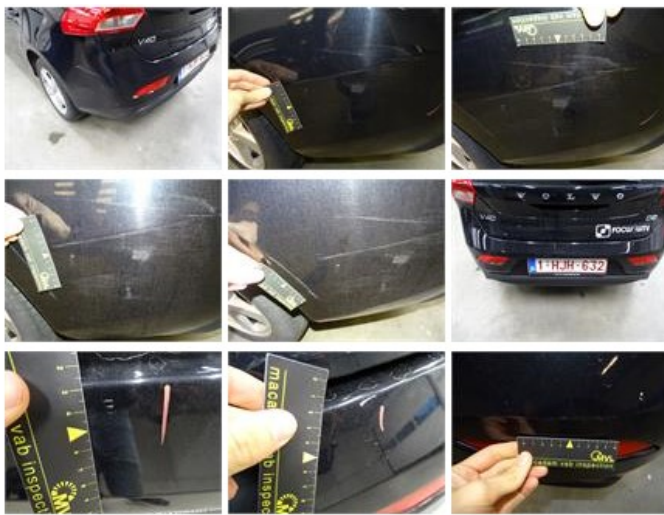
Total cost ex VAT	1247,92
Bumper R, Scratch(es), LI - Repair and paint (complete)	211,80

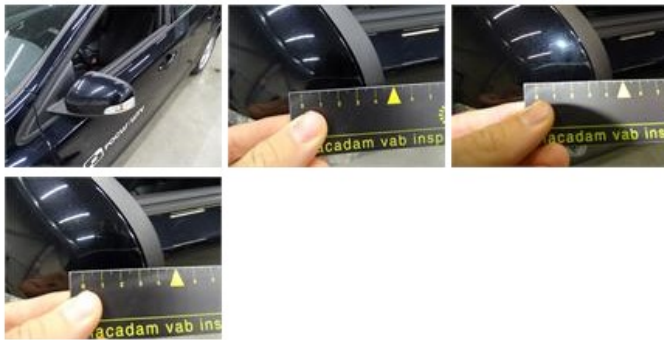
Rearview mirror housing L, Scratch(es), LI - Repair and paint (complete)

115,56

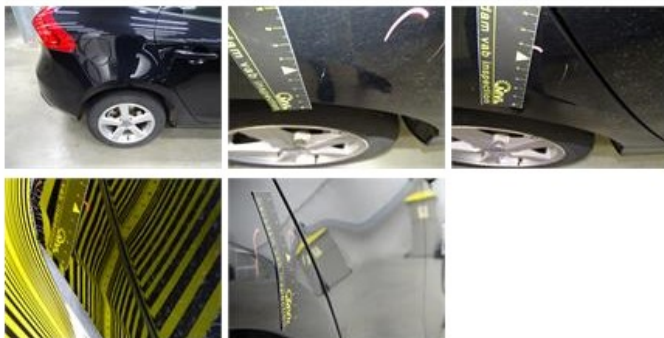
Wing R R, Dent(s) and scratch(es), LI - Repair and paint (complete)

308,20

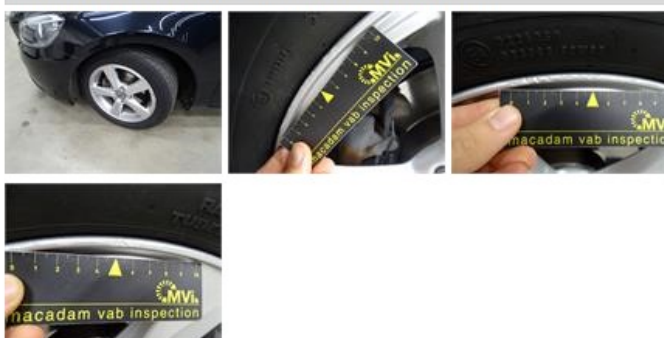
Alloy rim F L, Scratch(es), LI - Repair and paint (complete)

95,00

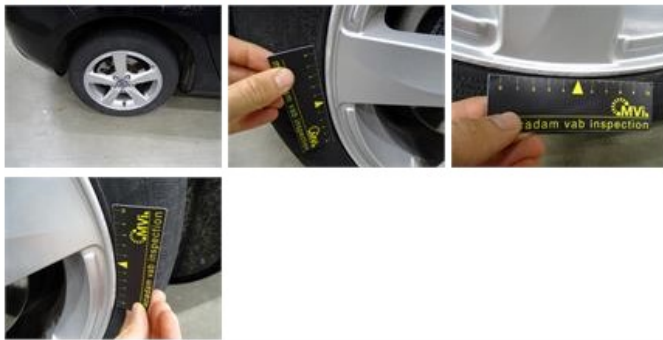
Alloy rim R R, Scratch(es), LI - Repair and paint (complete) 95,00

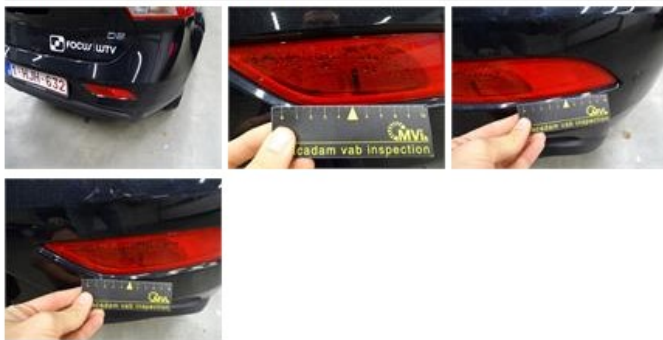
Reflector, Waterinfiltration, Acceptable 0,00

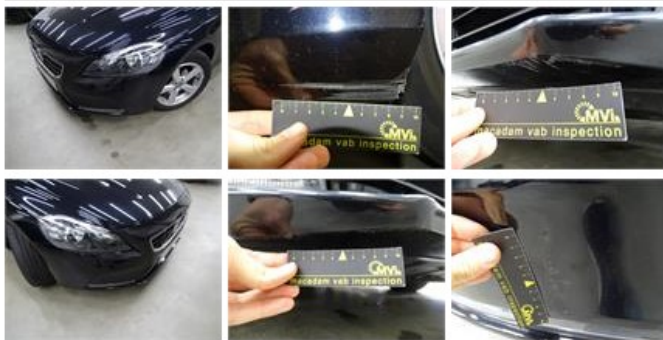
Bumper F, Scratch(es), LI - Repair and paint (complete) 211,80
