VOLKSWAGEN TOURAN: 1PKZ346

Limited Technical Inspection

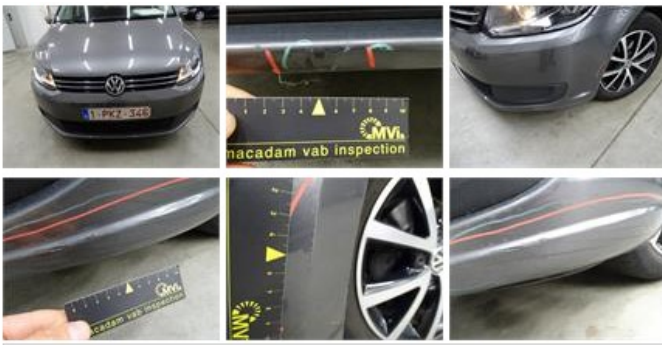
Bumper F, Scratch(es), LI - Repair and paint (complete)

211,80

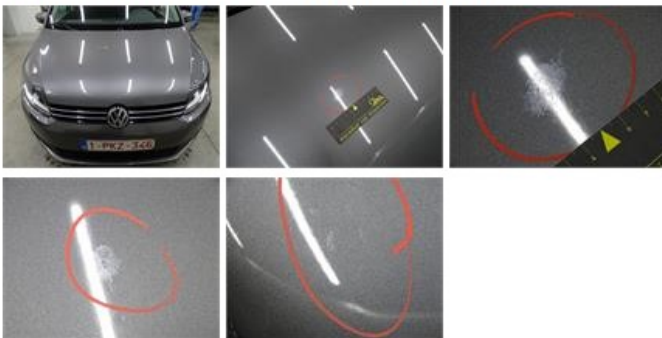
Bonnet, Chemical polution, LI - Repair and paint (complete) 290,08

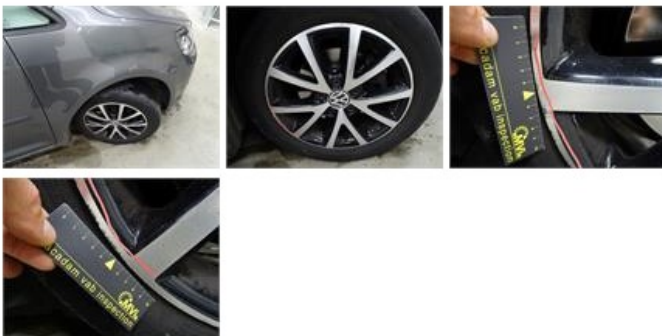
Alloy rim F R polished, Scratch(es), LI - Repair and paint (complete) 95,00

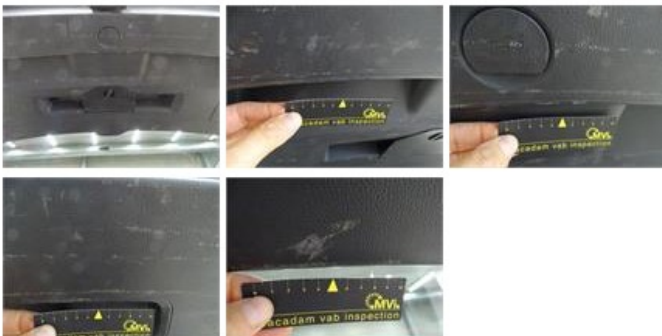
Trunk lid covering R, Scratch(es), Smart repair 110,64

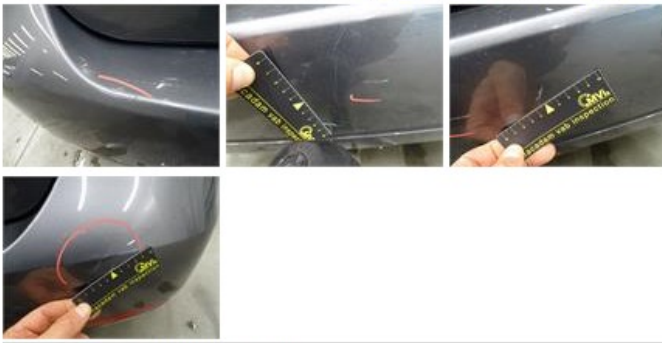
Bumper R, Scratch(es), LI - Repair and paint (complete) 211,80

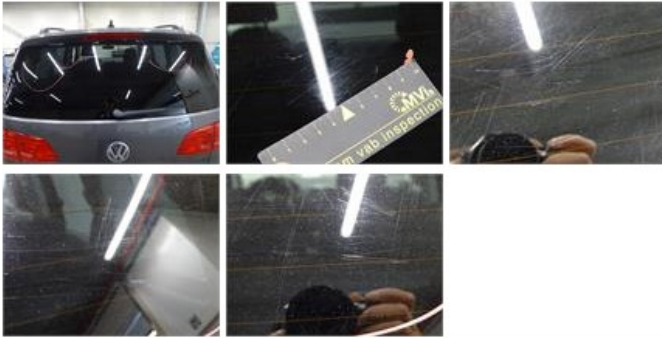
Rear window, Scratch(es), E - Replace 370,00
