VOLVO V60: 1HRH955

Limited Technical Inspection

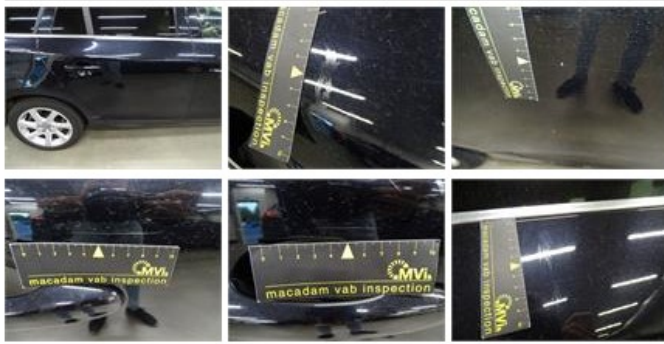
Door R R, Chemical polution, LI - Repair and paint (complete)	318,35
---	--------

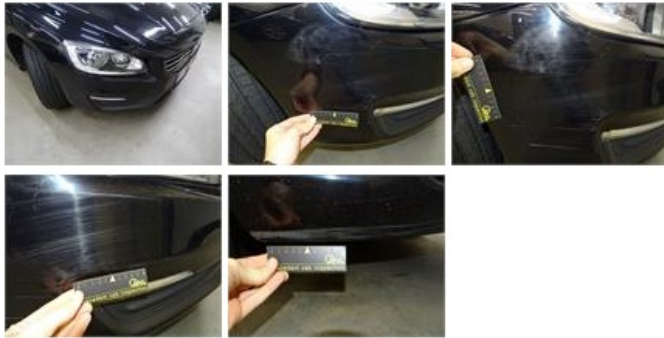
Bumper F, Scratch(es), LI - Repair and paint (complete) 211,80

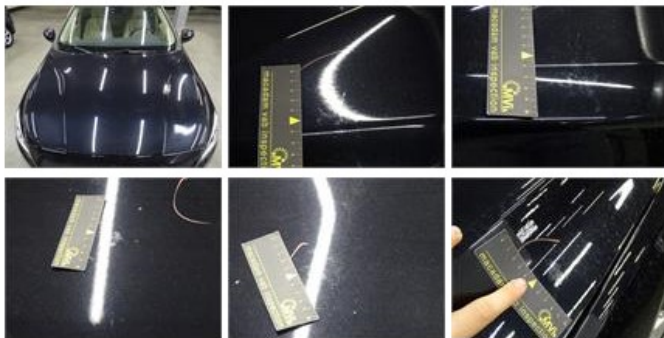
Bonnet, Chemical polution, LI - Repair and paint (complete) 290,08

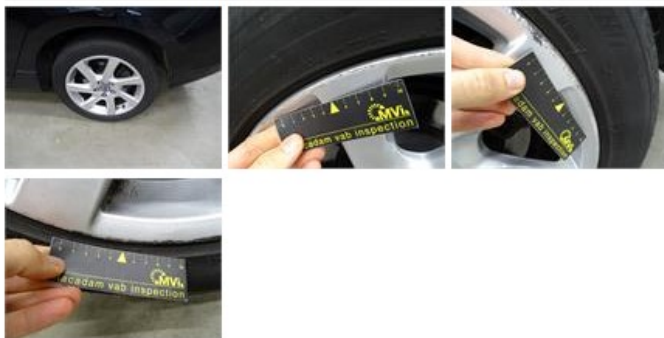
Alloy rim R L, Scratch(es), LI - Repair and paint (complete) 95,00

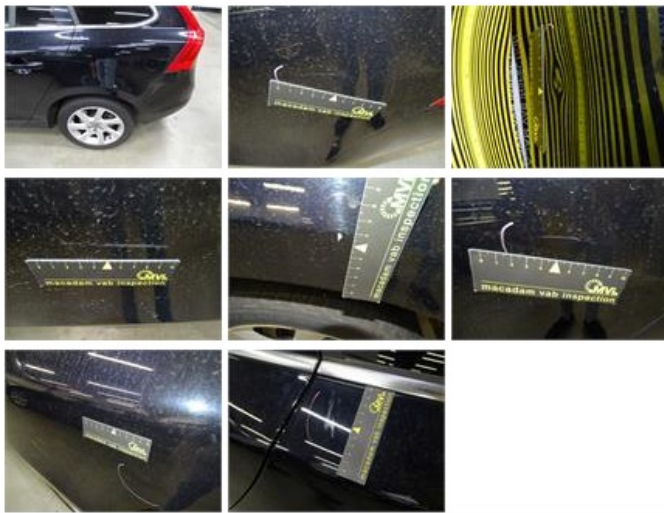
Wing R L, Dent(s) and scratch(es), LI - Repair and paint (complete) 308,20

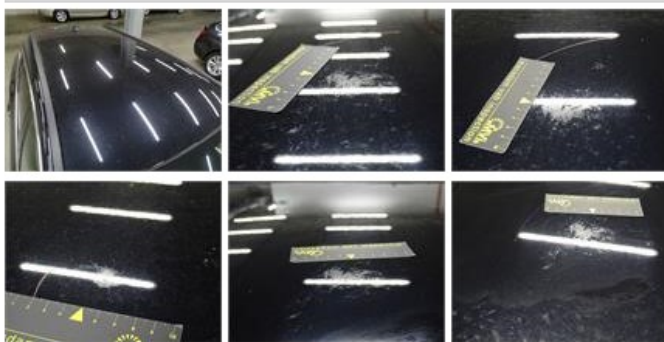
Roof, Chemical polution, LI - Repair and paint (complete) 481,50

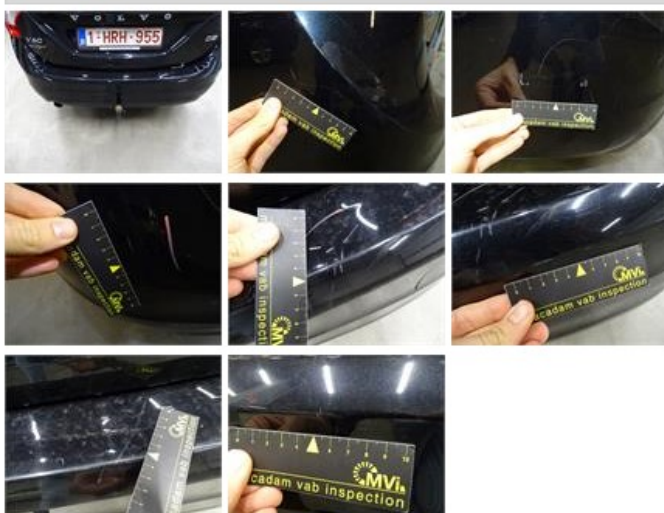
Bumper R, Scratch(es), LI - Repair and paint (complete) 211,80

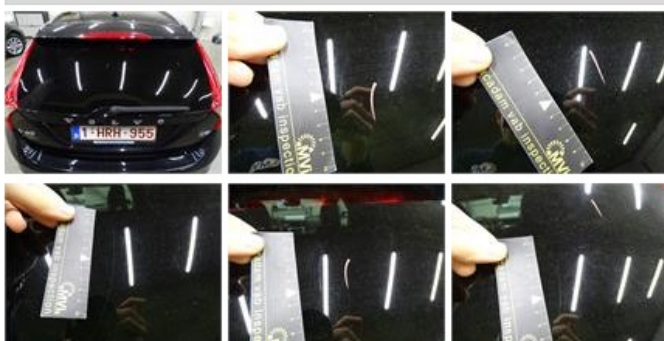
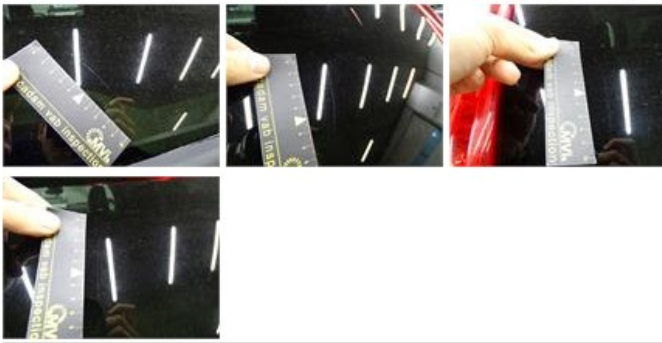
Rear window, Scratch(es), E - Replace 0,00
